Swindon United Charities Almshouses  
(Christ Church Cottages / Anderson's Hostel)

Cricklade Street  
Swindon

**Conservation Statement For  
Swindon United Charities Almshouses  
(Christ Church Cottages / Anderson's Hostel)  
Cricklade Street, Old Town, Swindon**

**In connection with planning application  
reference number: S/LBC/08/1674**

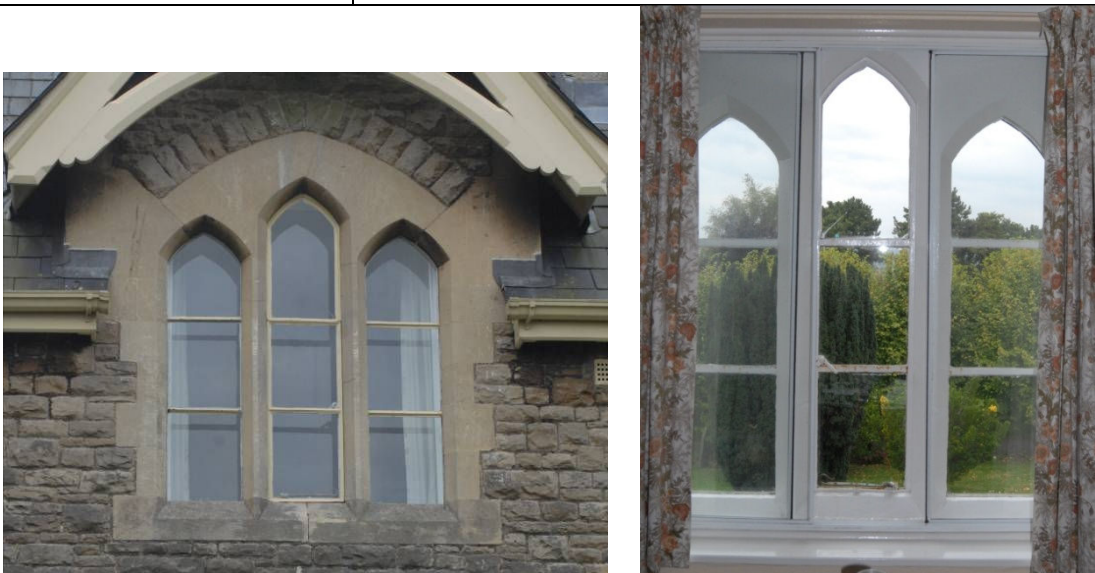
<b>Wall</b>	Front
<b>Window</b>	1

<b>Window ID</b>	1A
<b>Configuration</b>	1x3, upper pane shaped to fit lancet arch
<b>Furniture</b>	None
<b>Defects</b>	Corroding frame, loose putty
<b>Window ID</b>	1B
<b>Configuration</b>	1x2 side-hung casement with single pane over, shaped to fit lancet arch
<b>Furniture</b>	Replacement latch, original stay
<b>Ease of Opening</b>	Difficult
<b>Defects</b>	Top pane cracked in LH and RH lower corners, corroding frame
<b>Window ID</b>	1C
<b>Configuration</b>	1x3, upper pane shaped to fit lancet arch
<b>Furniture</b>	None
<b>Defects</b>

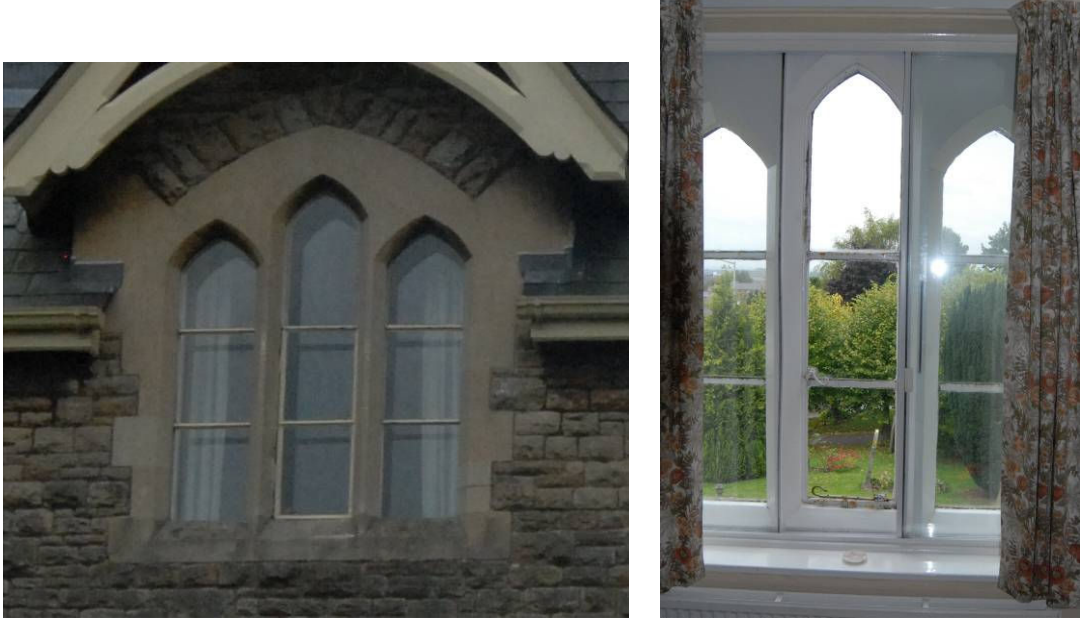
<b>Wall</b>	Front
<b>Window</b>	2

<b>Window ID</b>	2A
<b>Configuration</b>	1x3, upper pane shaped to fit lancet arch
<b>Furniture</b>	None
<b>Defects</b>	
<b>Window ID</b>	2B
<b>Configuration</b>	1x2 side-hung casement with single pane over, shaped to fit lancet arch
<b>Furniture</b>	Original spiral latch, original stay
<b>Ease of Opening</b>	Difficult
<b>Defects</b>	Corroding frame, loose putty, loose stonework adjacent to hinge, ingress of damp
<b>Window ID</b>	2C
<b>Configuration</b>	1x3, upper pane shaped to fit lancet arch
<b>Furniture</b>	None
<b>Defects</b>	Corroding frame, missing putty

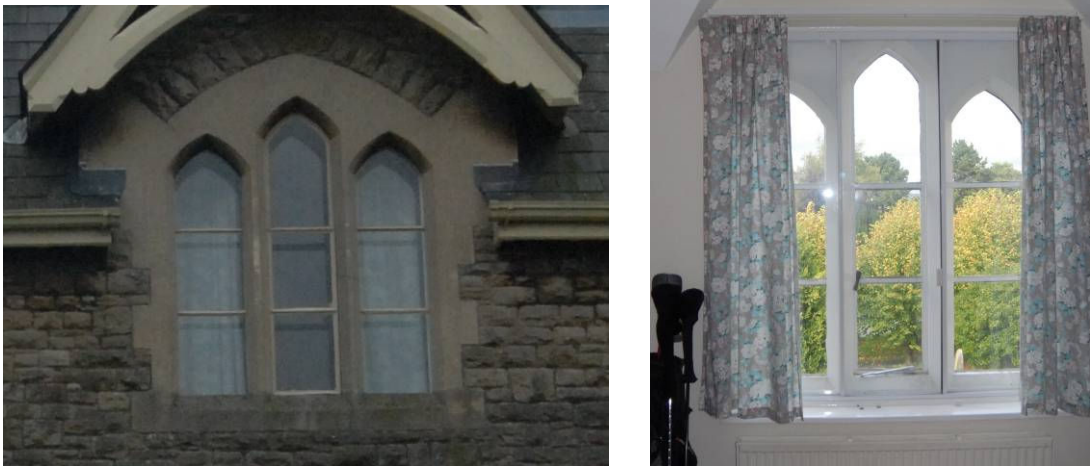
<b>Wall</b>	Front
<b>Window</b>	3

<b>Window ID</b>	3A
<b>Configuration</b>	1x3, upper pane shaped to fit lancet arch
<b>Furniture</b>	None
<b>Defects</b>	Upper pane cracked, bottom left, corroding frame
<b>Window ID</b>	3B
<b>Configuration</b>	1x2 side-hung casement with single pane over, shaped to fit lancet arch
<b>Furniture</b>	Replacement latch and stay
<b>Ease of Opening</b>	Opens easily
<b>Defects</b>	Corroding frame, loose putty, latch broken Window cannot be secured
<b>Window ID</b>	3C
<b>Configuration</b>	1x3, upper pane shaped to fit lancet arch
<b>Furniture</b>	None
<b>Defects</b>	Corroding frame

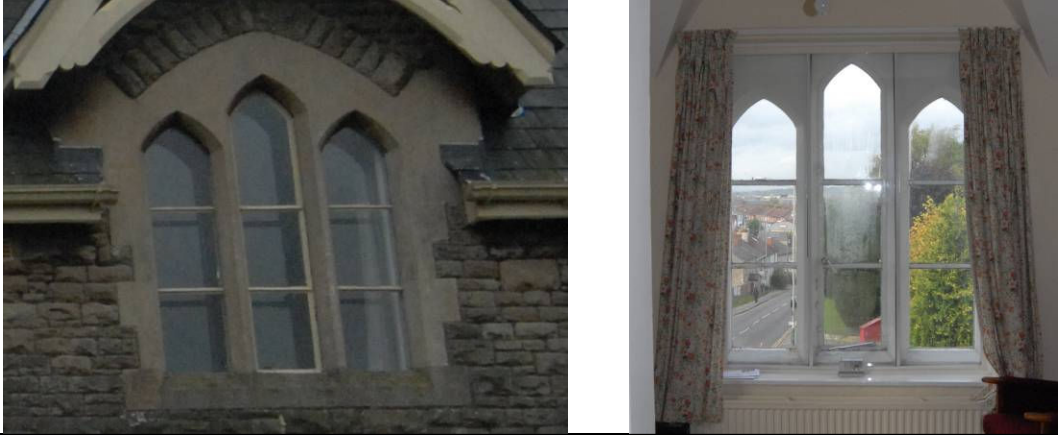
<b>Wall</b>	Front
<b>Window</b>	4

<b>Window ID</b>	4A
<b>Configuration</b>	1x3, upper pane shaped to fit lancet arch
<b>Furniture</b>	None
<b>Defects</b>	Upper pane cracked, bottom left, corroding frame
<b>Window ID</b>	4B
<b>Configuration</b>	1x2 side-hung casement with single pane over, shaped to fit lancet arch
<b>Furniture</b>	Replacement latch and stay
<b>Ease of Opening</b>	Difficult
<b>Defects</b>	Corroding frame, loose putty
<b>Window ID</b>	4C
<b>Configuration</b>	1x3, upper pane shaped to fit lancet arch
<b>Furniture</b>	None
<b>Defects</b>	Corroding frame

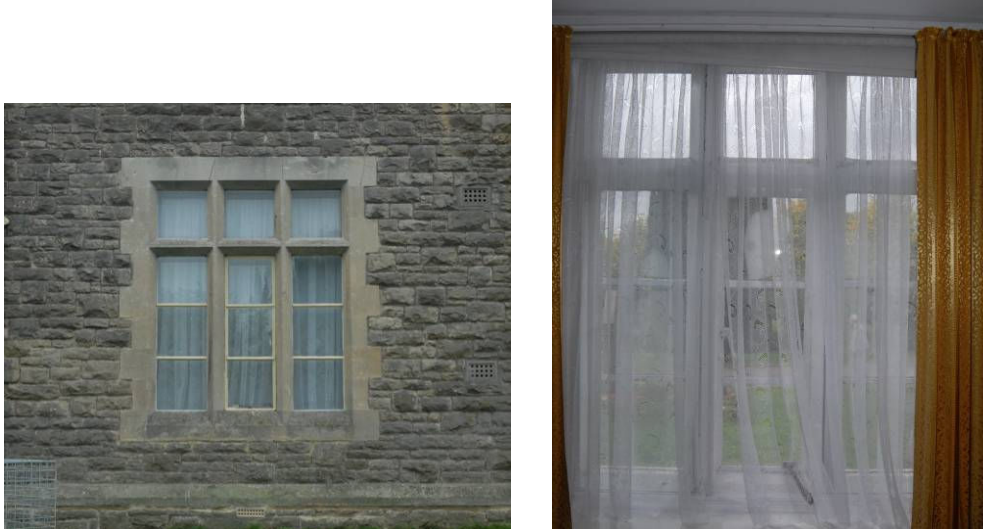
<b>Wall</b>	Front
<b>Window</b>	5

<b>Window ID</b>	5A
<b>Configuration</b>	Single square pane
<b>Furniture</b>	None
<b>Defects</b>	
<b>Window ID</b>	5B
<b>Configuration</b>	Single square pane
<b>Furniture</b>	None
<b>Defects</b>	
<b>Window ID</b>	5C
<b>Configuration</b>	Single square pane
<b>Furniture</b>	None
<b>Defects</b>	
<b>Window ID</b>	5D
<b>Configuration</b>	1x3
<b>Furniture</b>	
<b>Defects</b>	Corroding frame, cracked centre pane
<b>Window ID</b>	5E
<b>Configuration</b>	1x3 side-hung casement
<b>Furniture</b>	Replacement latch, original stay
<b>Ease of Opening</b>	Difficult
<b>Defects</b>	Corroding frame, missing putty
<b>Window ID</b>	5F
<b>Configuration</b>	1x3
<b>Furniture</b>	None
<b>Defects</b>	Corroding frame

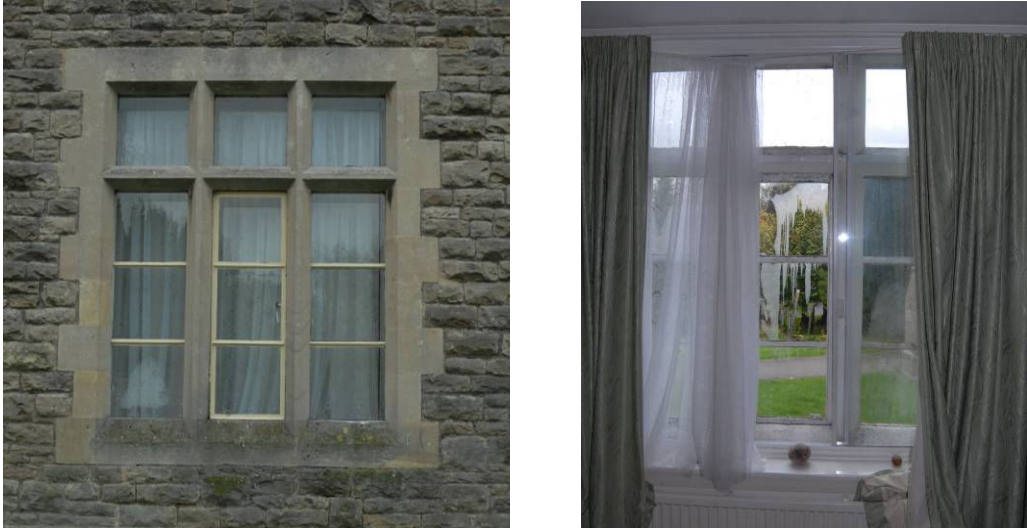
<b>Wall</b>	Front
<b>Window</b>	6

<b>Window ID</b>	6A
<b>Configuration</b>	Single square pane
<b>Furniture</b>	None
<b>Defects</b>	
<b>Window ID</b>	6B
<b>Configuration</b>	Single square pane
<b>Furniture</b>	None
<b>Defects</b>	
<b>Window ID</b>	6C
<b>Configuration</b>	Single square pane
<b>Furniture</b>	None
<b>Defects</b>	
<b>Window ID</b>	6D
<b>Configuration</b>	1x3
<b>Furniture</b>	
<b>Defects</b>	Corroding frame
<b>Window ID</b>	6E
<b>Configuration</b>	1x3 side-hung casement
<b>Furniture</b>	Replacement latch, stay absent
<b>Ease of Opening</b>	Difficult
<b>Defects</b>	Casement stay missing, ingress of damp, corroding frame
<b>Window ID</b>	6F
<b>Configuration</b>	1x3
<b>Furniture</b>	None
<b>Defects</b>	Corroding frame

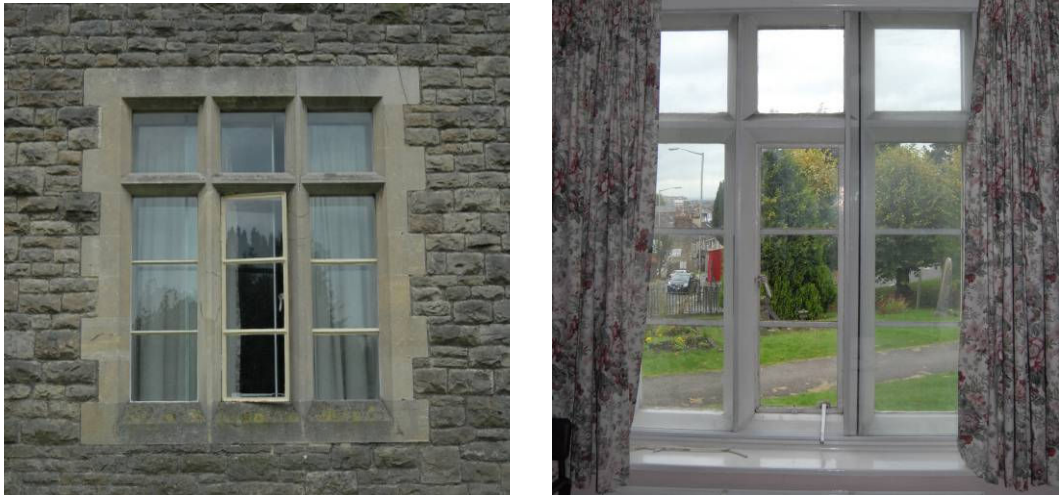
<b>Wall</b>	Front
<b>Window</b>	7

<b>Window ID</b>	7A
<b>Configuration</b>	Single square pane
<b>Furniture</b>	None
<b>Defects</b>	
<b>Window ID</b>	7B
<b>Configuration</b>	Single square pane
<b>Furniture</b>	None
<b>Defects</b>	
<b>Window ID</b>	7C
<b>Configuration</b>	Single square pane
<b>Furniture</b>	None
<b>Defects</b>	
<b>Window ID</b>	7D
<b>Configuration</b>	1x3
<b>Furniture</b>	
<b>Defects</b>	
<b>Window ID</b>	7E
<b>Configuration</b>	1x3 side-hung casement
<b>Furniture</b>	Replacement latch, replacement modern stay
<b>Ease of Opening</b>	Very difficult - can only be opened after applying considerable force
<b>Defects</b>	Corroding frame, will not close / open without considerable force
<b>Window ID</b>	7F
<b>Configuration</b>	1x3
<b>Furniture</b>	None
<b>Defects</b>	Corroding frame

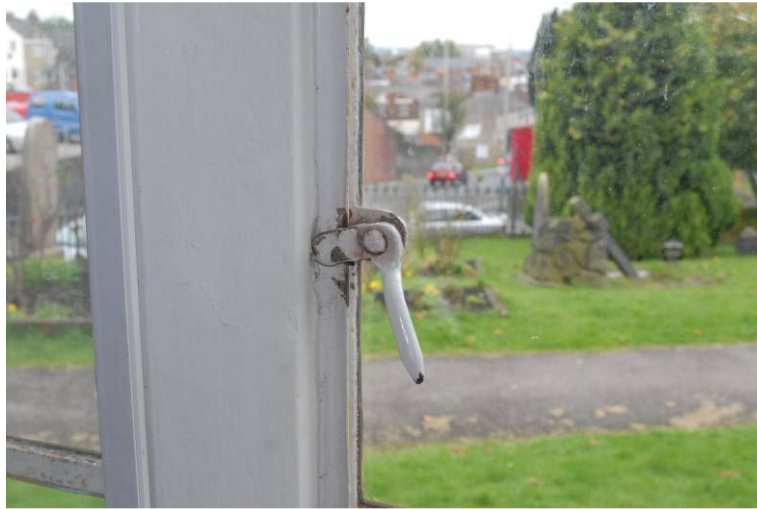
## Window 7 Detail

Note screwdriver marks

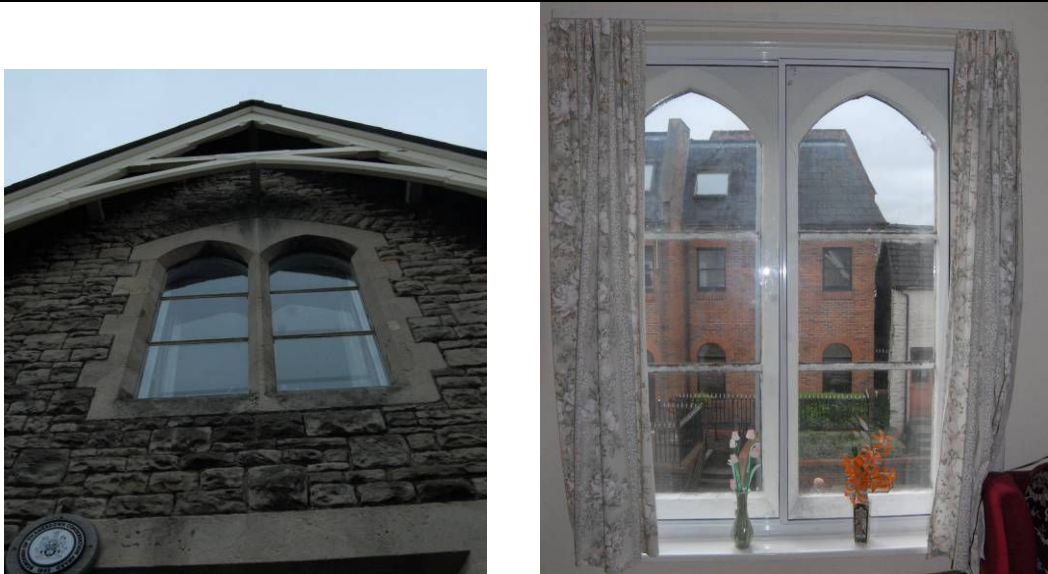
<b>Wall</b>	Side
<b>Window ID</b>	1

<b>Window ID</b>	1A
<b>Configuration</b>	1x3, upper pane shaped to fit lancet arch
<b>Furniture</b>	
<b>Defects</b>	Corroding frame
<b>Window ID</b>	1B
<b>Configuration</b>	1x3, upper pane shaped to fit lancet arch
<b>Furniture</b>	
<b>Defects</b>	Corroding frame
