***Building Recording Report***

***The Barn, Betwyns Garage,  
Station Road, Goring on Thames***

**The Barn, Betwyns Garage,  
Station Road, Goring-on-Thames, Oxfordshire**

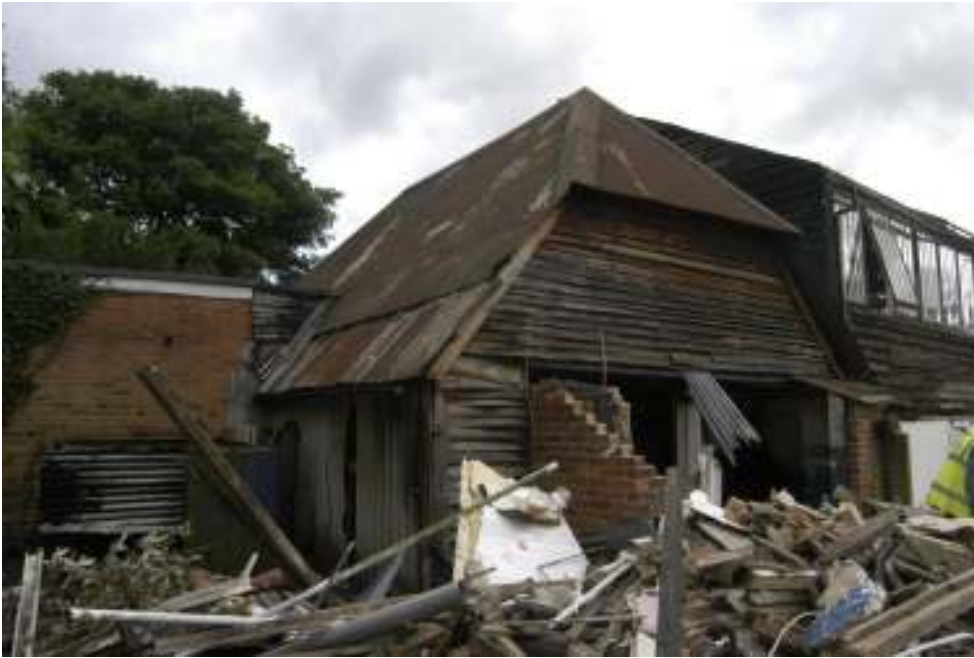
***Figure 3: The barn prior to demolition, NW elevation***

As can be seen in figure 3, the barn had a half-hipped roof, more recently covered in corrugated metal sheet, whereas the north wall was covered in cement-bonded asbestos up until it joined the brick building to the left of the picture. The barn is likely to have been thatched when originally built. The west wall featured a brick extension, although this had been demolished prior to the site visit. The west wall was timber clad in a similar style to that of the main building to the south. It is thought that this cladding is not original, and that the earlier timber facing was replaced contemporary to the cladding of the main building.

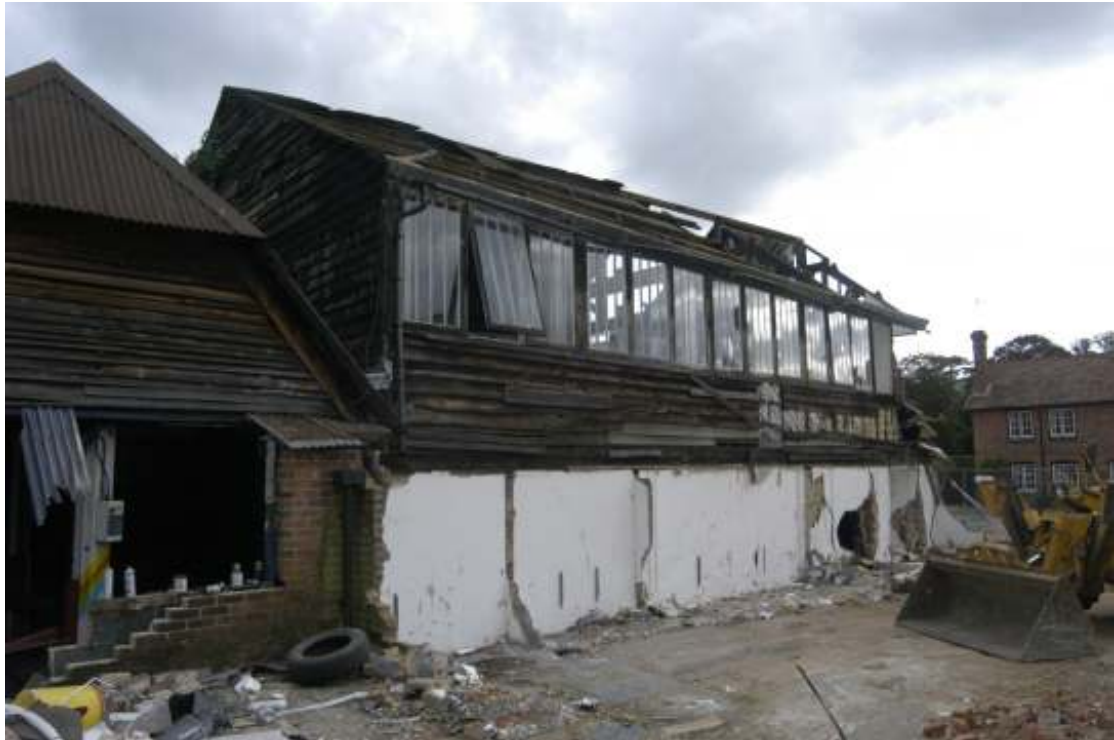
**Figure 5: West elevation of barn and main workshop**

The southern side of the barn was amalgamated into the main workshop building. The wall of the barn had been removed to allow vehicle access between the structures.

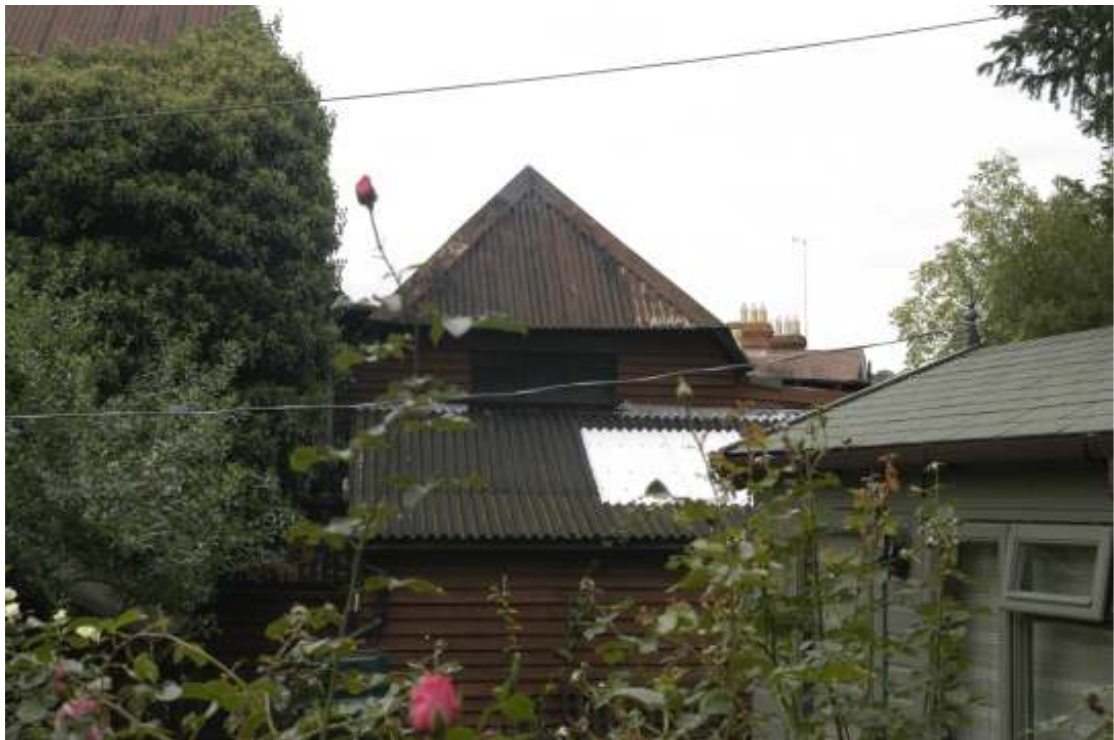
**Figure 6: East elevation of barn**

As can be seen from figure 6, the eastern end of the barn had a small extension again with a corrugated roof. This extension was more apparent inside. The extension also formed the property boundary.

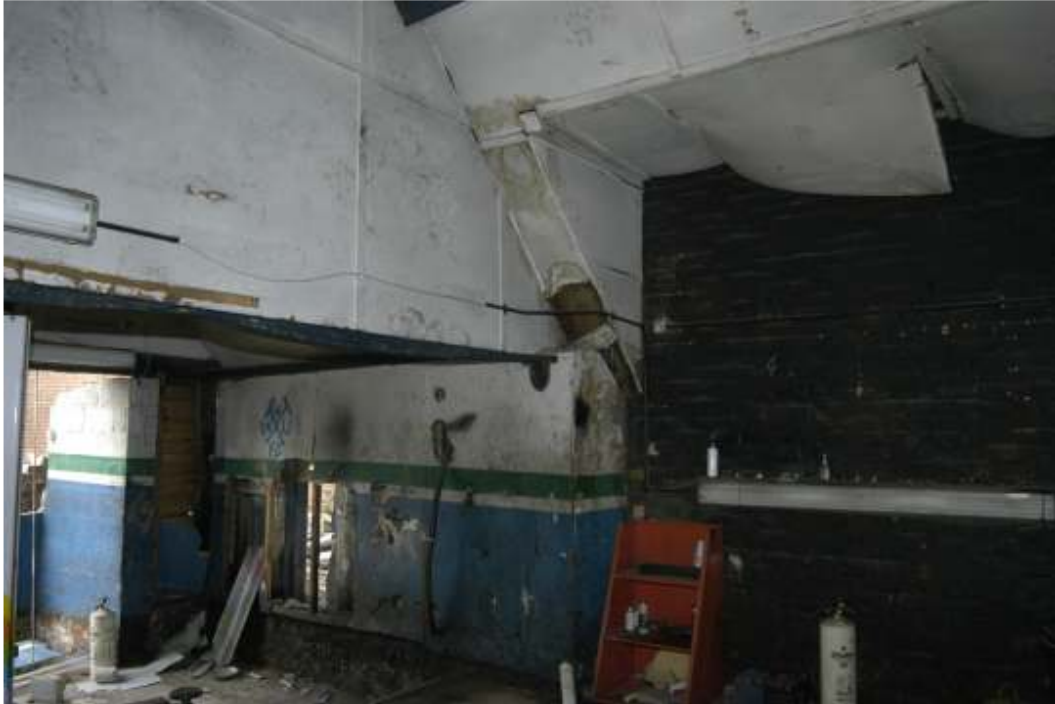
*Figure 7: Interior, northern elevation*

The northern wall of the barn had incurred several modifications in its existence. To the left of figure 7, the stepped-in western extension can be seen, and to the right of the image, the black wall is present where the brick building shown in figure 3 has been built onto the barn at some point in the 20<sup>th</sup> century. The middle portion appears to be the original wall of the barn, now clad with cement bonded asbestos sheet to the exterior and timber battens supporting hardboard on the interior face.

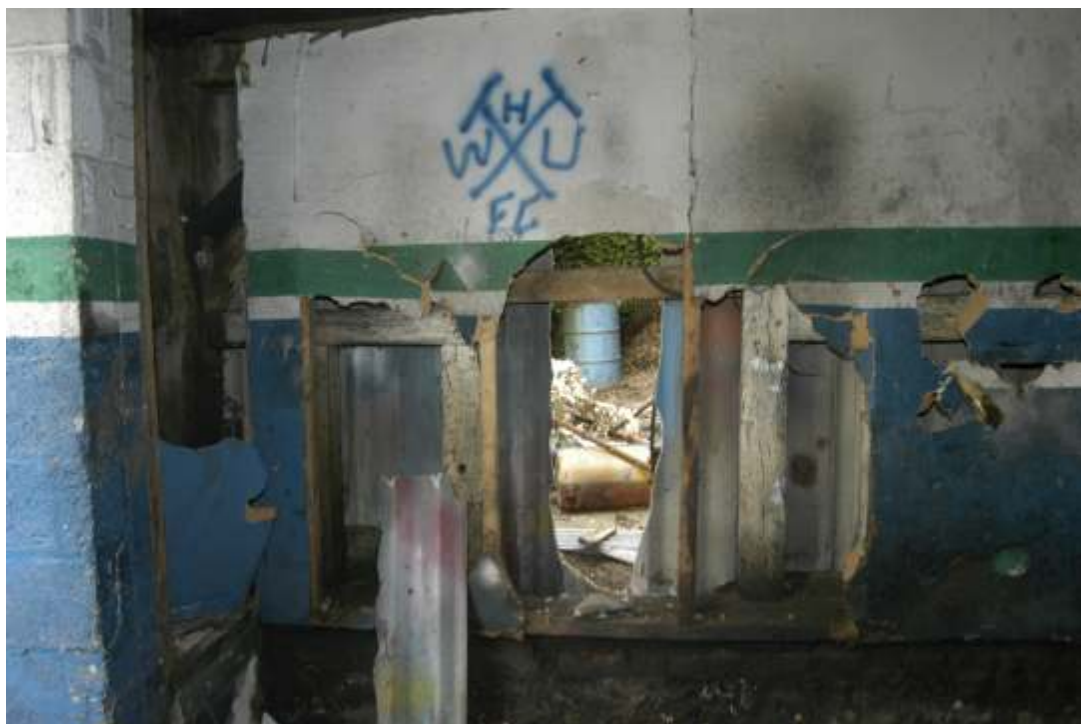
*Figure 8: North wall detail, showing original timbers*

Figure 8 illustrates some of the original timbers visible through holes in the interior cladding created by vandals. Either side of the hole through which daylight can be seen, a post can be seen, with beams horizontally above. In the top left corner, an angle brace is visible leading from a post off to the right. Angle braces are common from the 14<sup>th</sup> century onwards.

In addition to the timbers, the absent hardboard and the piece of corrugated material in the foreground indicates that prior to the application of hardboard, the barn may well have been used as a paint spray-shop, owing to the appearance of paint sprayed on the inside of the exterior wall – a common procedure to test the spray-gun before applying paint to the subject.

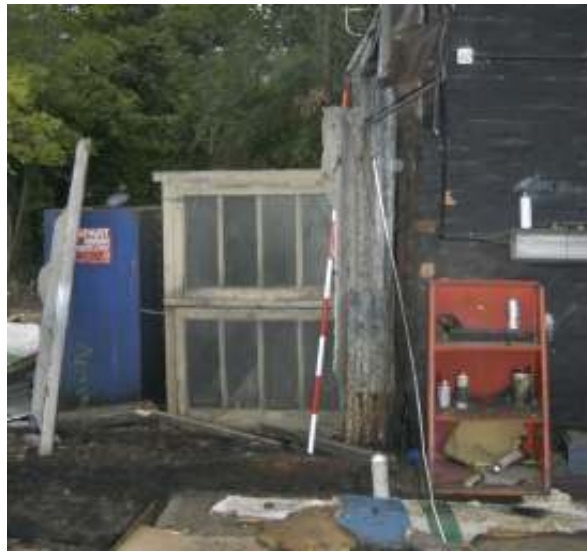
**Figure 9: North wall following demolition**

The north wall was examined following partial demolition. It is clear from figure 9 that at one stage windows were inserted into the wall. These were still glazed, although some panes have been broken. Also visible was a timber sill to which the structural posts were fixed.

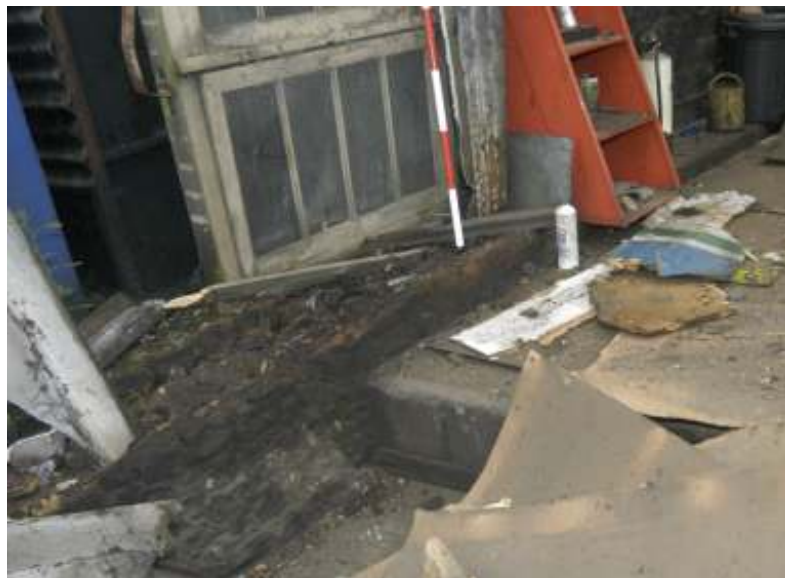
**Figure 10: Timber sill beneath the north wall**

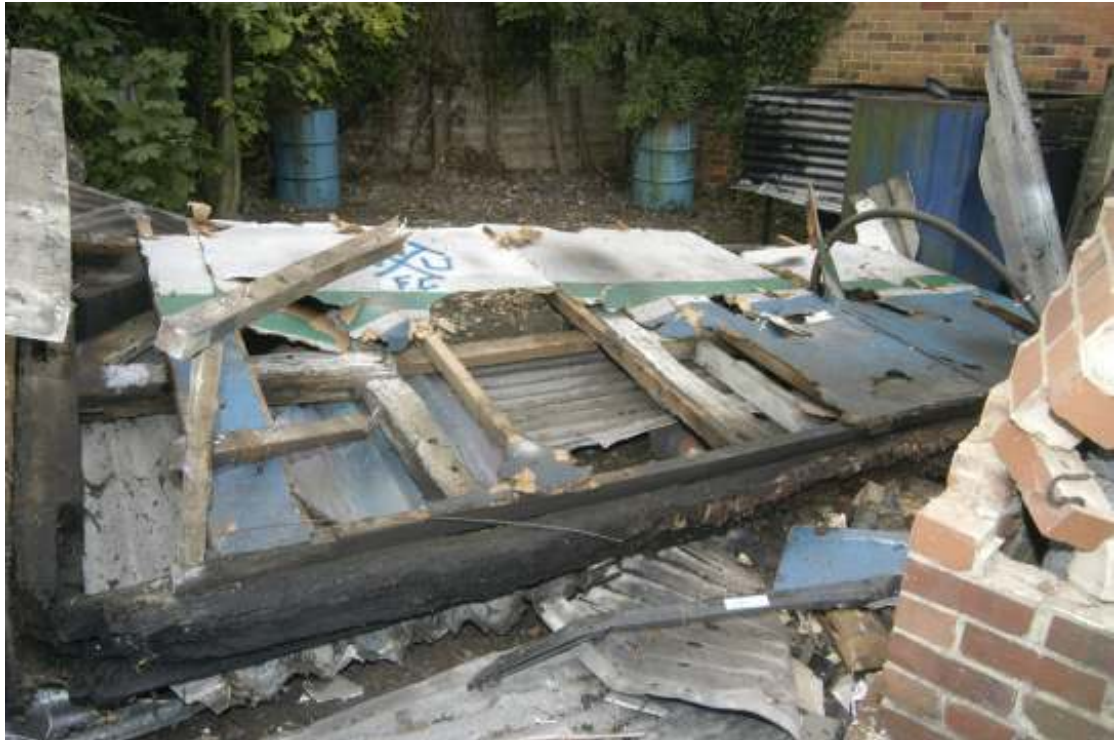
*Figure 11: The north wall following demolition, part of the sill clearly visible*

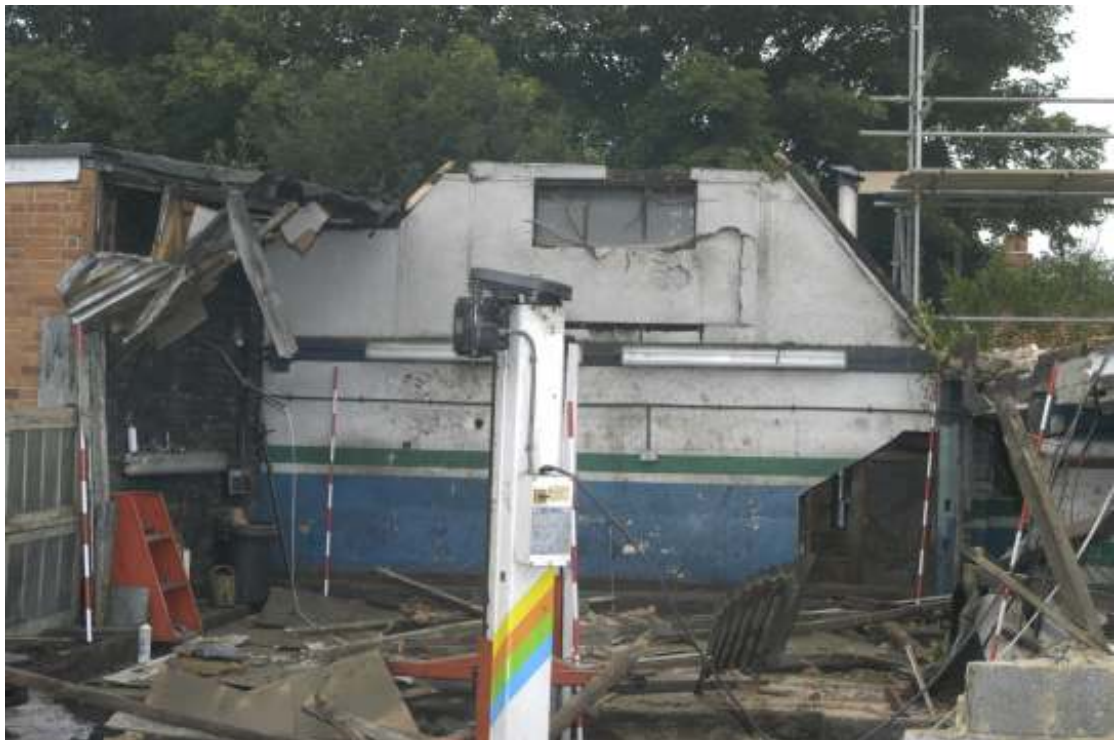
*Figure 12: The eastern wall of the barn*

The eastern wall of the barn was similarly clad with hardboard although a section was cut away in the southern corner for access to what is thought to have been a boiler. The east wall, like the north, was also fixed to a timber sill, visible below the hardboard wall.

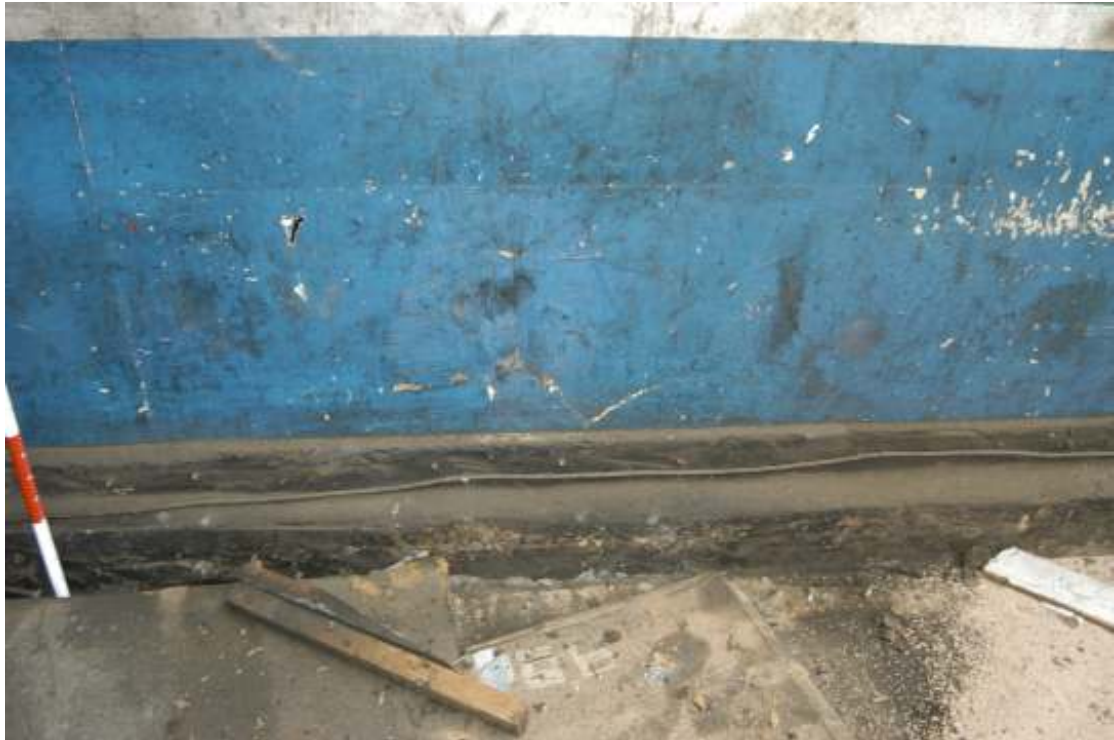
**Figure 13: Timber sill beneath eastern wall**

Examining the boiler recess in the east wall (figure 13), it is apparent that the majority of the eastern extension is not used.

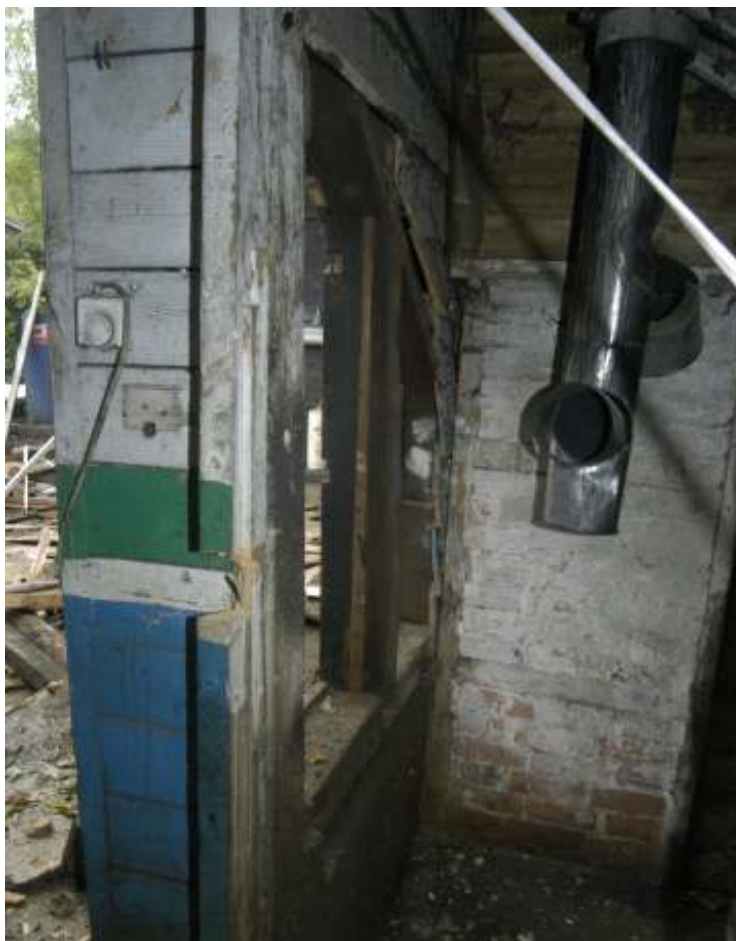
**Left: Figure 14: Boiler recess, east wall**

Figure 14 illustrates the reason for the shape of the cut-out in the east wall into the boiler recess. The cut follows the line of a diagonal strut in the original timber frame. Looking above this strut, it is possible that some of the original shuttering remained, in this case, whitewashed.

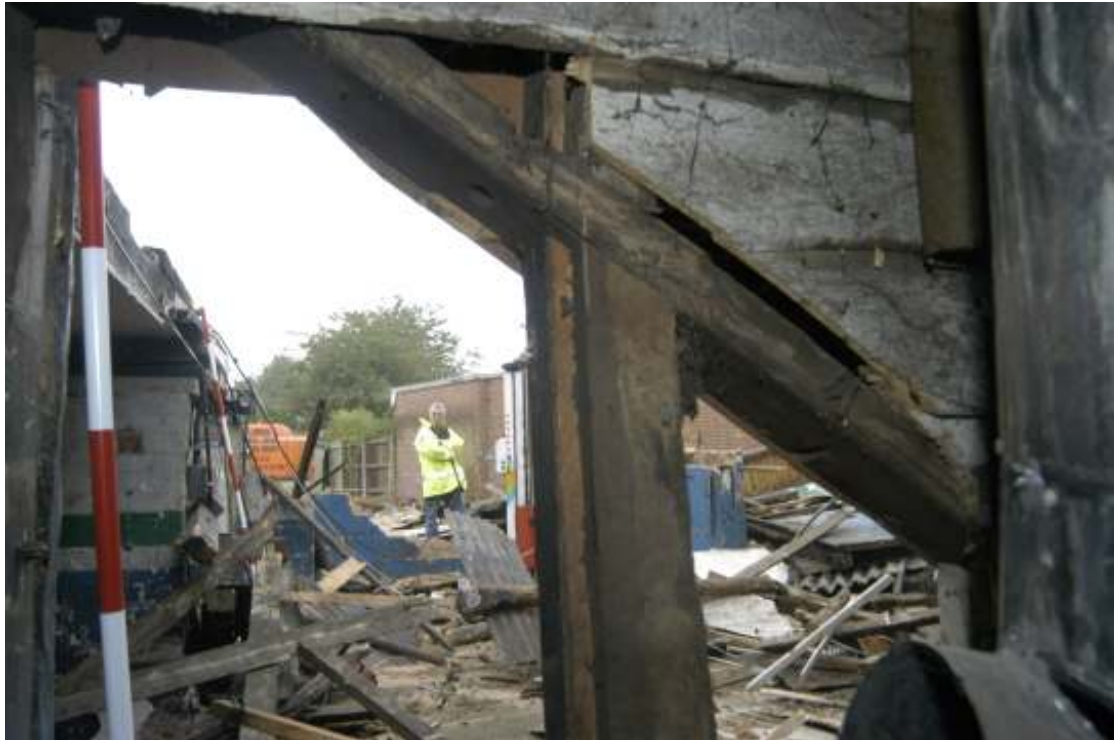
**Figure 15: Cut-out in east wall showing timbers and possible original cladding**

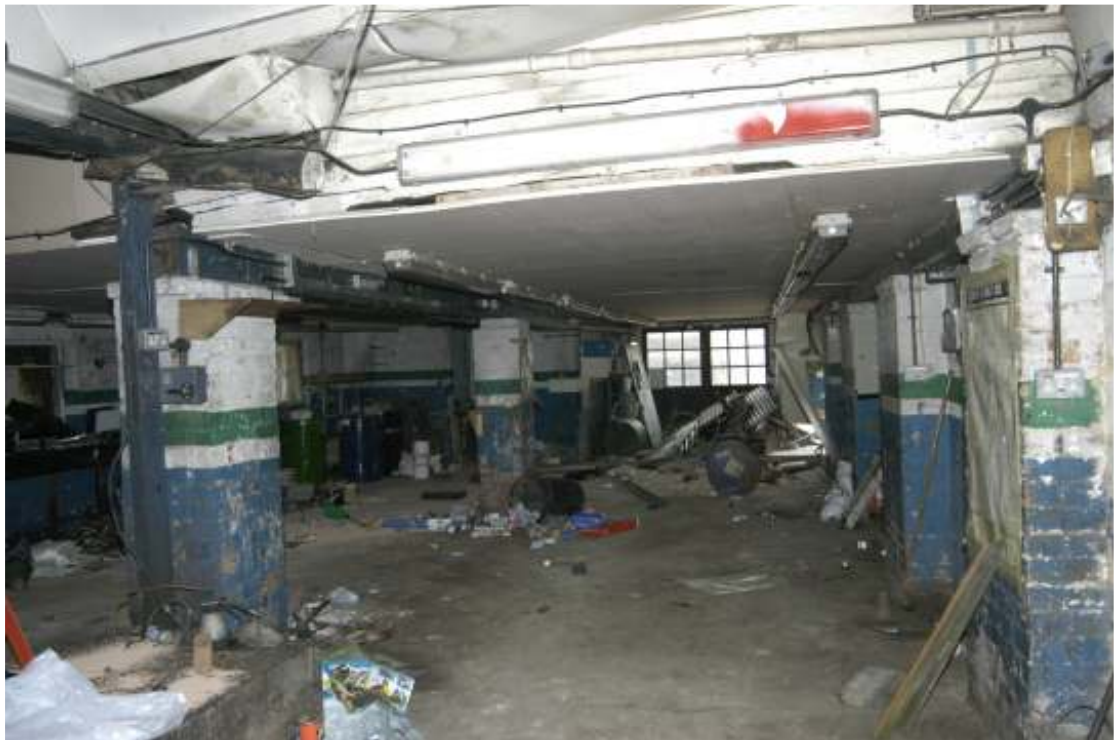
**Figure 16: South of the barn, the main workshop**

It is clear that on the construction of the main garage, the south wall of the barn was removed in order to join the structures. Wooden posts were installed to support the tie beams and the wall plates were cut off (see figure 16).

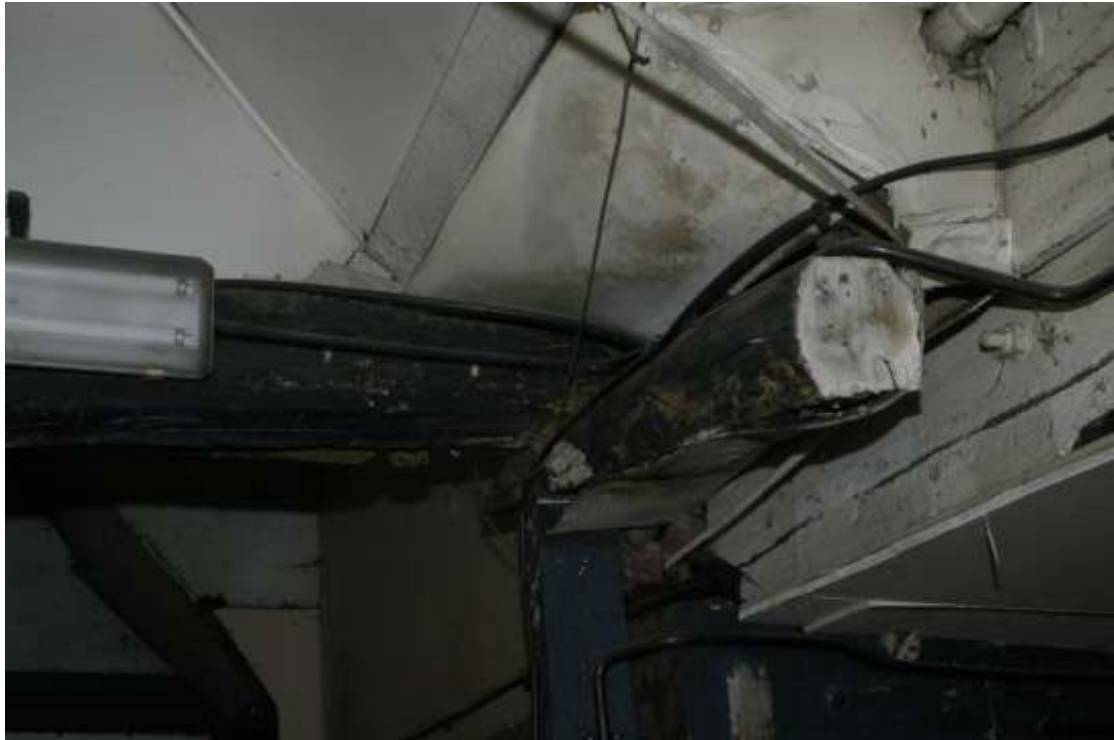
*Figure 17: Wall plate truncated when new garage constructed*

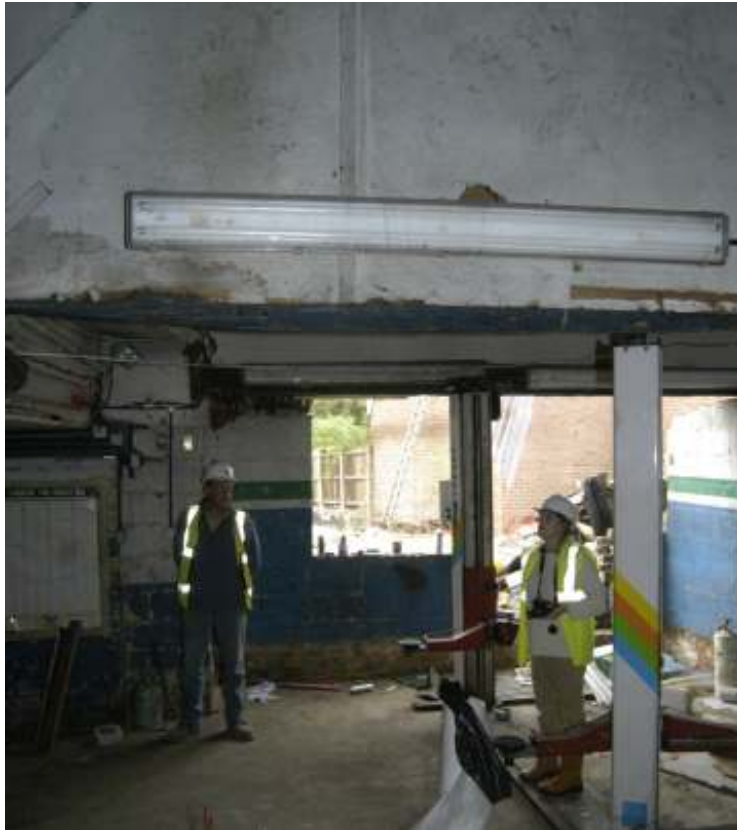
**Figure 19: West elevation of barn**

It is thought that the majority of the west wall had been destroyed in the construction of the extension, and that nothing historically significant remained.

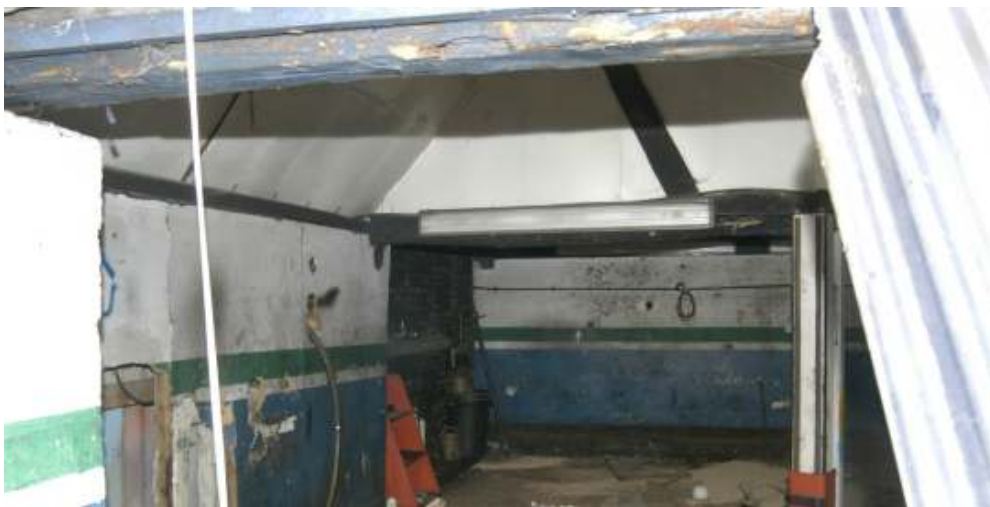
**Figure 20: Central truss partially visible showing panelling either side of queen post**

The roof had a single central truss that was also panelled between timbers, which were generally painted in a considerably darker tone than the white panelling throughout the roof.

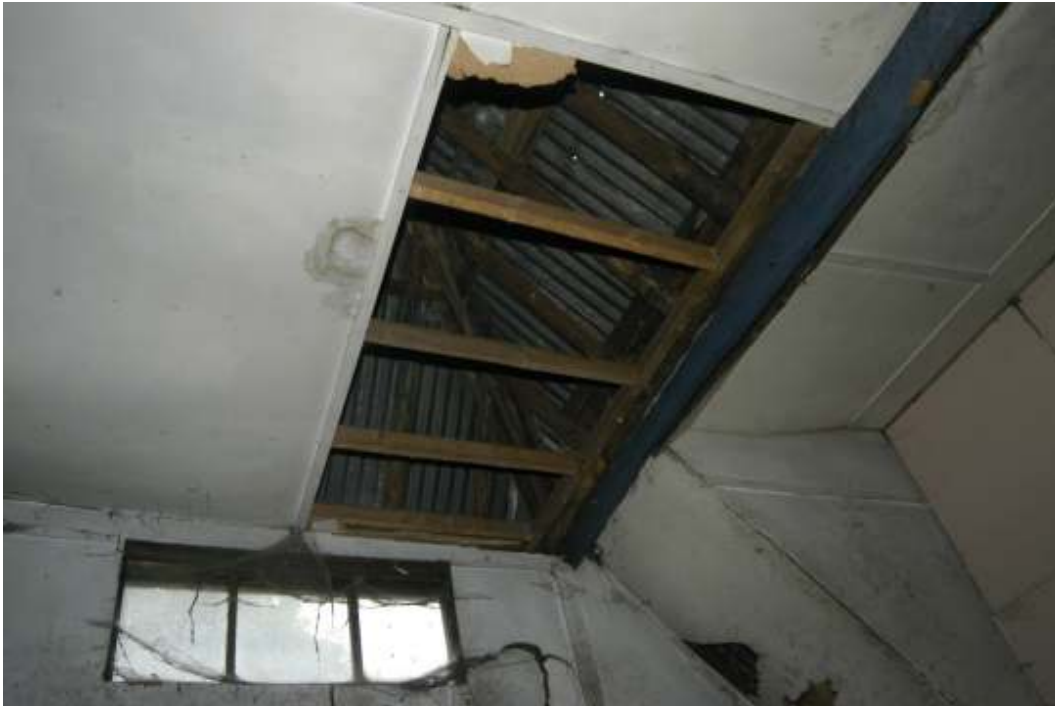
**Figure 21: Roof panelling removed showing original timbers above**

From photographic evidence, the roof appeared to be in good condition.

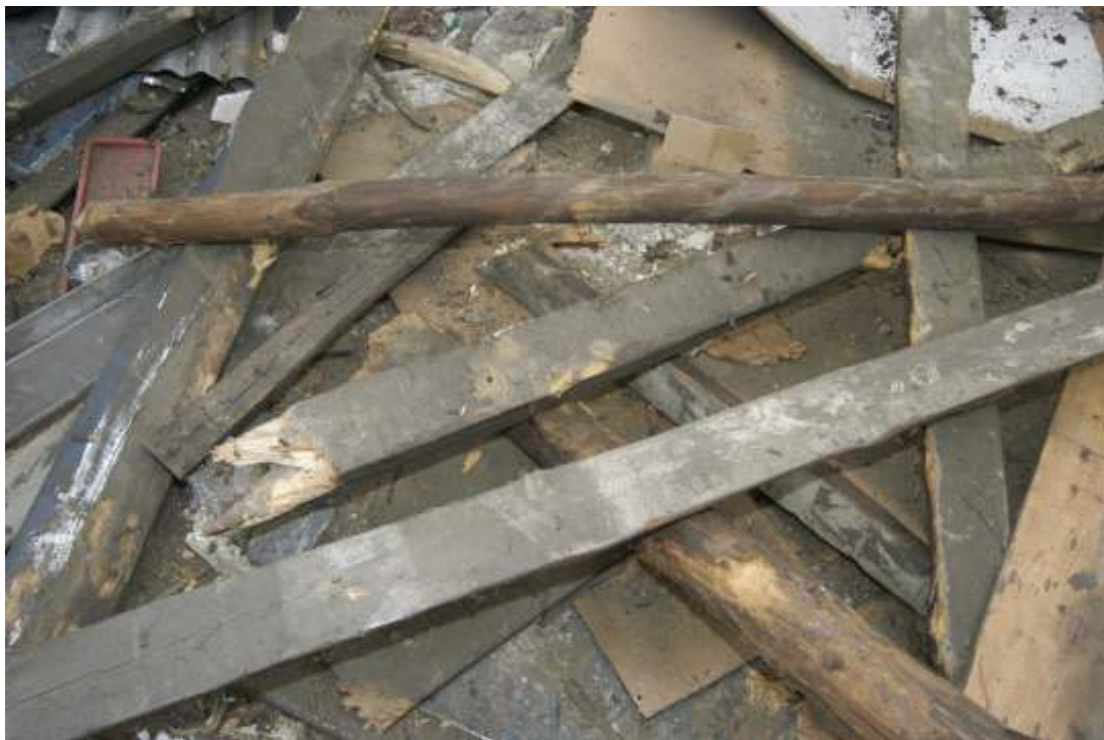
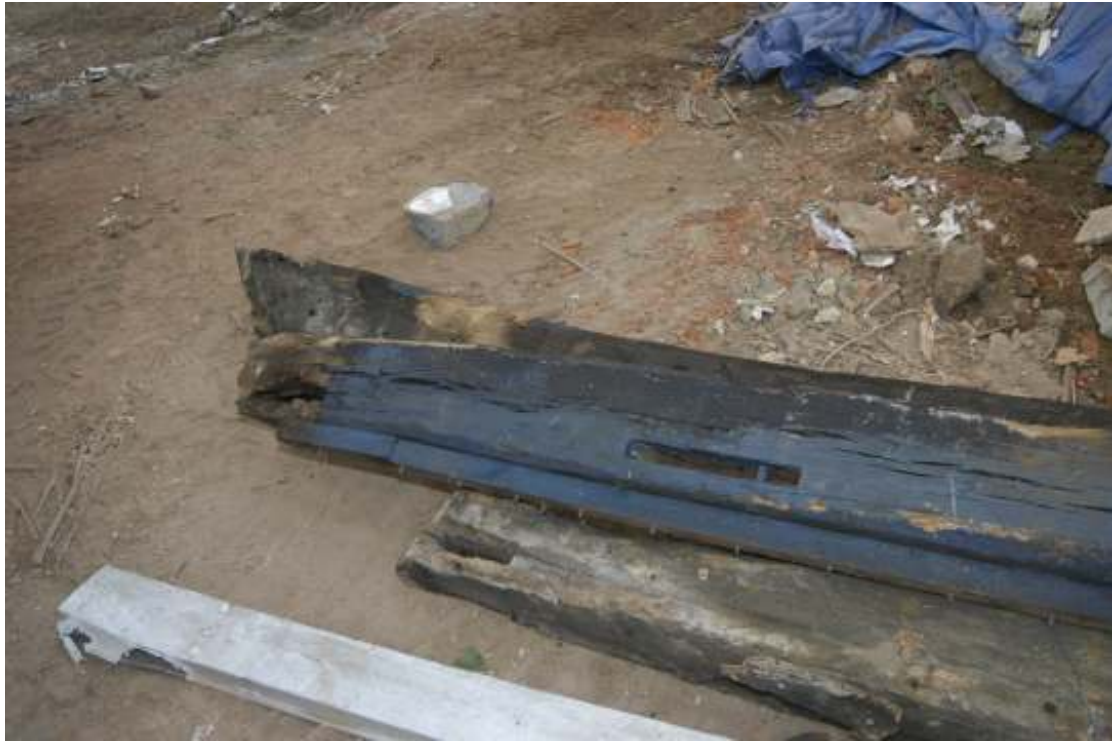
Due to the difficulty and hurried nature in recording the barn, it is impossible to assess the building fully. With the inability to remove wall coverings, it was unfeasible to assess the surviving structure of the building, or its condition. Examination of timbers following demolition suggests that c. 80% of the original structure remained and the vast majority of this was still in good sound condition.
