CONSERVATION STATEMENT

**MANOR FARM
LOWER SLAUGHTER
GLOUCESTERSHIRE**

**Conservation Statement
For
Manor Farm
Lower Slaughter, Gloucestershire**

Site Name	Manor Farm
Address	Lower Slaughter
County	Gloucestershire
NGR	SP167225
Listing	Not Listed – Curtilage of Grade II farmhouse and wall
Conservation Area	Lower Slaughter Conservation Area
Material	Cotswold Limestone
Date	18 th century – modern
Function	Farm
Alterations	Conversion to residential accommodation and stables
Original Features	Cart shed, threshing barn, barn
Historic Interest	Fair
Architectural Merit	Fair
Degree of Alteration	Very high

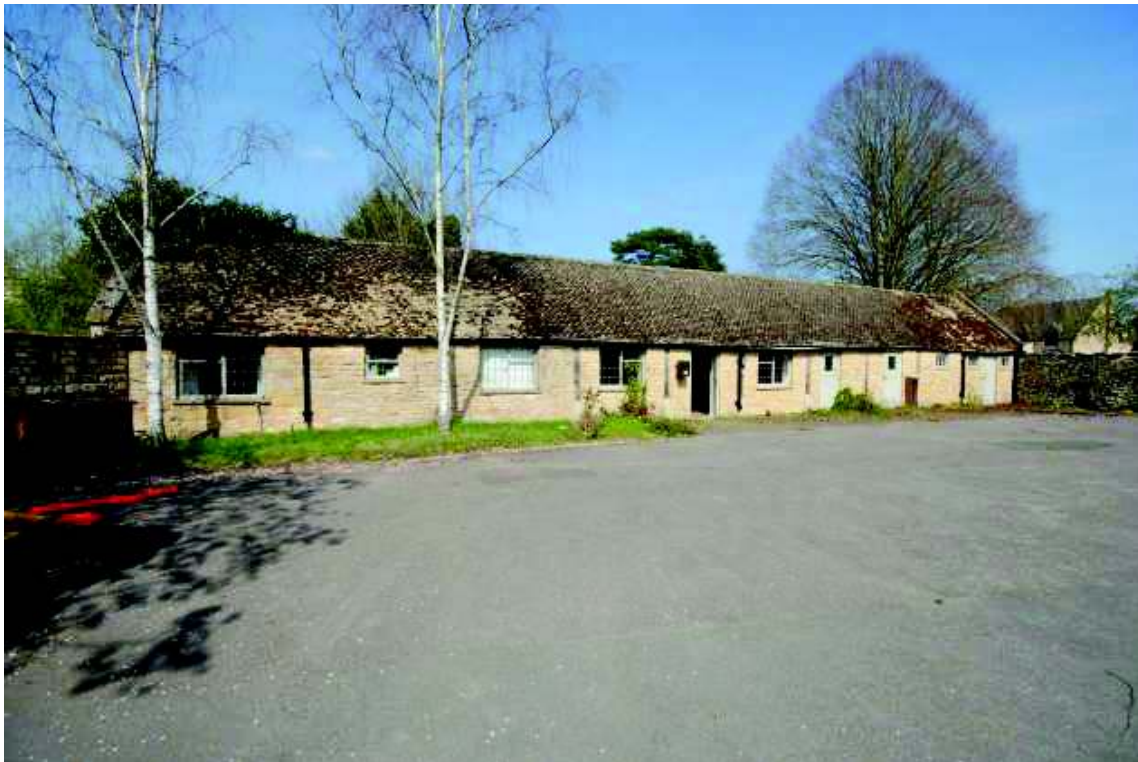
Plate 1: Southern elevation, building 1

Building 1 was constructed as a large ten bay cart shed bordering Copse Hill Road. It forms the northern boundary of the farmyard and has been converted into office accommodation.

The cart shed is one of the older buildings on the site, however it has been extensively adapted in the modern period. The building is constructed of limestone walls with a timber framed roof. The timbers are visible on the inside of the building and are hand-sawn hardwood. Although sawmills were introduced in c. 1790, hand sawing of timber continued to be popular well into the 19th century, especially in rural areas.

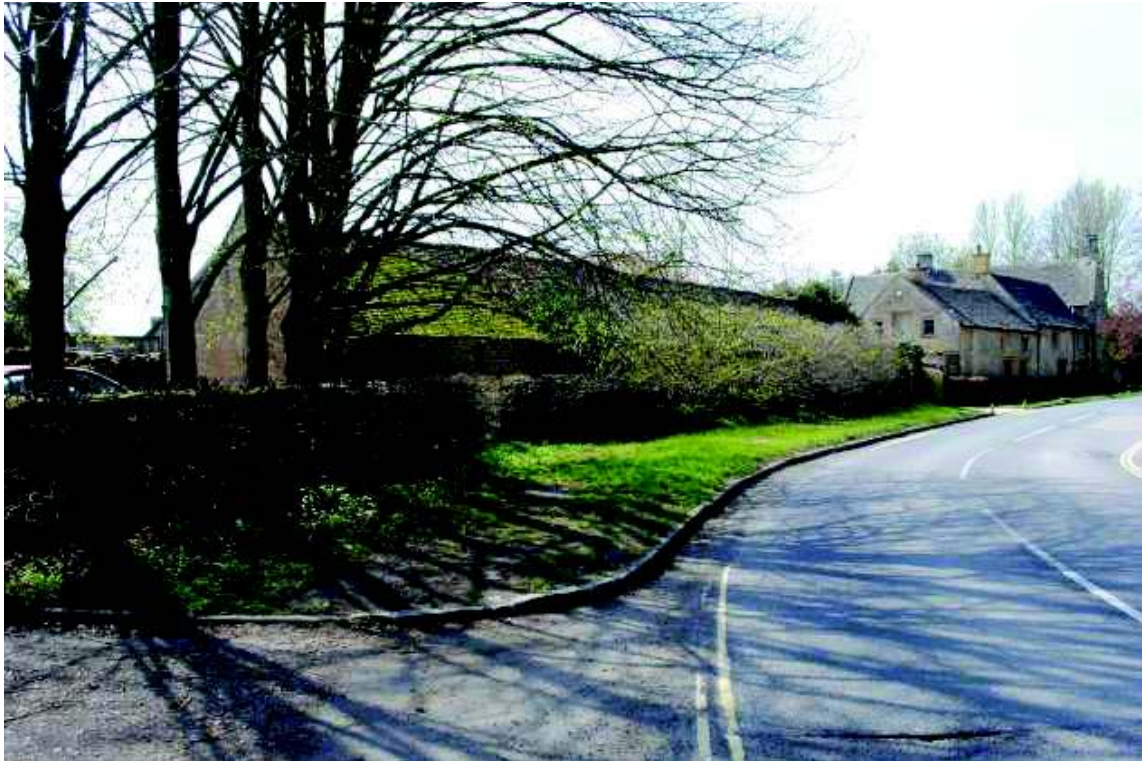
Plate 2: Rear (northern) aspect, building 1, viewed from road

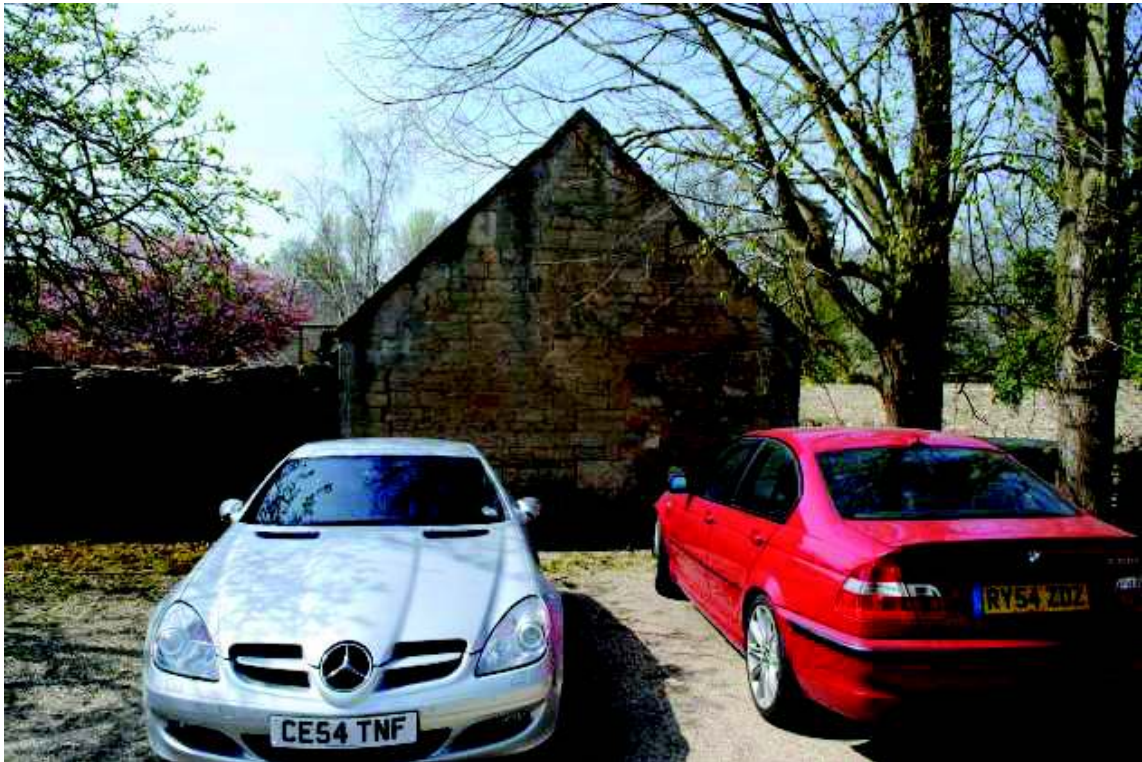
Plate 3: East elevation, building 1

The original eastern wall faces the entrance to the farm from the road. The wall is largely of dressed stone blocks on a base of c. 5 courses of undressed stone. At the northern end of the eastern wall, the outline and lintel of a doorway is apparent, now filled with stone to match the remainder of the wall. The date of this infill is unknown.

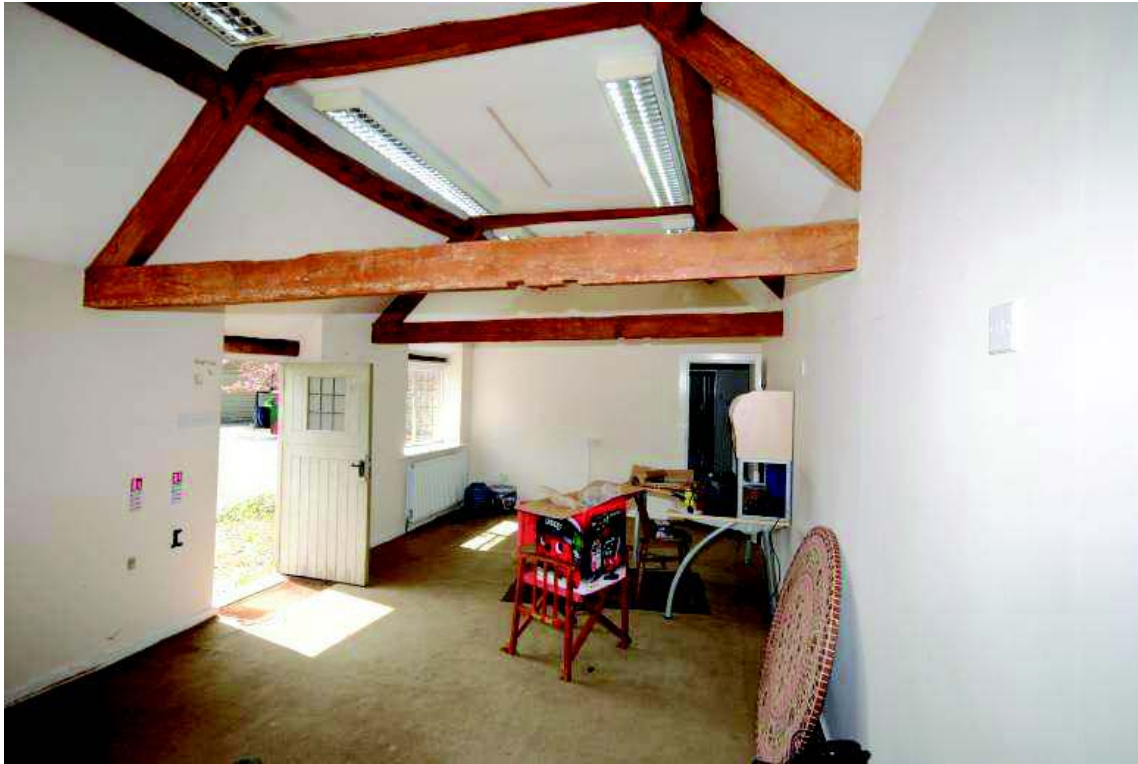
Plate 4: Detail of roof truss, central room, building 1

The visible roof structure comprises purlins, tie beams, collars and principal rafters, especially visible in the central room. The construction uses pegged mortise joints.

The roof timbers visible in the central room are substantially paler than those in the rest of the building although this is thought to reflect post 1964 treatment of the timbers during the conversion of the building. A number of carpenters' marks are apparent on the heads of the southern posts and on internal roof timbers. The marks visible on the external posts match up with those on the internal roof trusses, suggesting these have not been altered since their construction.

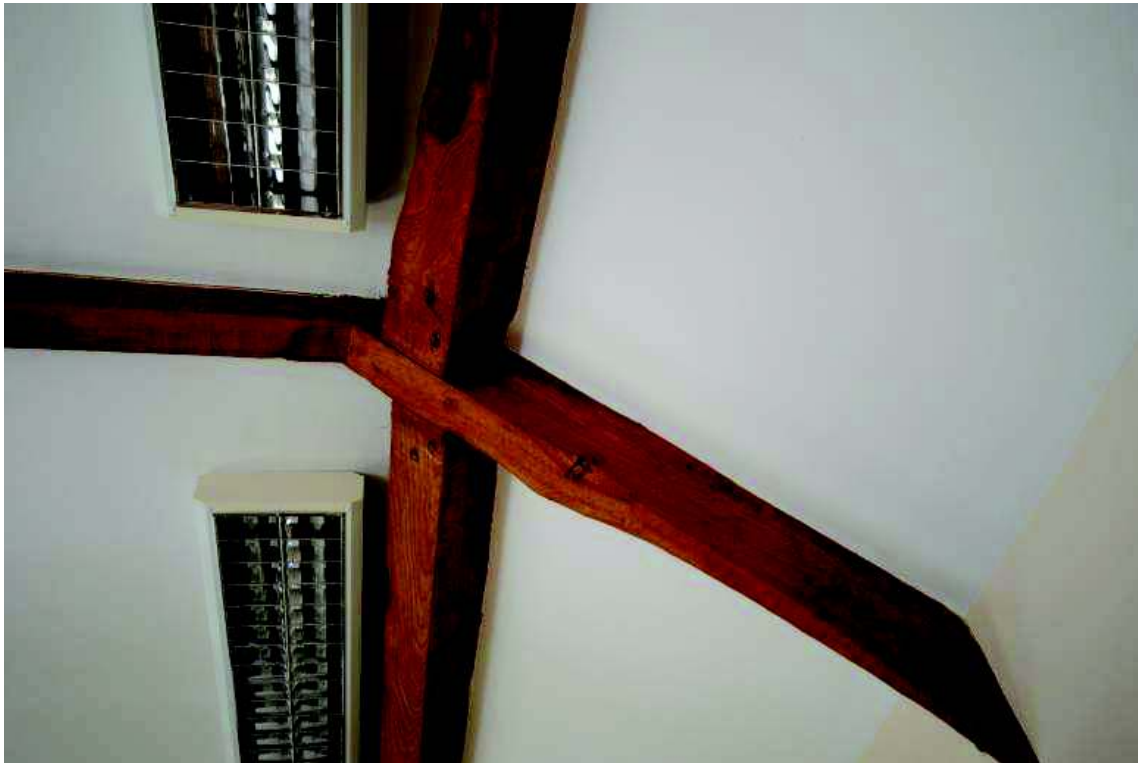
Plate 5: Detail of construction of roof truss, central room, building 1

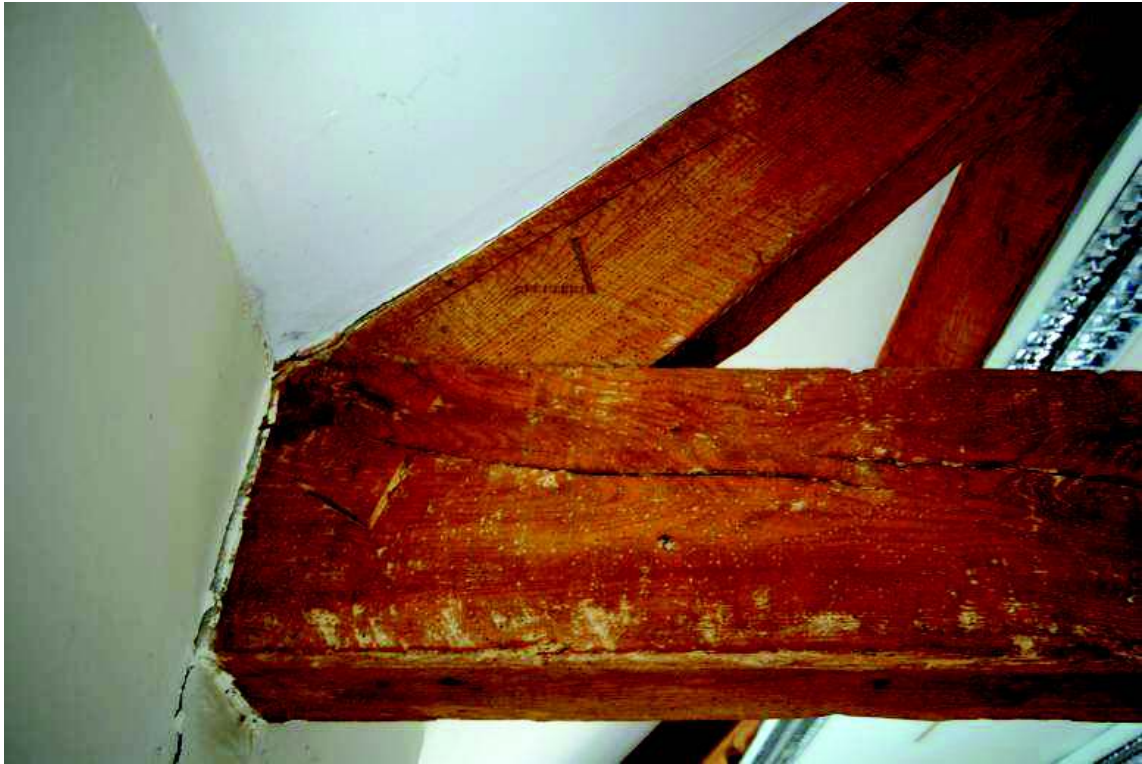
Plate 6: Internal carpenters' marks, building 1 (manipulated image)

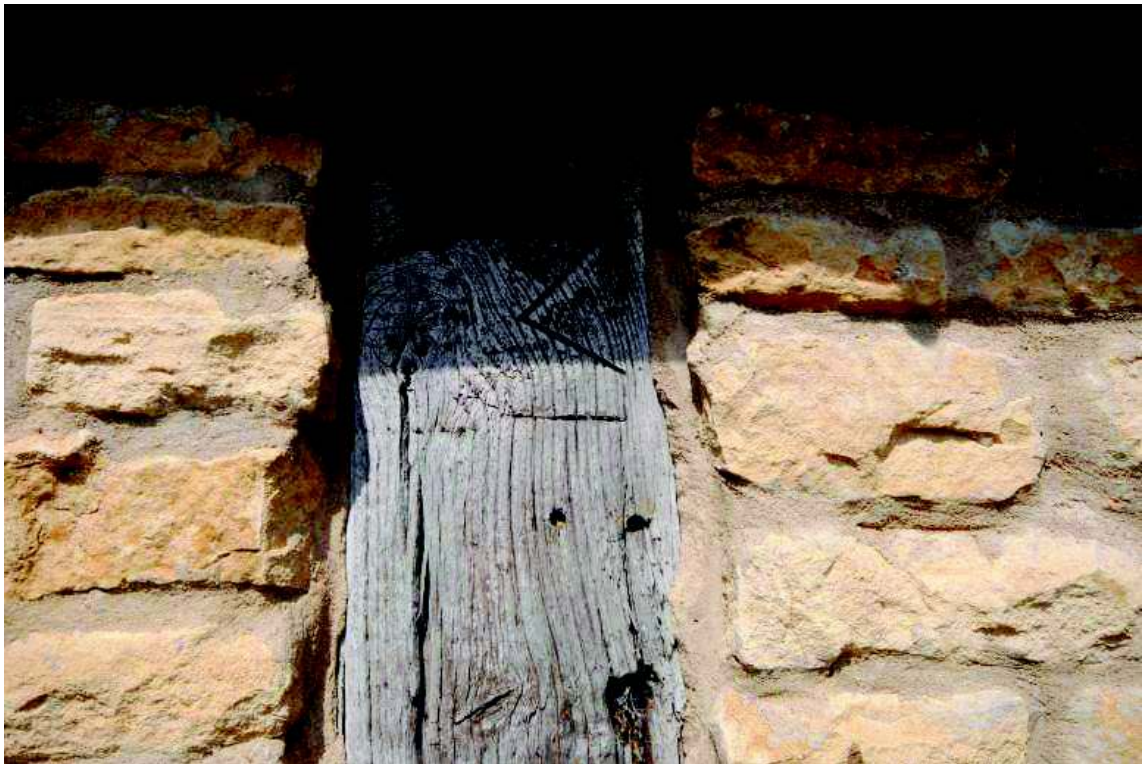
Plate 7: External carpenters' marks, building 1

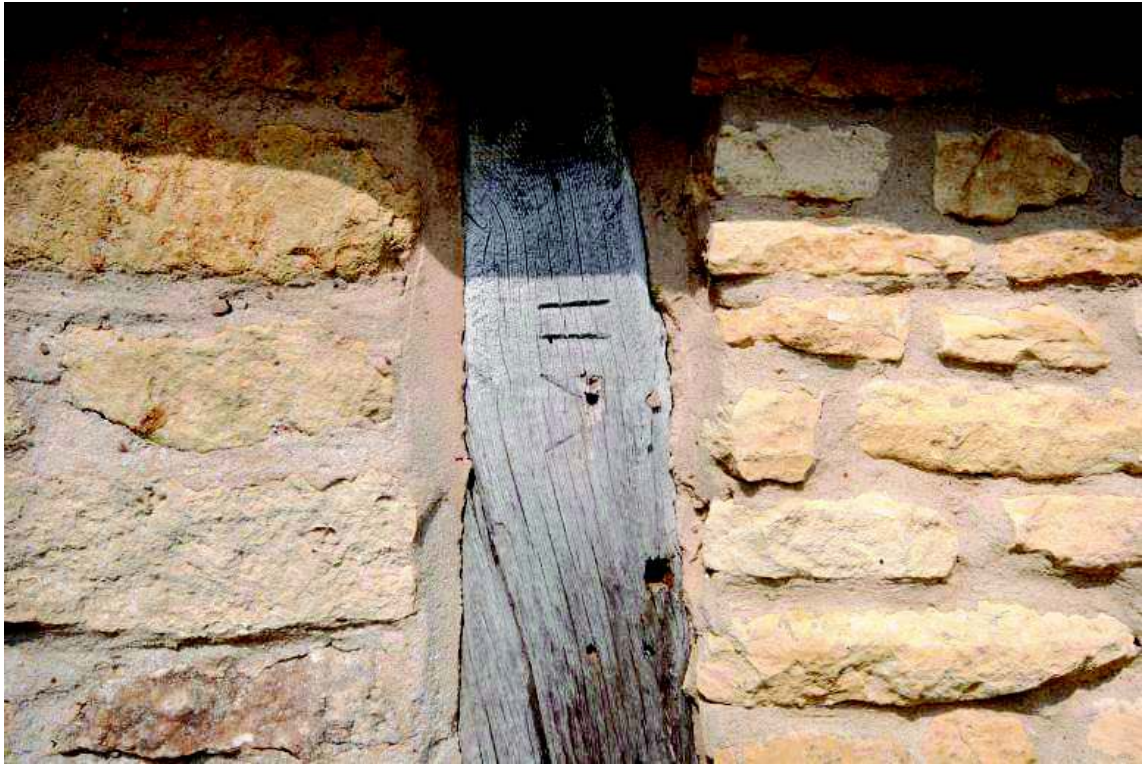
Plate 8: External carpenters' marks, building 1

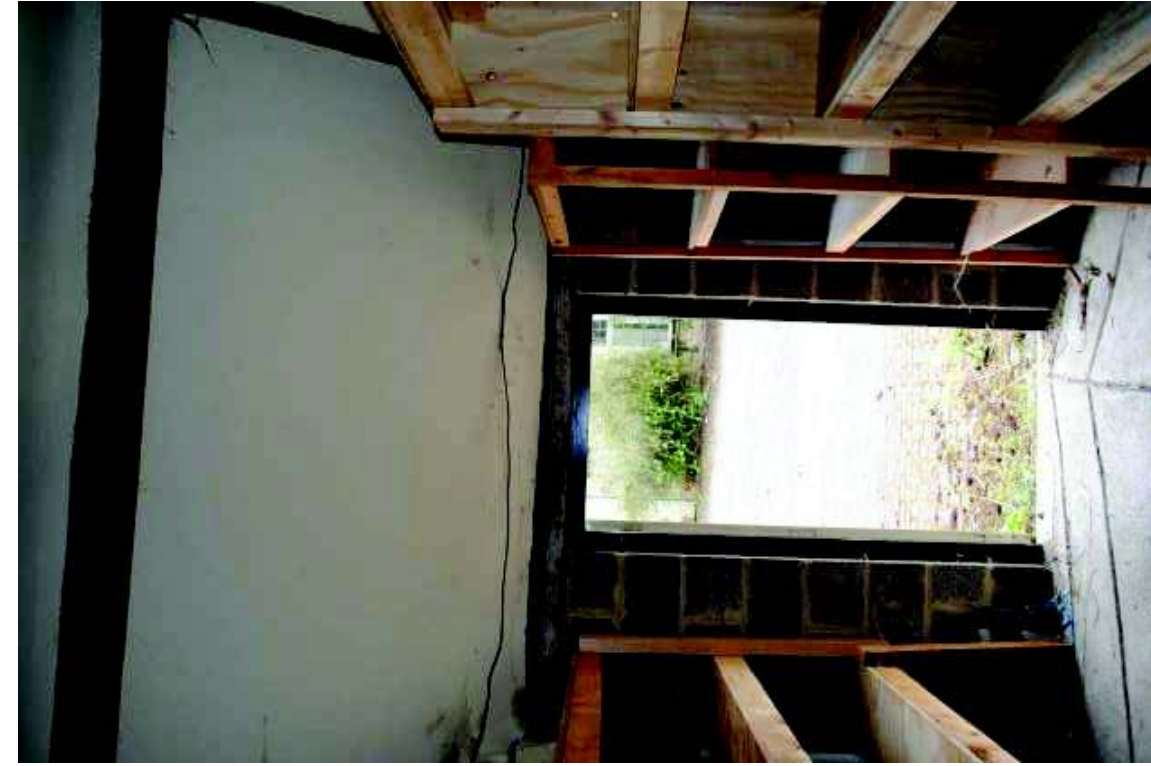
Plate 9: Store room, building 1, looking south

Timbers are visible in the ceiling of the store room but not the kitchen or mess-room. Also visible in the store room is the rear of the southern wall - constructed in concrete block but

faced externally in stone (see Plate 9). It is thought that other parts of the southern wall reflect this also.

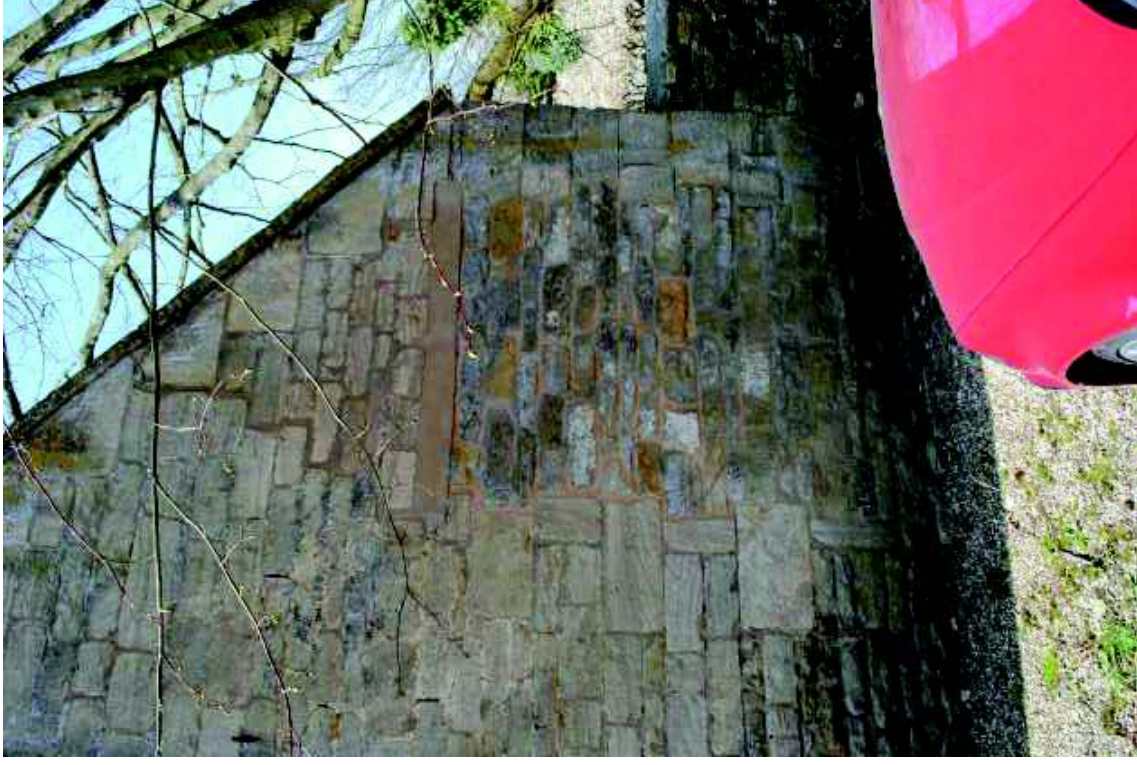
Plate 10: Detail of blocked doorway, eastern elevation, building 1

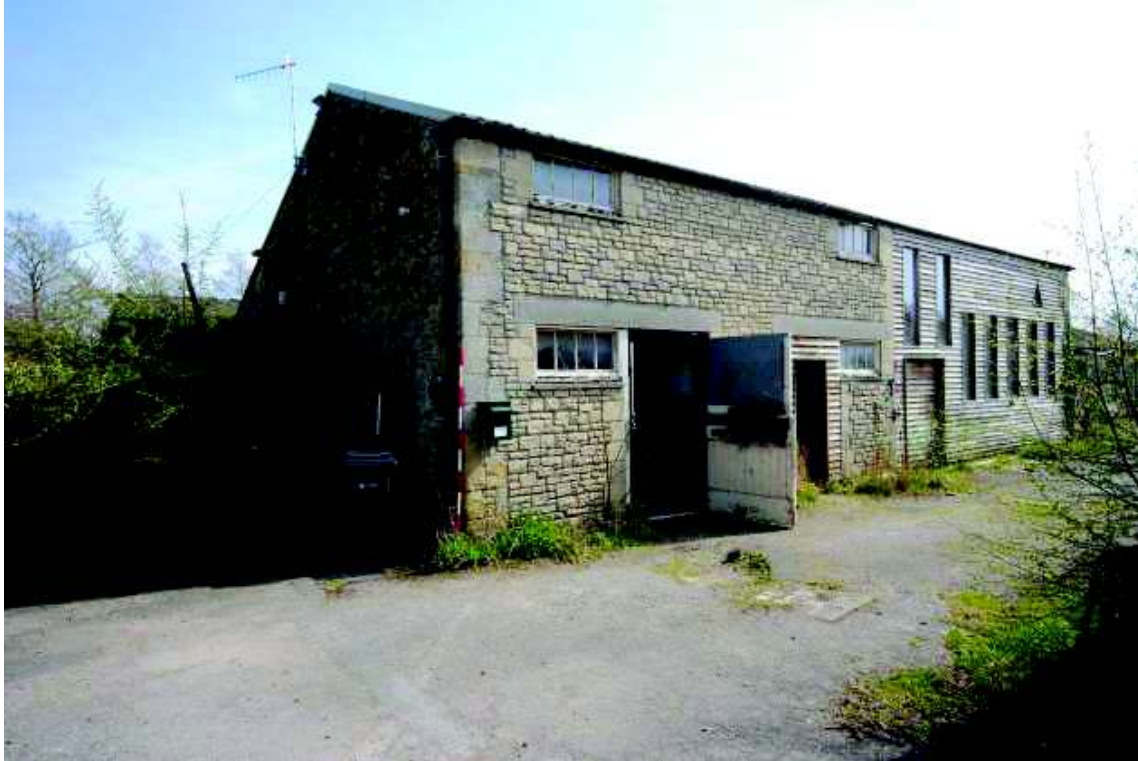
Plate 11: Northwest aspect, building 2A

Building 2A is depicted on an early 1960s air photograph (Plate 54) as a hay barn open to the west. This is a direct contrast to its current form of stone and wood construction. It is built in local stone in the general Manor Farm style and features a gabled corrugated metal roof with a gentle slope - a more modern style than the steep pitched roofs of Cotswold stone present elsewhere on site. Evidence from historic maps suggests the building was constructed at some point between 1885 and 1902.

The western wall is the front of building of 2A and was erected at some point after 1977 filling in the previous open face of the building. The northern stable part of the building is constructed in the general Manor Farm style and features a pair of tall (c. 2.2m) doors located either side of centre. A small window consisting of a row of four vertical panes is present north of the northern door and south of the southern door, at the same height as the head of the doorway, sharing its lintel. Above these windows, further matching windows into the hayloft are located immediately below the eaves.

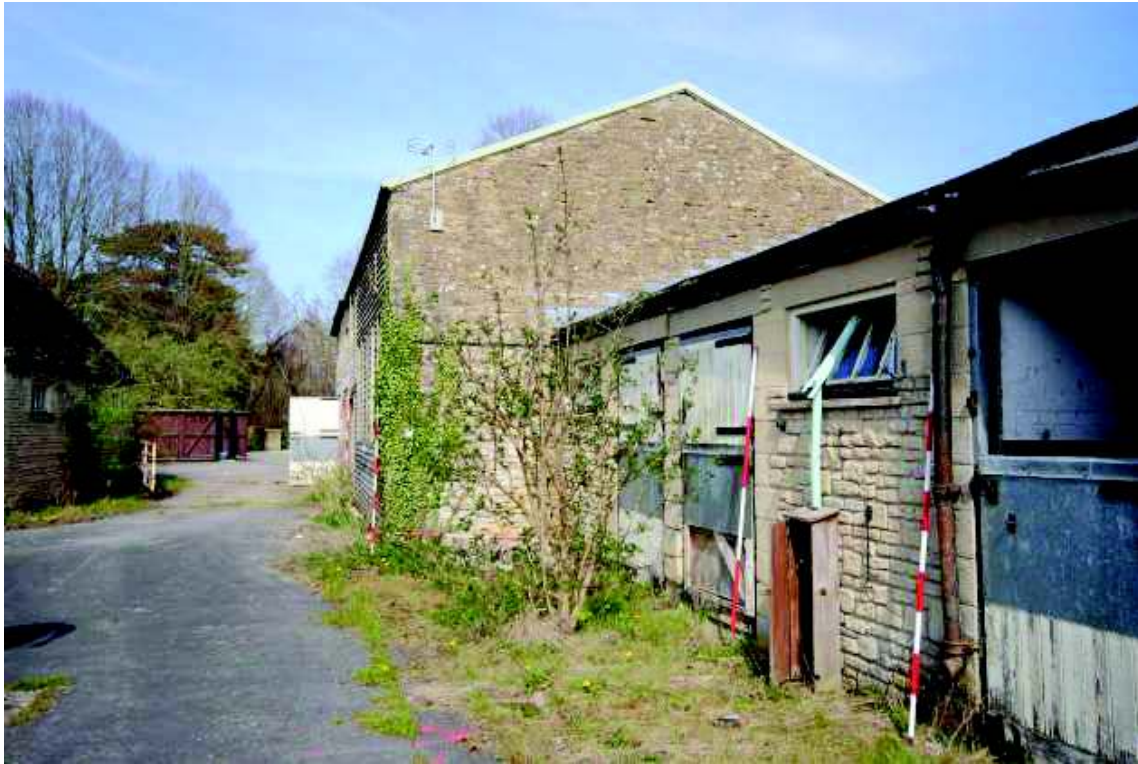
Plate 13: Southern elevation, building 2A

The southern wall of 2A is somewhat more weathered than the western wall. It is again constructed in the local style. The wall is largely obscured by building 2C, built on at a later date.

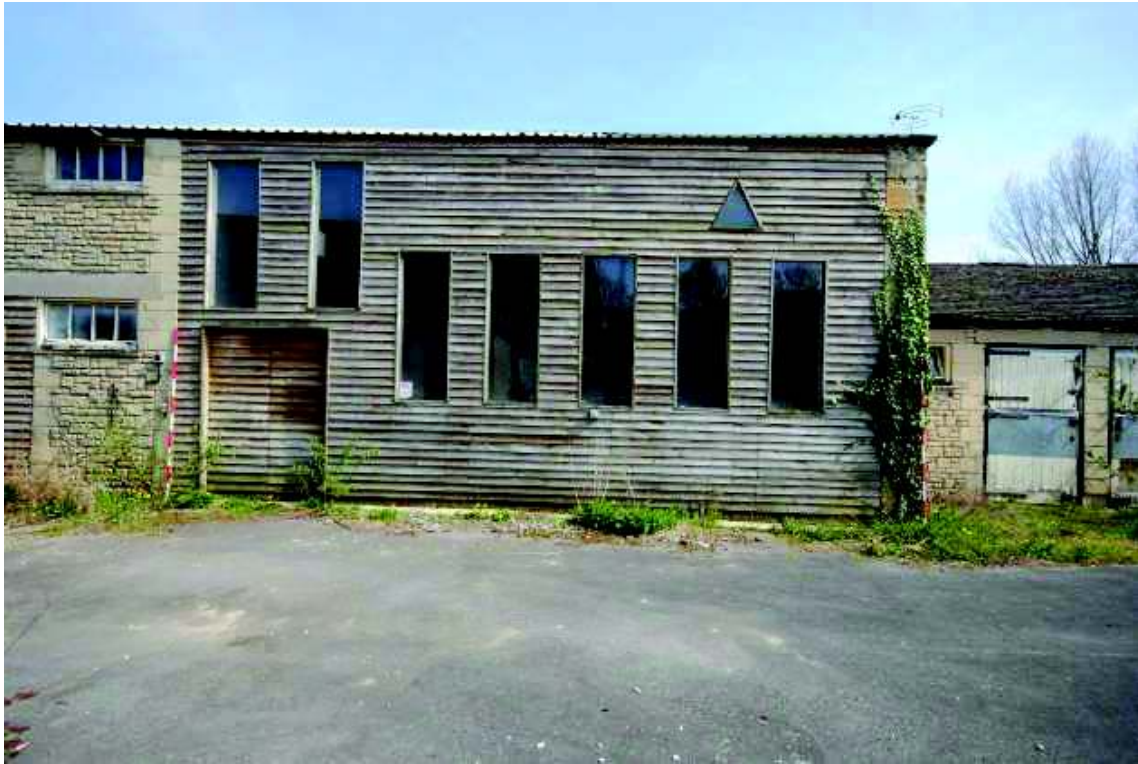
Plate 15: Southern part, western elevation, building 2A

The western elevation of 2A south of the stable part is clad entirely in modern timber featherboard, with various door and window openings. The side of the ashlar of the southern wall is the only historic feature visible on this part of the building, obscured by ivy growth.

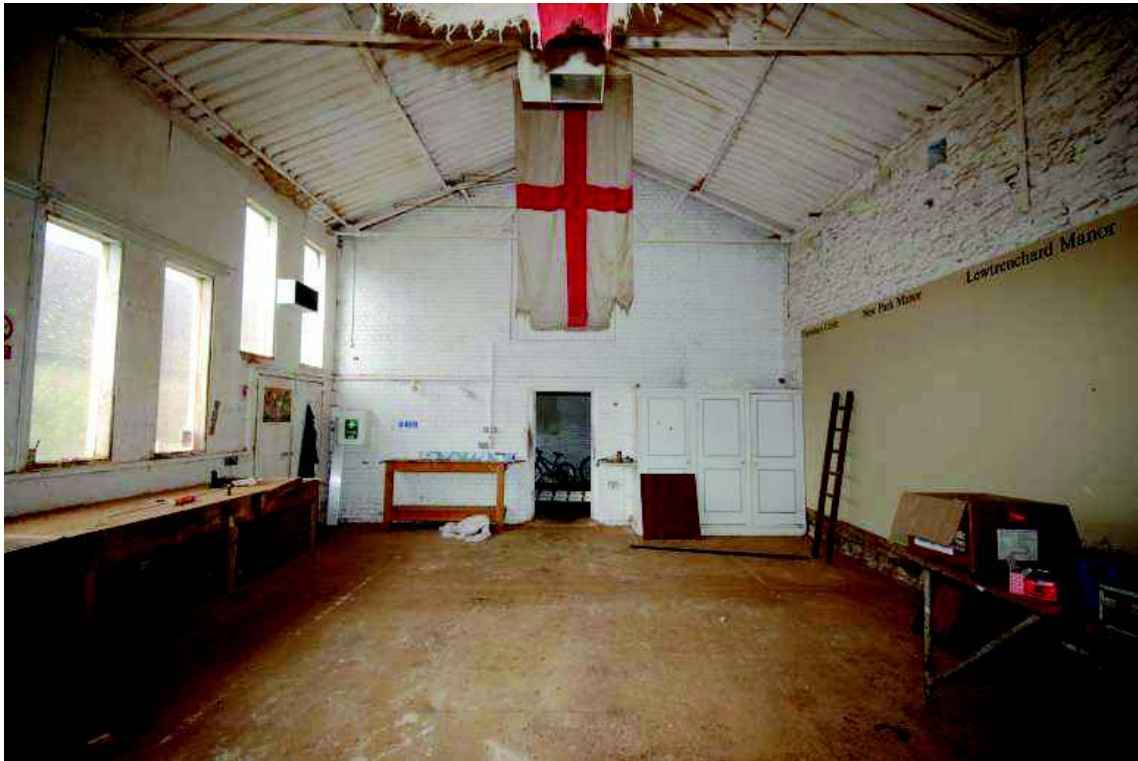
Plate 16: Workshop, 2A

Internally, the building is divided with a post 1964 brick wall. The southern part of 2A was converted for use as a full-height workshop. Some benches from this remain.

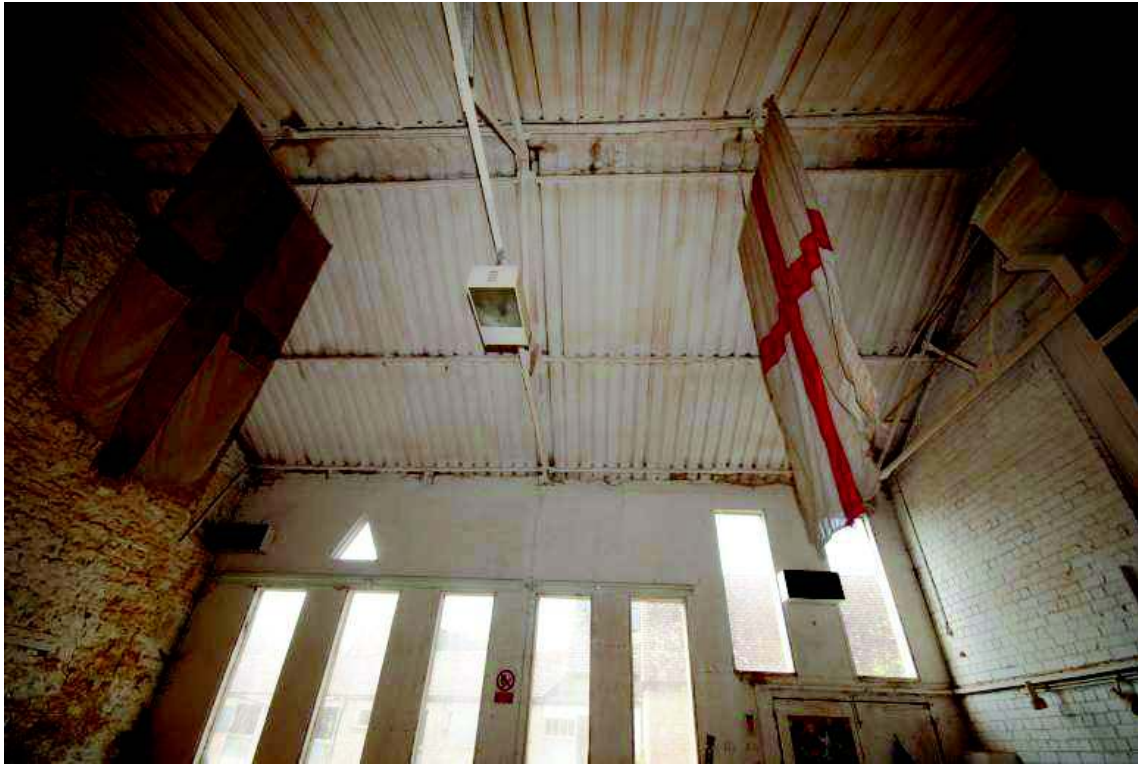
Plate 17: Detail of roof structure, 2A

The roof structure of 2A is entirely of steel construction, insulated over the first floor area. The roofs on other historic buildings at Manor Farm have a steeper pitch than the roof of 2A. There is no way to ascertain from the structure of the building that this roof was any steeper in the past although it is tempting to suggest that the roof of 2A may have been steeper originally.

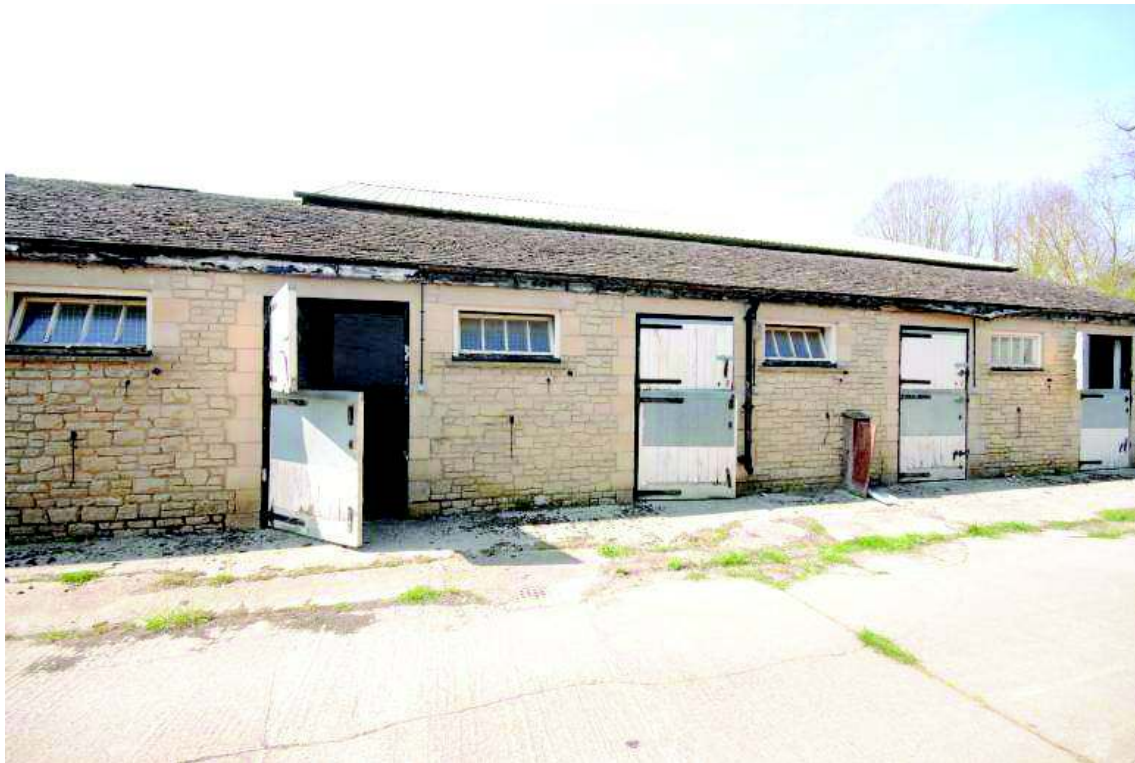
Plate 20: Eastern elevation, 2B

Building 2B is a lean-to structure constructed against the eastern wall of 2A. Its most recent use is as a row of four stables.

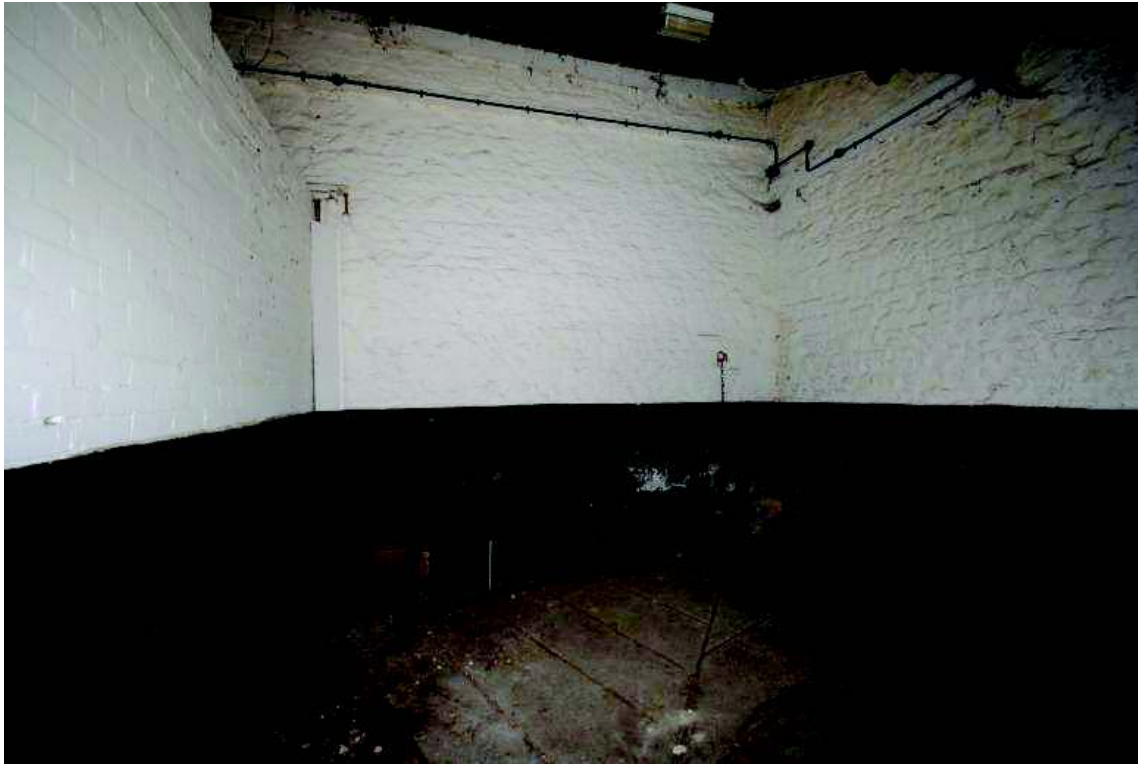
Plate 21: Northwest aspect, northern stable, 2B, showing original walls of 2A and 2B

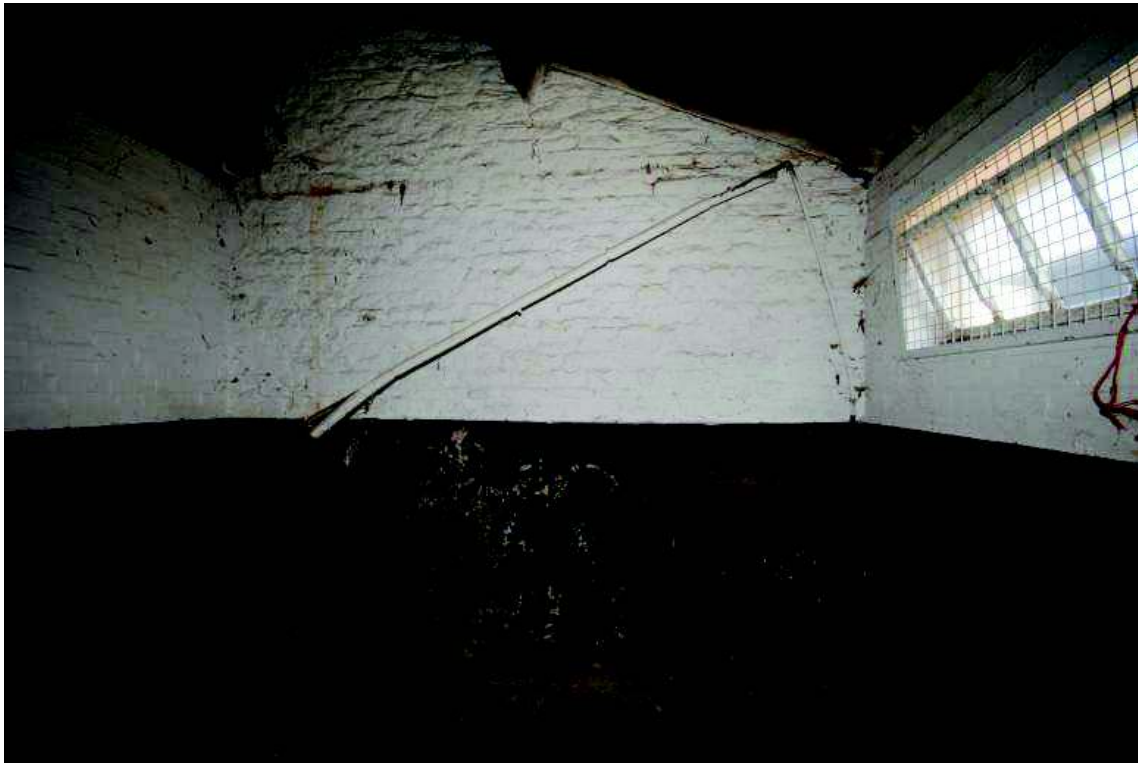
Plate 22: Southern wall, 2B, viewed from south

The only historic parts of 2B are therefore the northern and southern walls, although even these were constructed no earlier than 1885. The walls are constructed of stone although the inside faces are rougher in construction than those externally. The lean-to roof structure is entirely of machine-sawn timber.

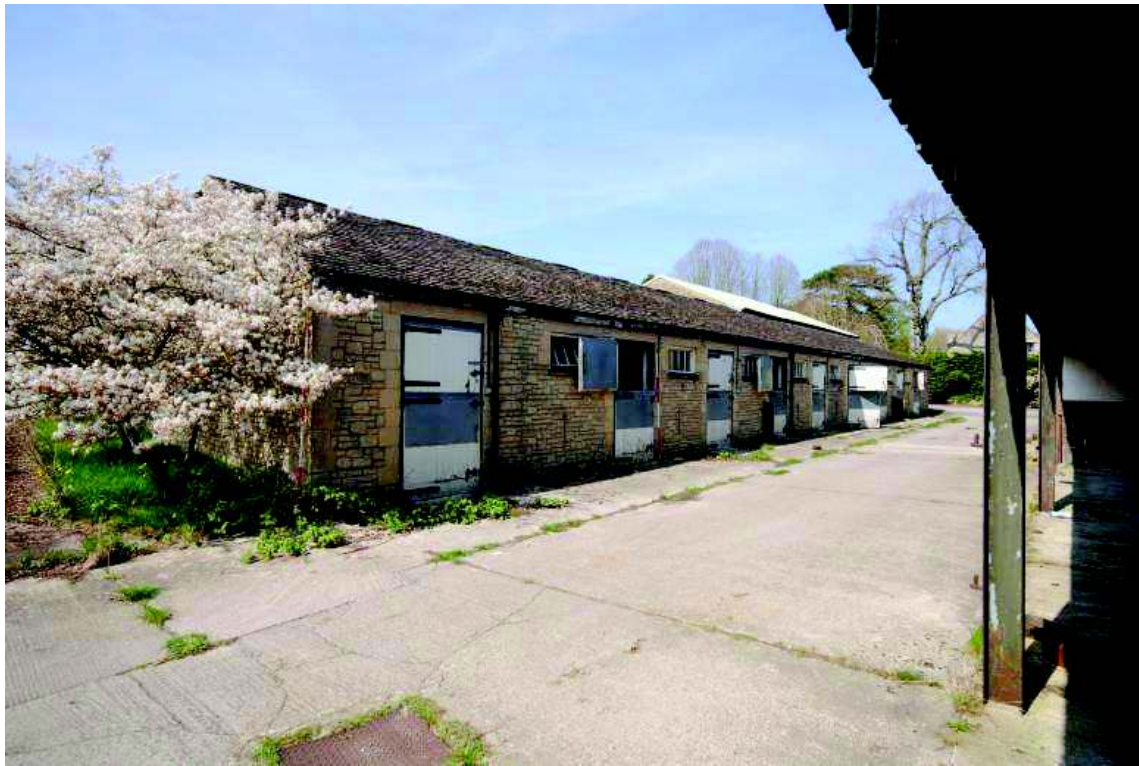
Plate 24: Eastern aspect, 2C and 2B

Building 2C was constructed in the Manor Farm style at some point between 1964 and 1977 as a back-to-back stable block, extending 2B to the south and mirroring it to the south of 2A. Although constructed in a traditional style, there are no historic features in this building.

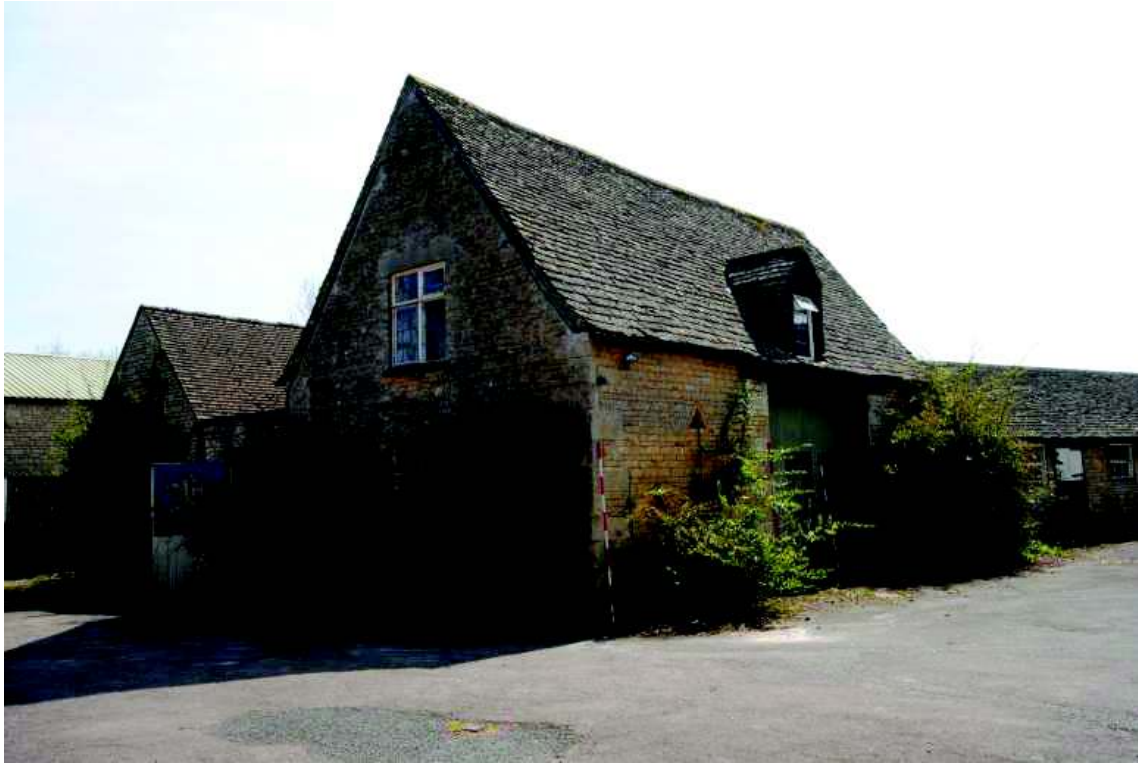
Plate 28: Northwest aspect, 3A

Building 3A is one of the early buildings at Manor Farm, thought to have been constructed between 1769 and 1847. It was originally constructed as a threshing barn although has been extensively modified into a two storey residential property.

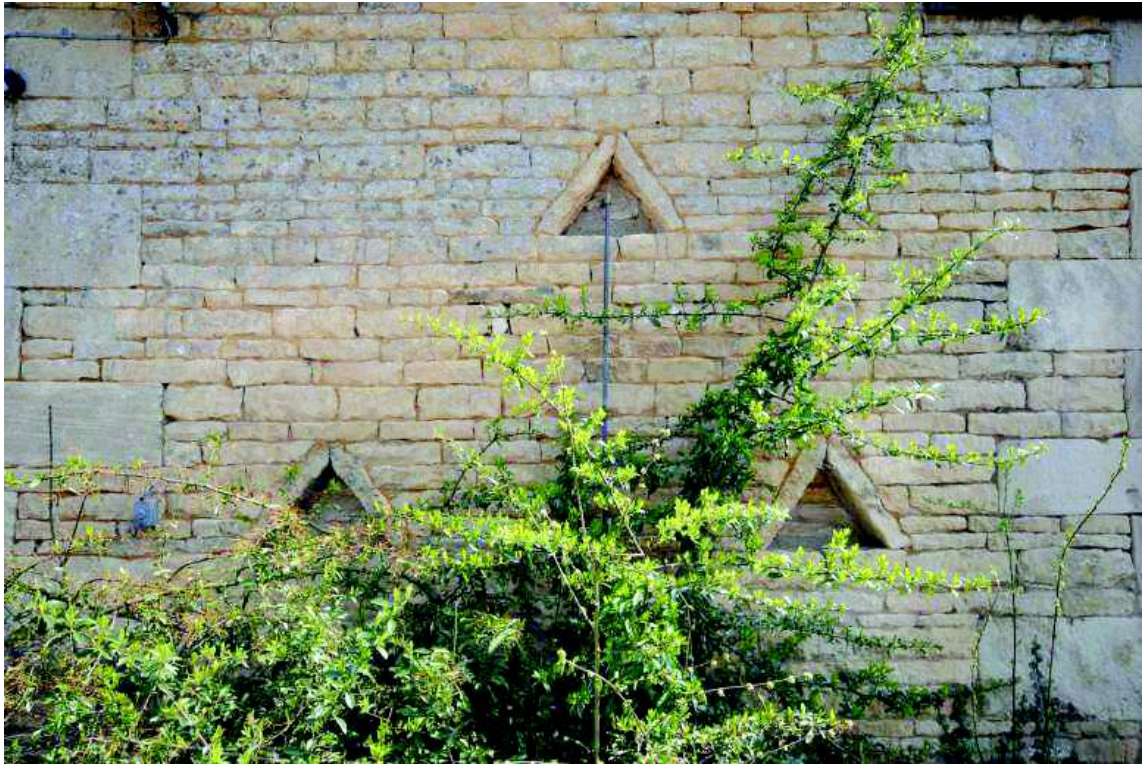
Plate 30: Detail of blocked air vents, west elevation, 3A

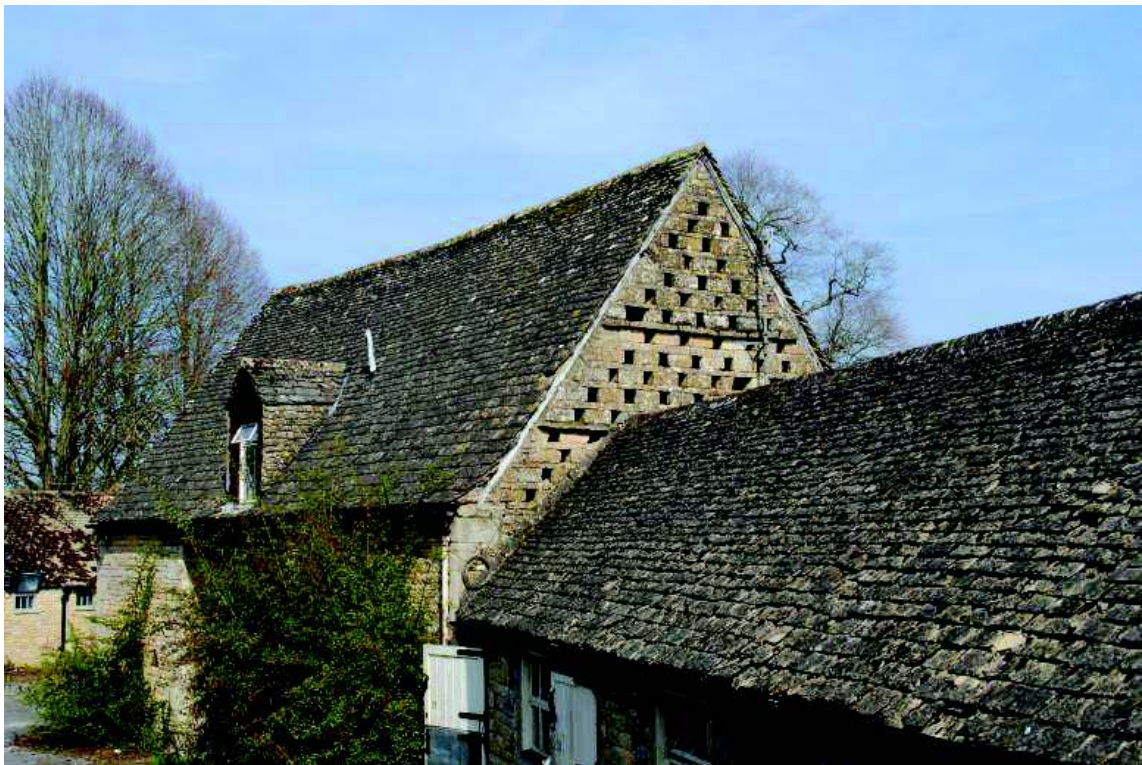
Plate 31: Southern elevation, 3A

The southern elevation of 3A is again ventilated, although with many more smaller square openings across the wall. Again, these are blocked internally. The lower part of the wall is obscured by 3B.

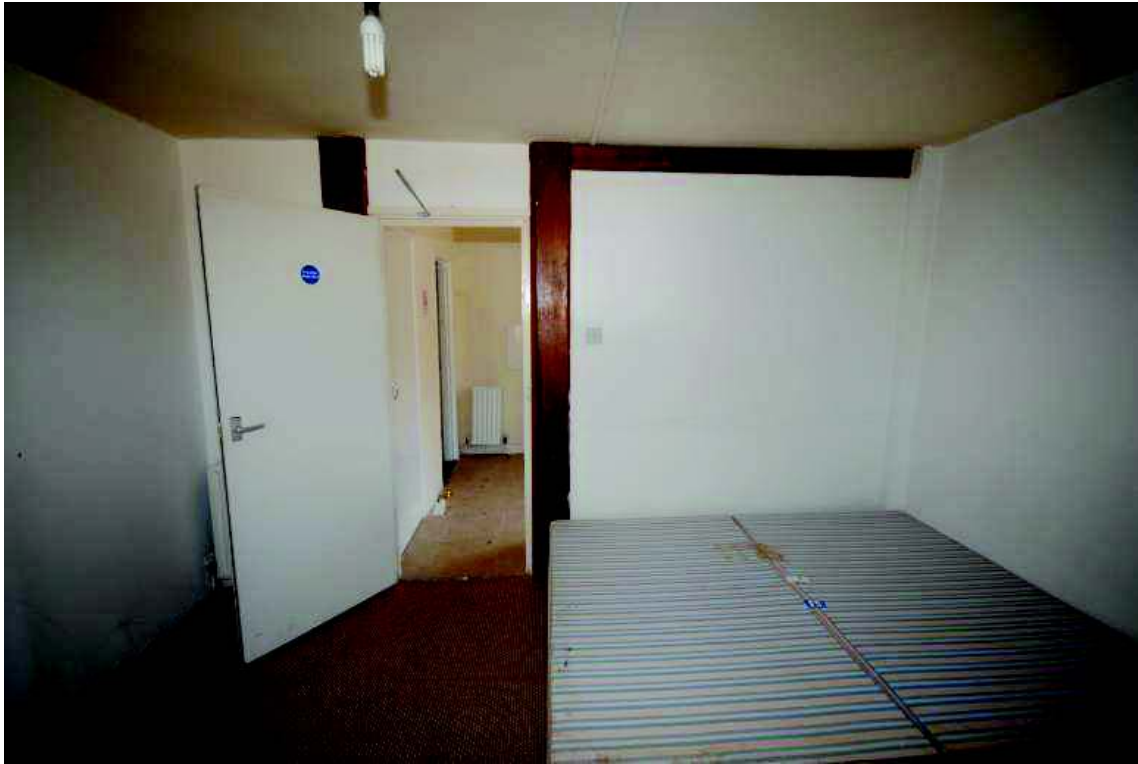
Plate 32: Modern timbers, ground floor, 3A

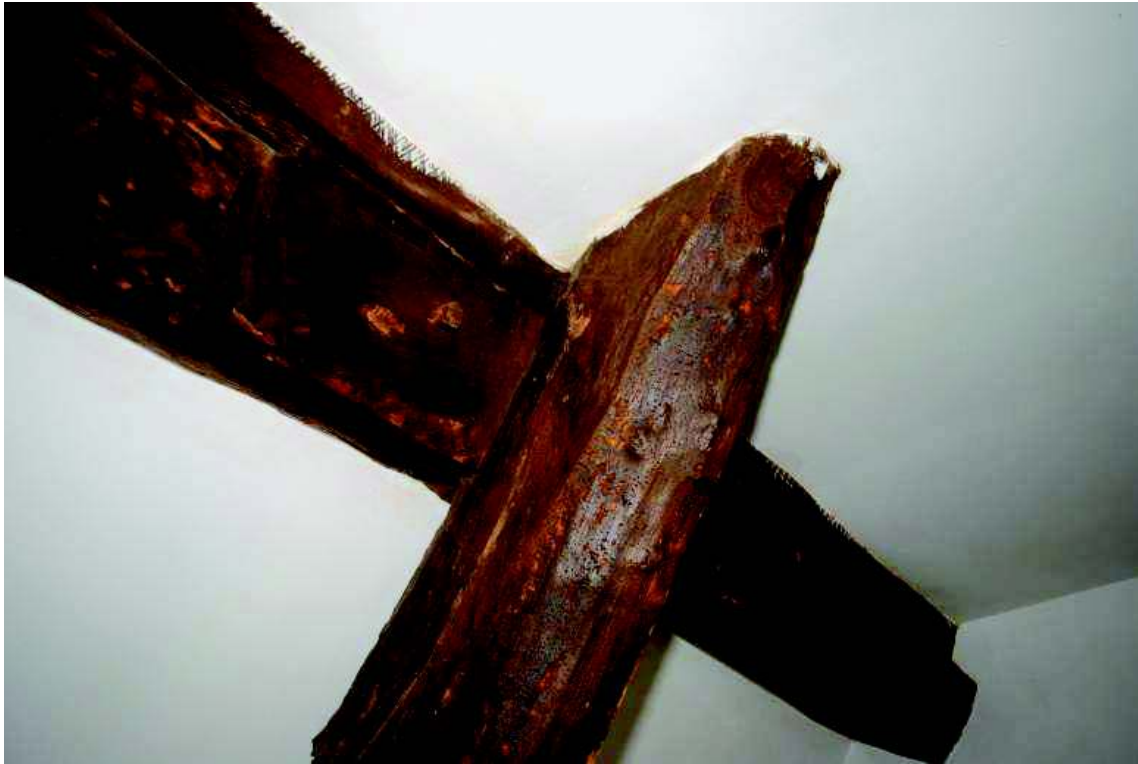
Plate 34: Detail of timbers, first floor south, 3A

On the first floor, roughly hewn roof timbers are visible. The roof has double purlins, both of which are visible in the southern room, along with a pair of principal rafters.
