CONSERVATION STATEMENT

**MANOR FARM
LOWER SLAUGHTER
GLOUCESTERSHIRE**

**Conservation Statement
For
Manor Farm
Lower Slaughter, Gloucestershire**

Site Name	Manor Farm
Address	Lower Slaughter
County	Gloucestershire
NGR	SP167225
Listing	Not Listed – Curtilage of Grade II farmhouse and wall
Conservation Area	Lower Slaughter Conservation Area
Material	Cotswold Limestone
Date	18 th century – modern
Function	Farm
Alterations	Conversion to residential accommodation and stables
Original Features	Cart shed, threshing barn, barn
Historic Interest	Fair
Architectural Merit	Fair
Degree of Alteration	Very high

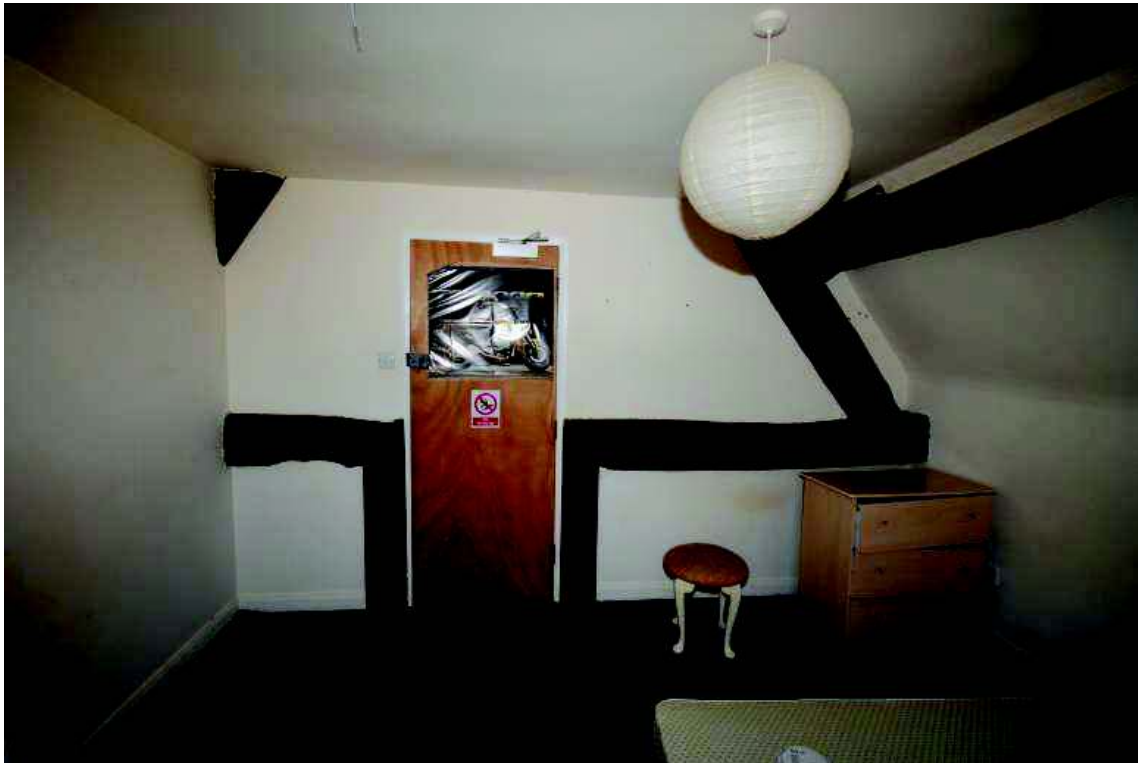
Plate 35: Roof truss, first floor north, 3A

The northern part of the first floor has a lower floor level than the southern and consequently the lower purlins only are visible, with the uppers concealed by the ceiling. In the northern bedroom, a truss is partially visible, comprising principal rafters and a collar. The latter has been cut in order to fit the door to the bedroom, with the addition of posts either side of the doorway (see Plate 35). The eastern lower purlin is visible in the stairwell and cupboard in the landing area.

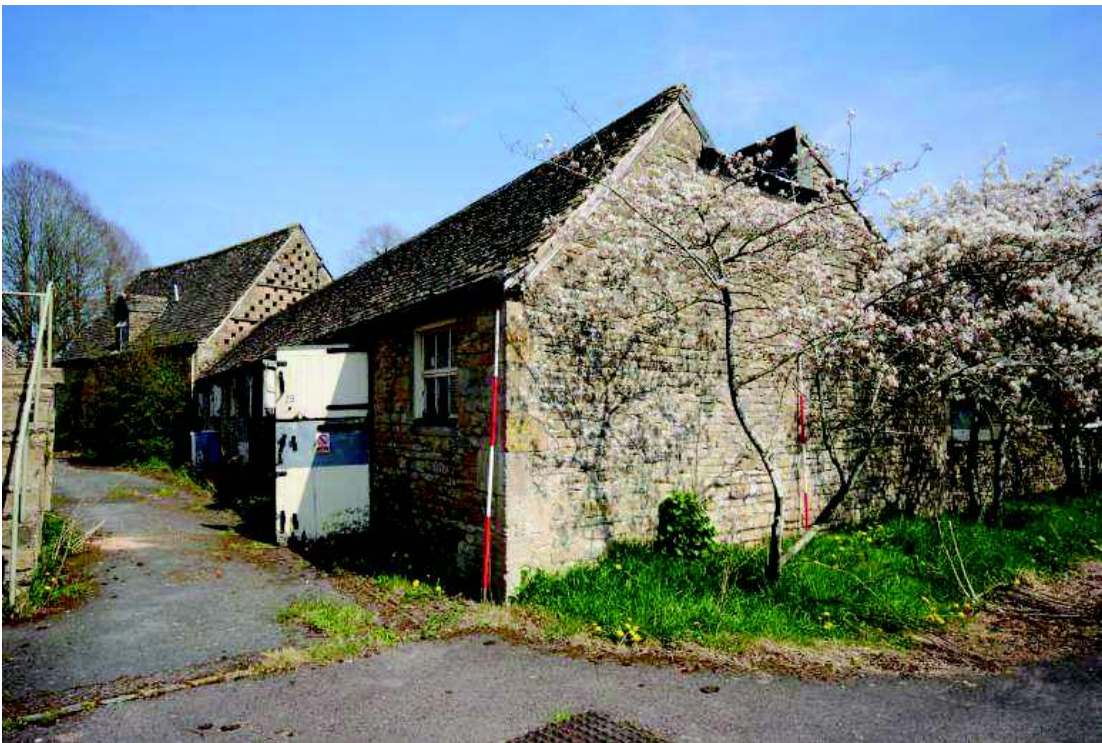
Plate 37: Southwest aspect, 3B

3B is a block of five stables located south of 3A with which it shares a party wall. 3C backs on to 3B.

A building is present on the northern two thirds of the site of 3B from at least 1847. This building did not cover the full extent of 3B as it stands today. The building was constructed to its modern extent at some point between 1922 and 1964 of brick faced with stone in the Manor Farm style. The roof structure of 3B is entirely of machine-sawn timber. The walls, both internal and external, are of uniform construction and it is therefore thought that the current building is an entirely new structure constructed post 1922, rather than being an extension of the earlier structure. There are no features of historic interest in 3B.

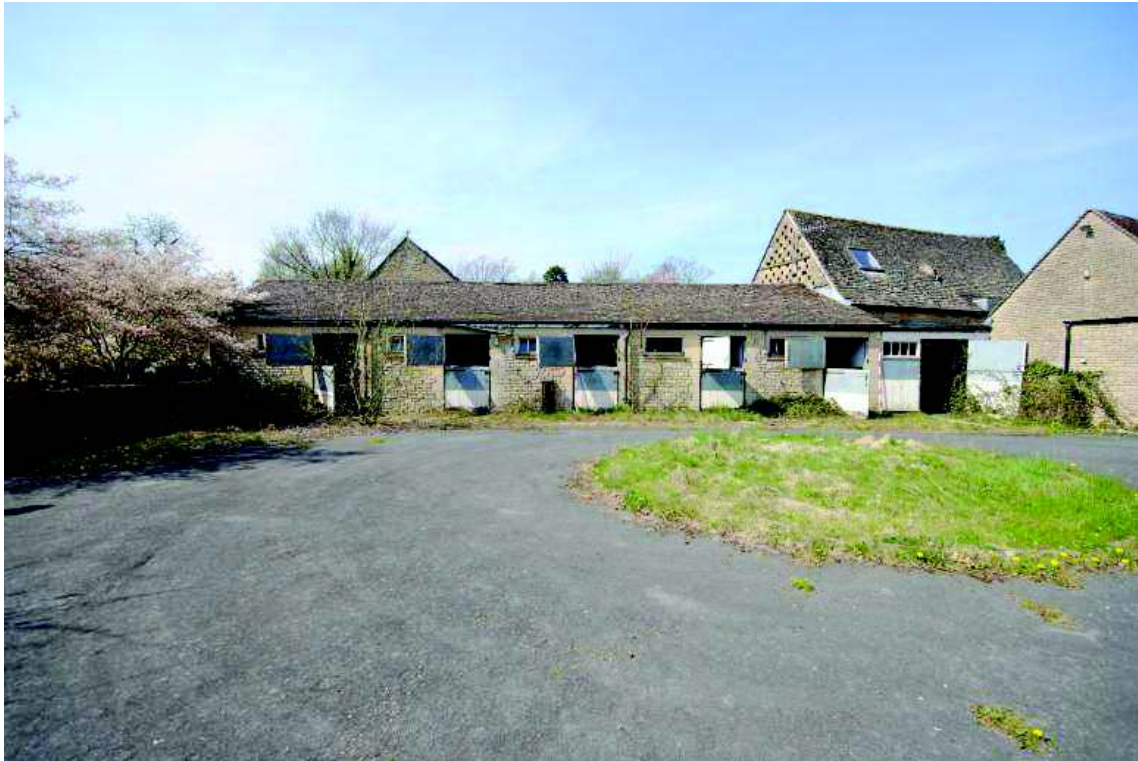
Plate 38: Building 3C

Evidence from historic maps suggests 3C was constructed at some point between 1964 and 1977. The building is a block of five stables backing on to block 3B, located south of 3A and 3E. 3C is constructed in the Manor Farm Style and has no features of historic interest.

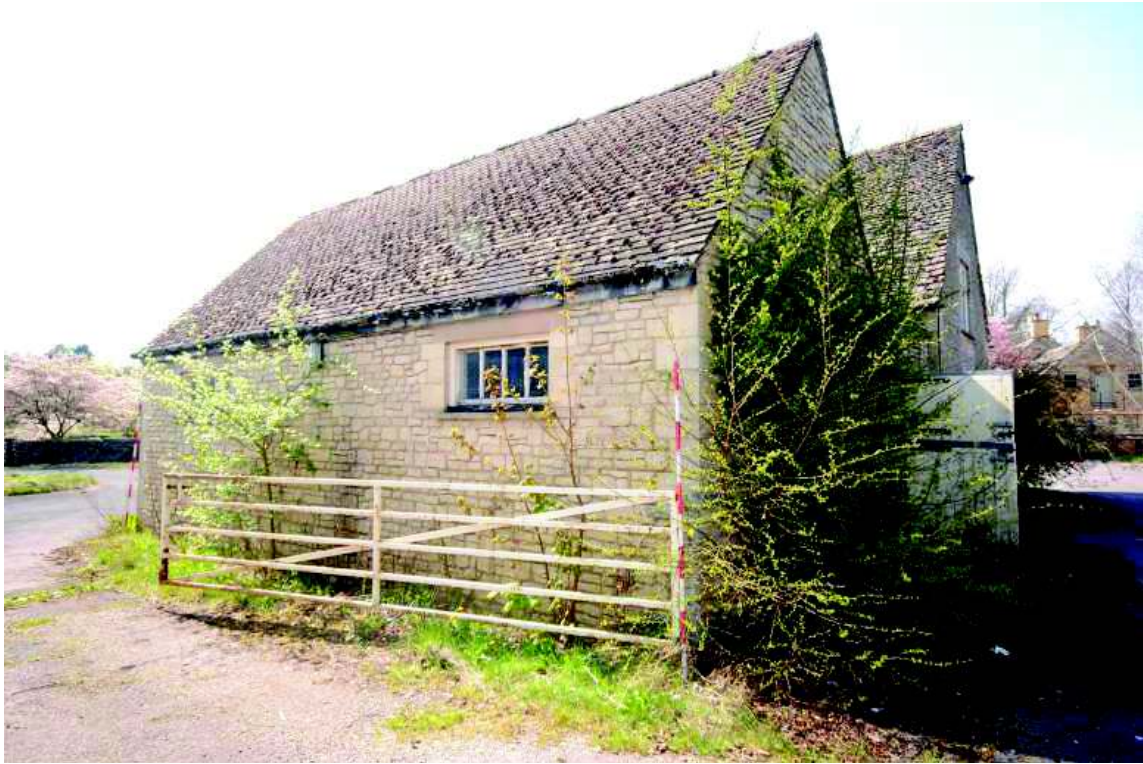
Plate 39: Building 3D

Evidence from historic maps suggests 3D was constructed at some point between 1964 and 1977. The building consists of two rooms and has walls of brick faced with stone in the Manor Farm style. Entry is via building 3E, which was constructed after 3D.

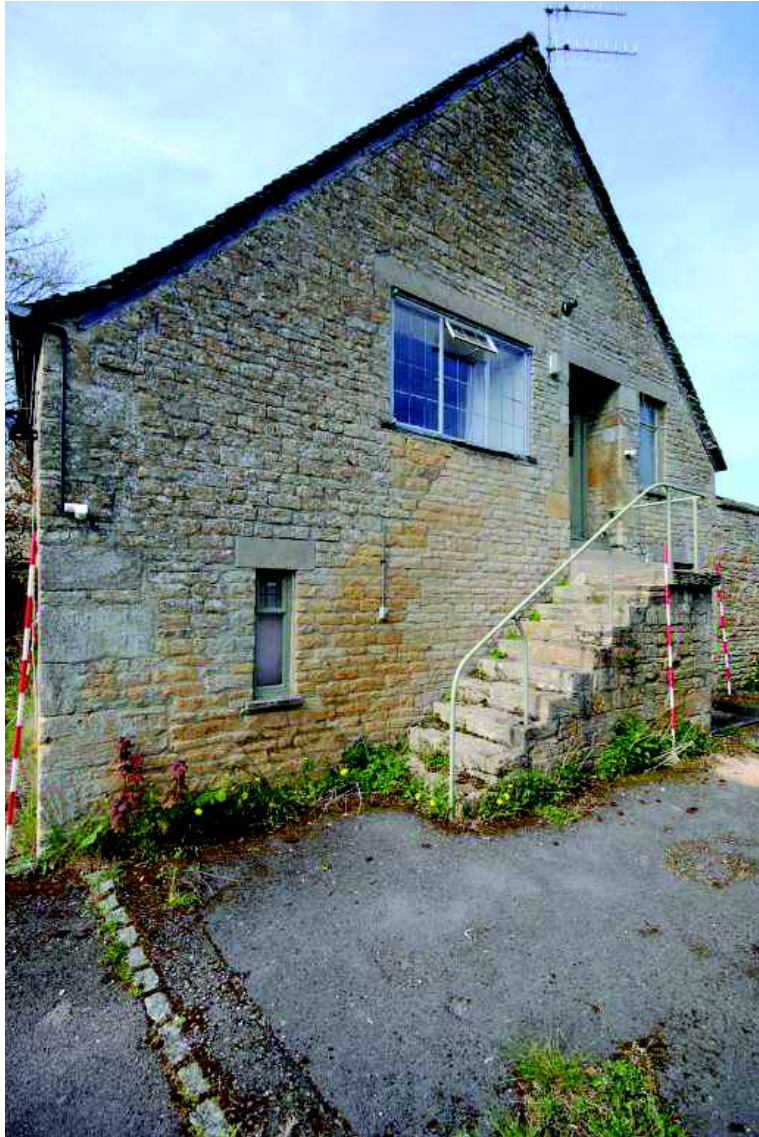
Plate 44: Eastern elevation, 4A

4A is one of the oldest structures on the farm, considered to have been constructed between 1769 and 1847. The building is constructed over the eastern boundary of the current farmyard. The western part of the building is in separate ownership. The northern wall is obscured by the garage, 4B.

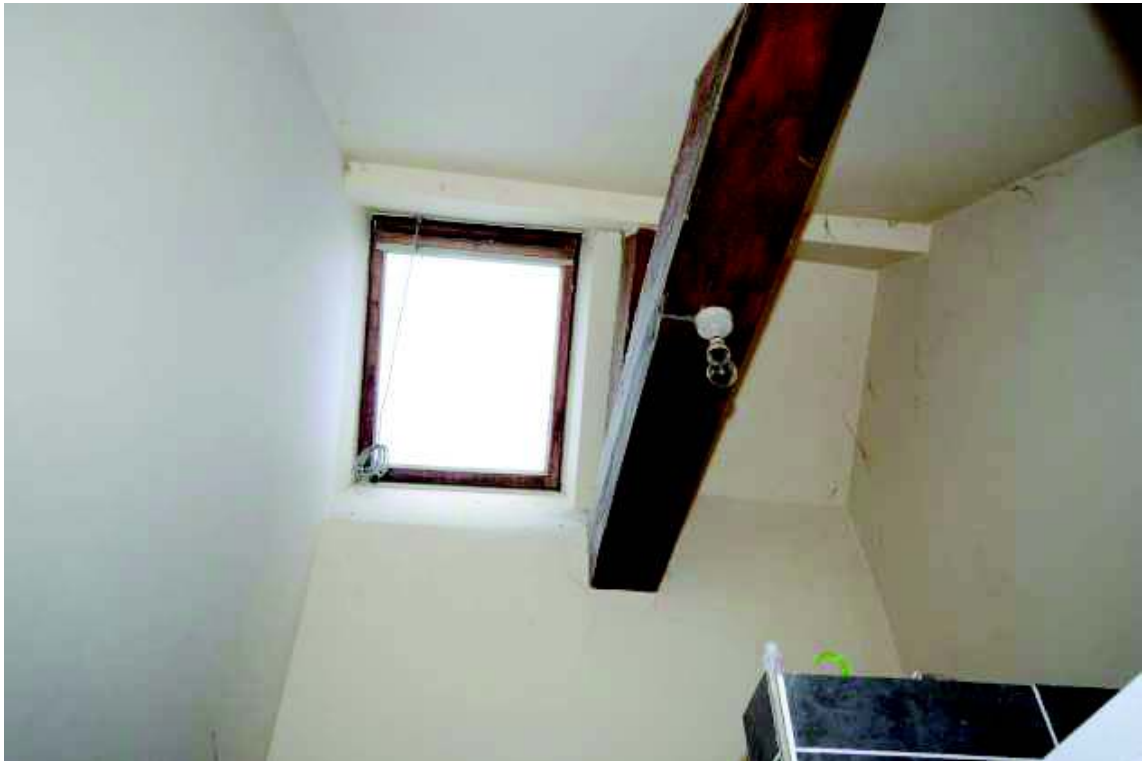
Plate 47: Timbers, ground floor bathroom, 4A

The ceiling level of the bathroom is located slightly into the eaves of the roof and consequently part of a truss is visible, consisting of a principal rafter and upright timber. The rafter is considered to be of machine-sawn hardwood, suggesting the roof structure was repaired or replaced during the post 1964 renovation.

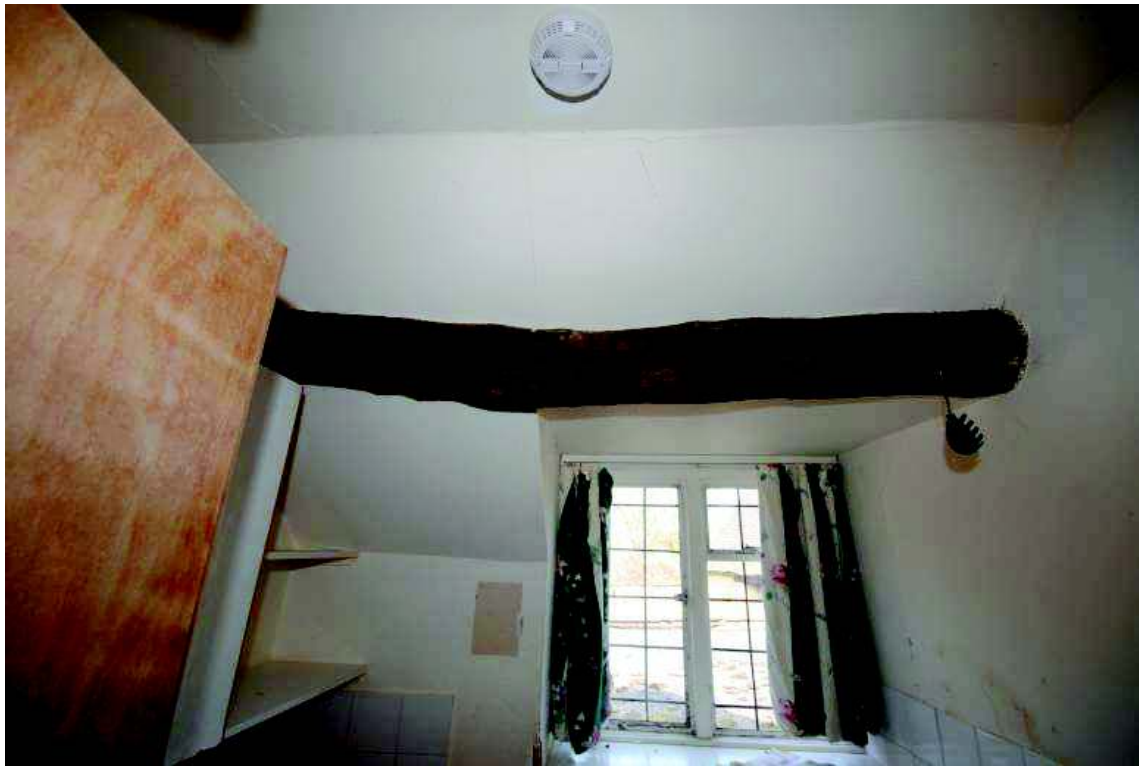
Plate 48: Detail of purlin, first floor kitchen, 4A

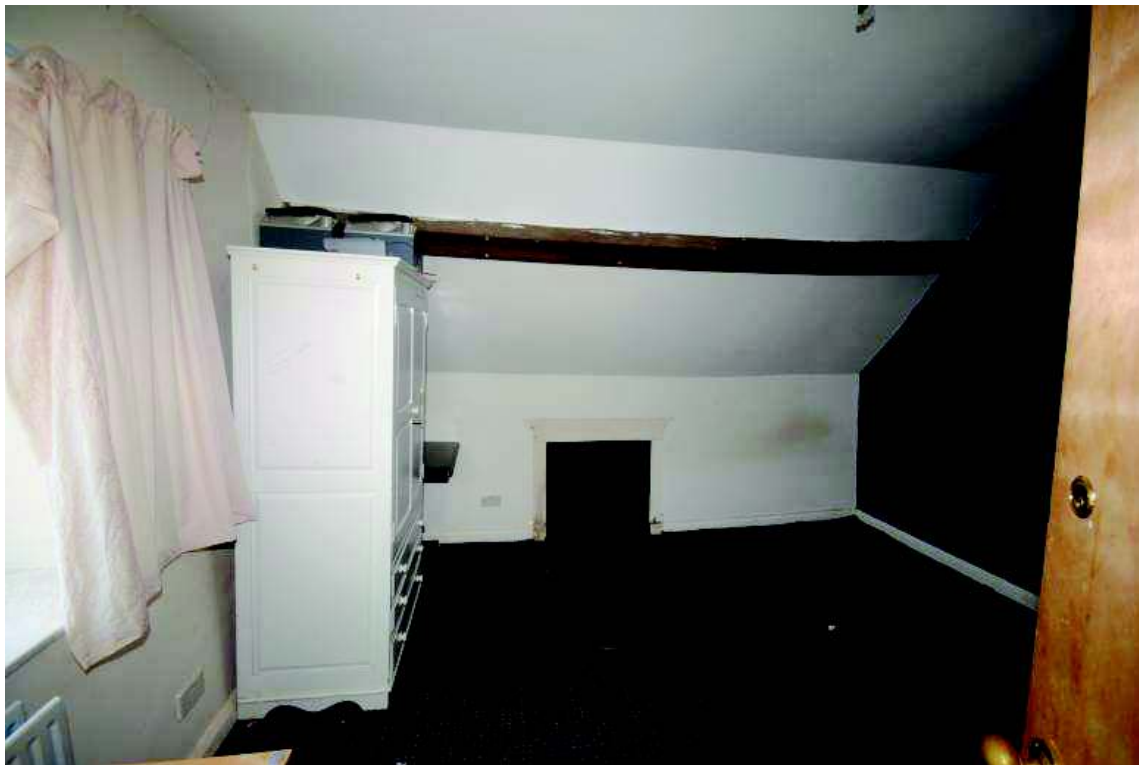
Plate 49: Detail of purlin, phase 1 bedroom, 4A

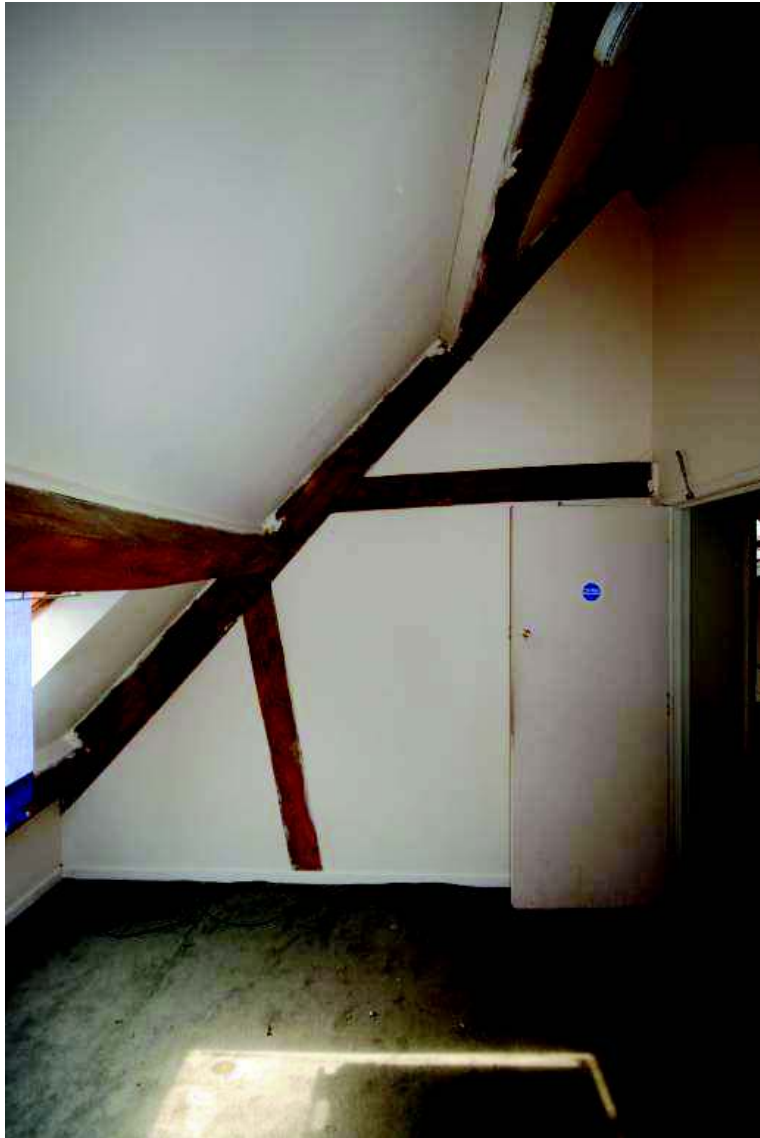
Plate 50: Detail of timbers, central bedroom, 4A

of the original phase is divided in two parts by a principal rafter truss running north-south. This is infilled, however the timbers are visible from the central bedroom and corridor area. The timbers are hand-sawn and the mortise joints are nailed. They are considered to be original to the construction of this phase of the building.

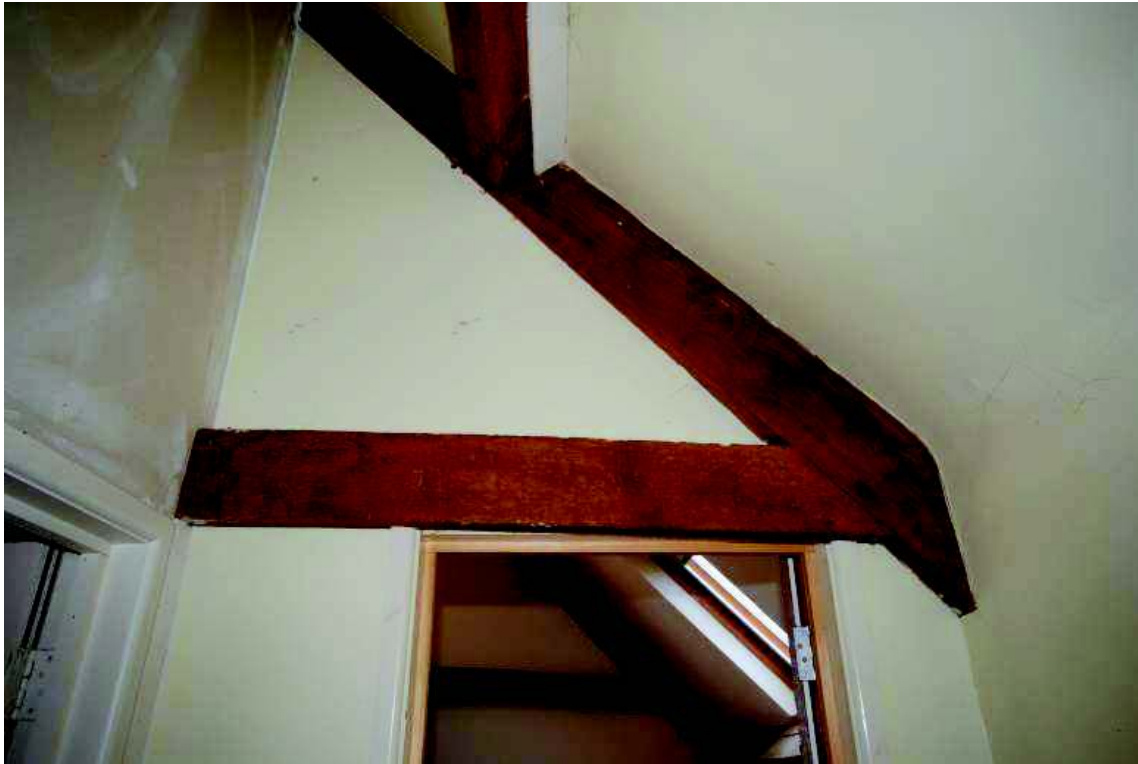
Plate 51: Detail of truss, first floor corridor, 4A

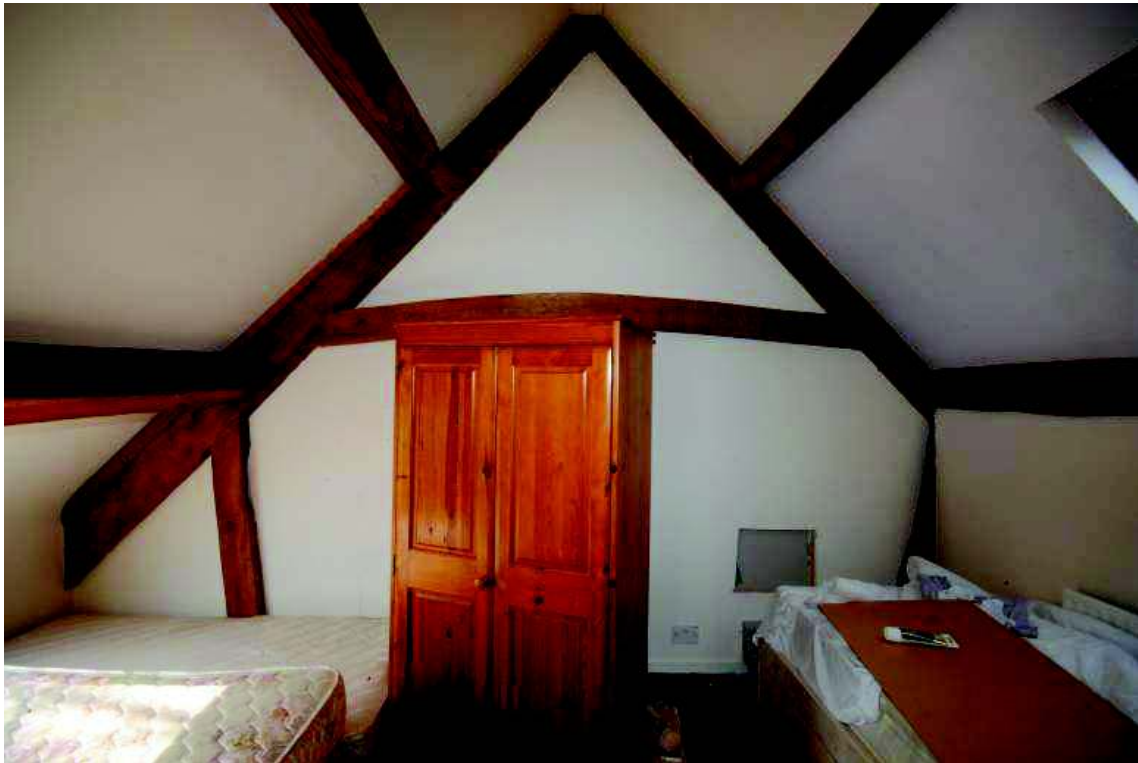
Plate 52: Detail of timbers, first floor west, 4A

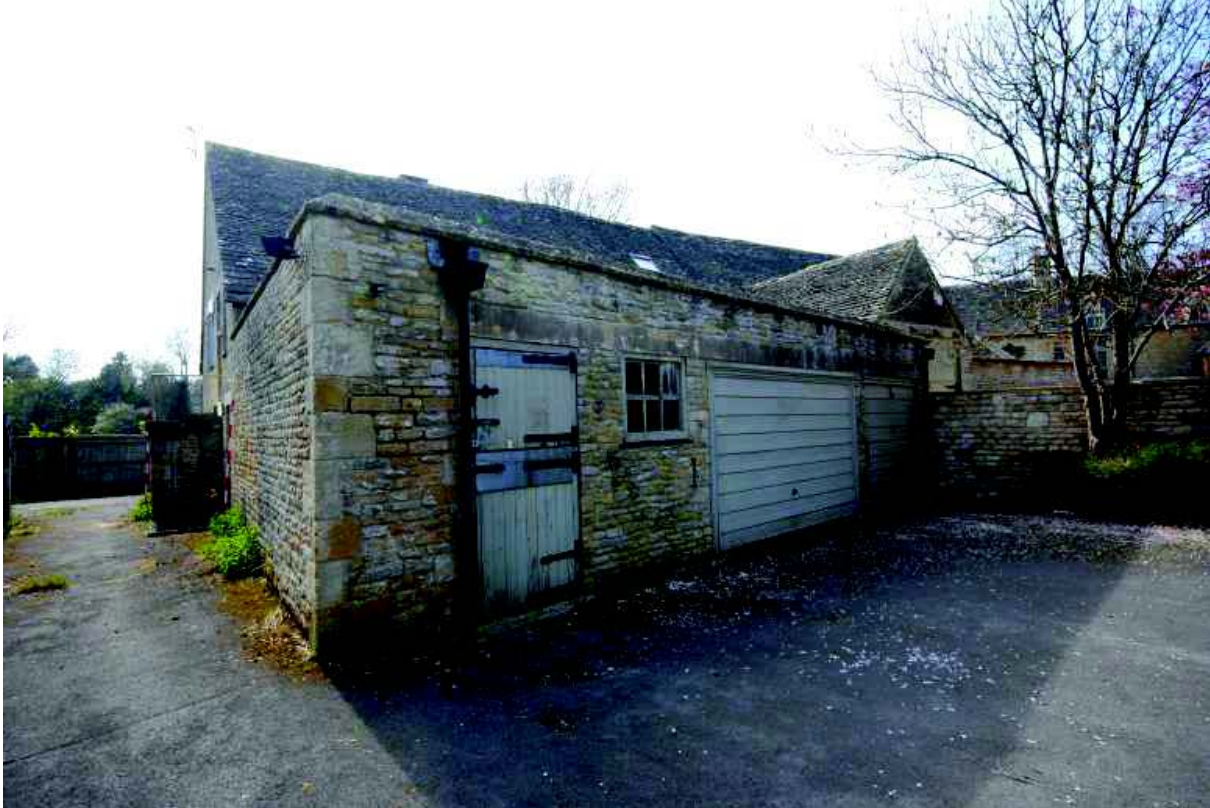
Plate 53: Building 4B, northwest aspect

4B is the newest of the structures reported in this study. It was constructed at some point between 1977 and c. 1989 as a garage. The building is flat roofed and is faced in local stone in the accepted style. It replaces an earlier lean-to building shown on the 1960s air photographs.

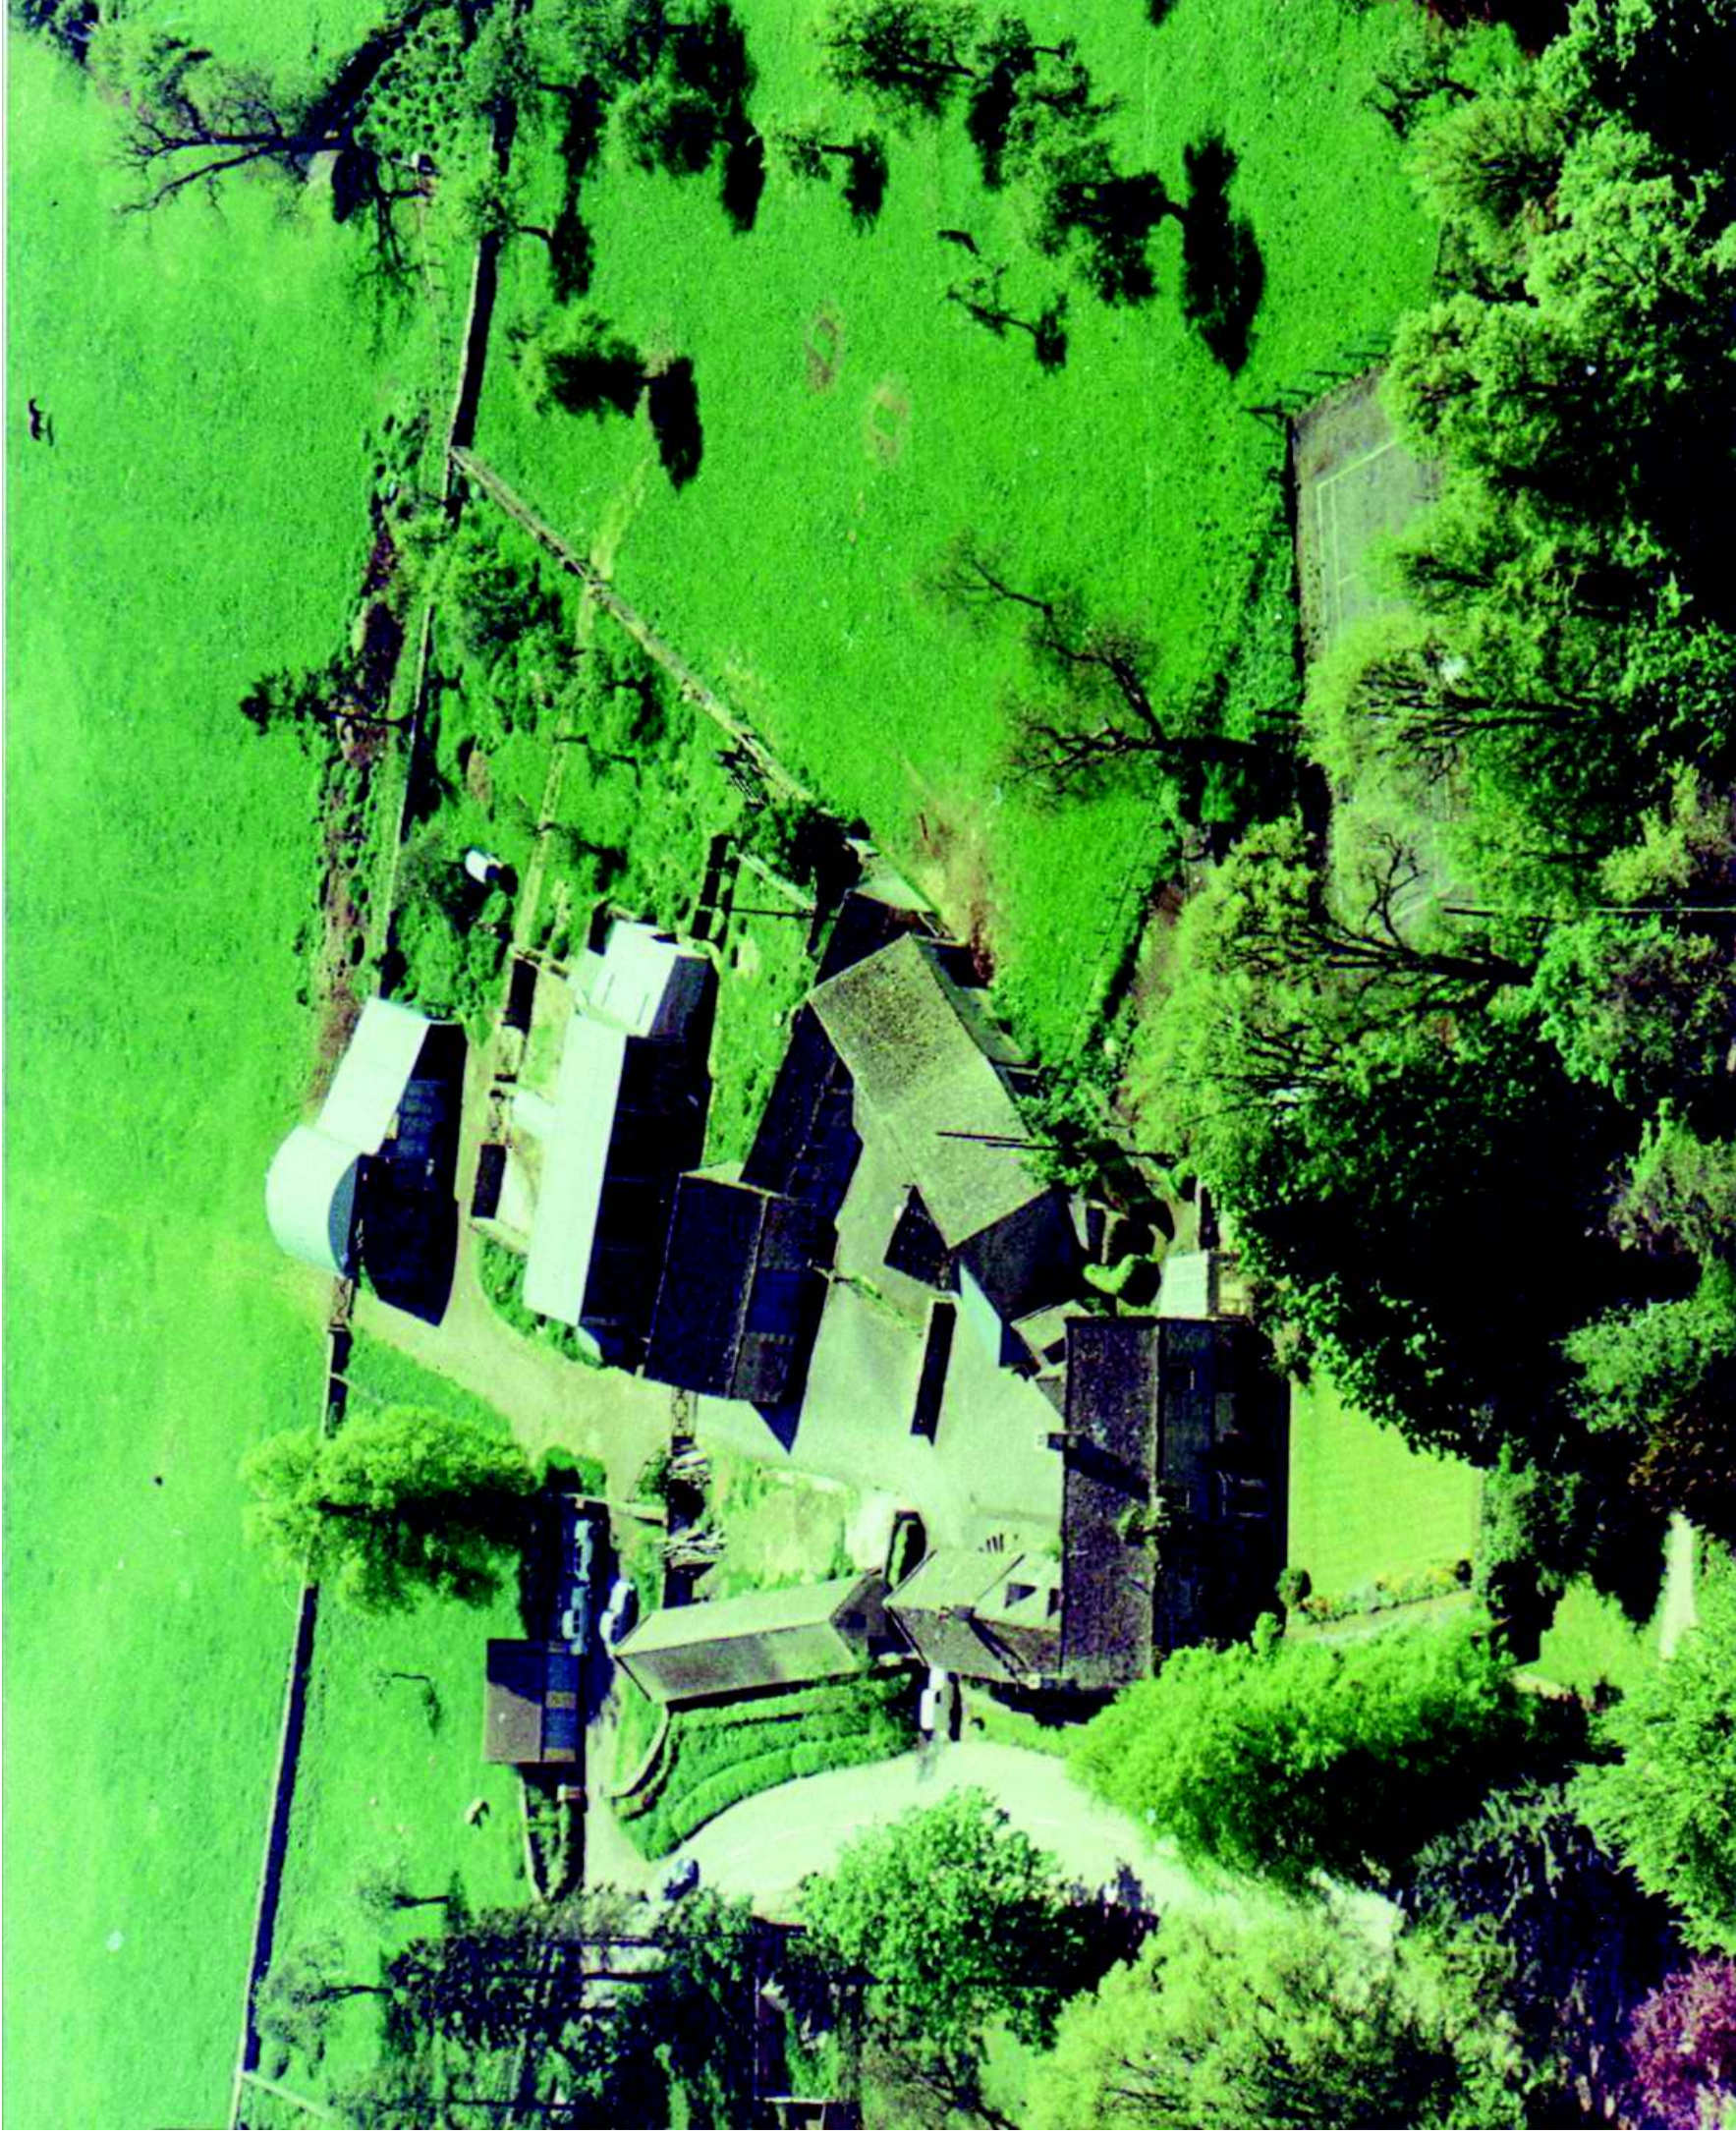
In this photograph, building 1 can be seen to the left of the image. Owing to the angle of the photograph, the cart shed bays cannot be seen.

Building 2A is present with stone gable walls visible at each end. The front of the building is open. The roof of 2A appears to be new. Lean-to structures are present on both the north and south ends of the building and the roof of 2B can be seen to the rear of the barn. 2C has not been constructed at this point.

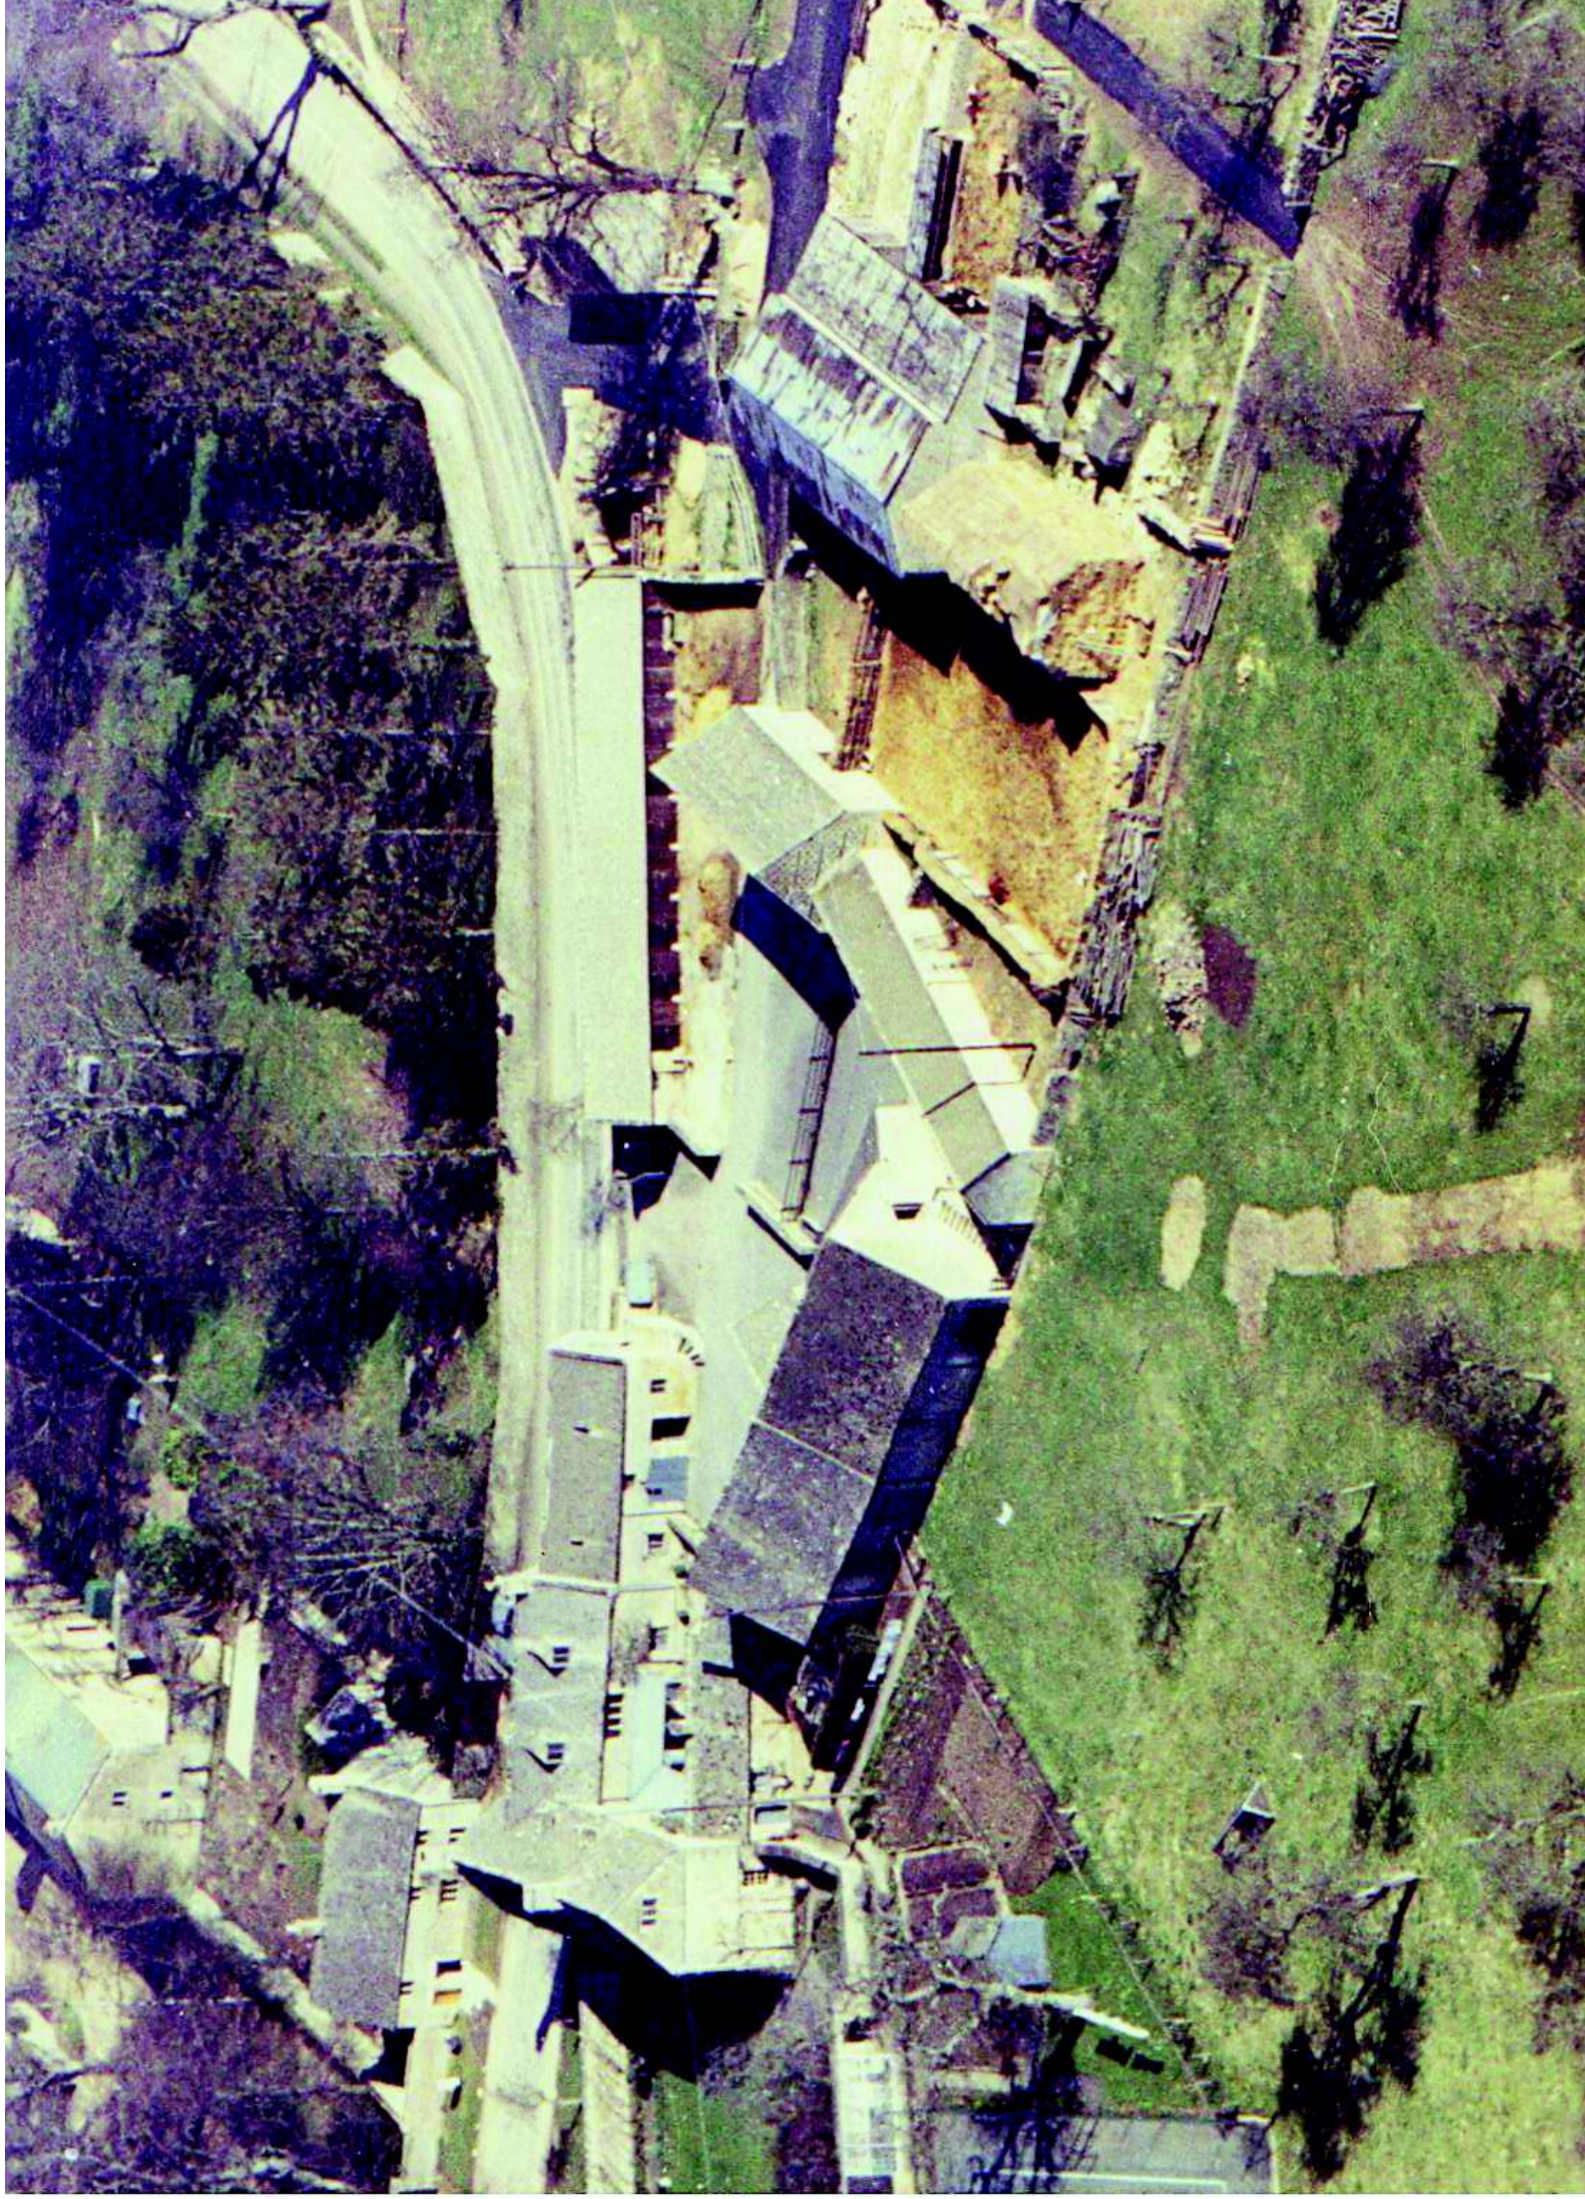
2A does not have its southern lean-to structure, and the location of the northern lean-to is obscured. A building in the location of 2B is present with an open front although the northern part is enclosed. A shelter projects from its centre to the east. 2C is not present. The roofs of 2A and 2B are rusty, indicating they are made of a ferrous metal.

Plate 55: Manor Farm in 1964, viewed from the south

An air photograph from 1964 (Plate 55) shows the cart shed with wooden doors closing the open bays on all but the westernmost bay, which appears to have a stone wall with a high window. The current southern wall is, therefore a post 1964 addition, including the westernmost bay as its window is now significantly different to that depicted in the 1964 photograph. It is noted that there is a considerable difference in the coursing and size of stone to the west of the original upright posts, suggesting a different date of construction, however this again can only be post 1964.

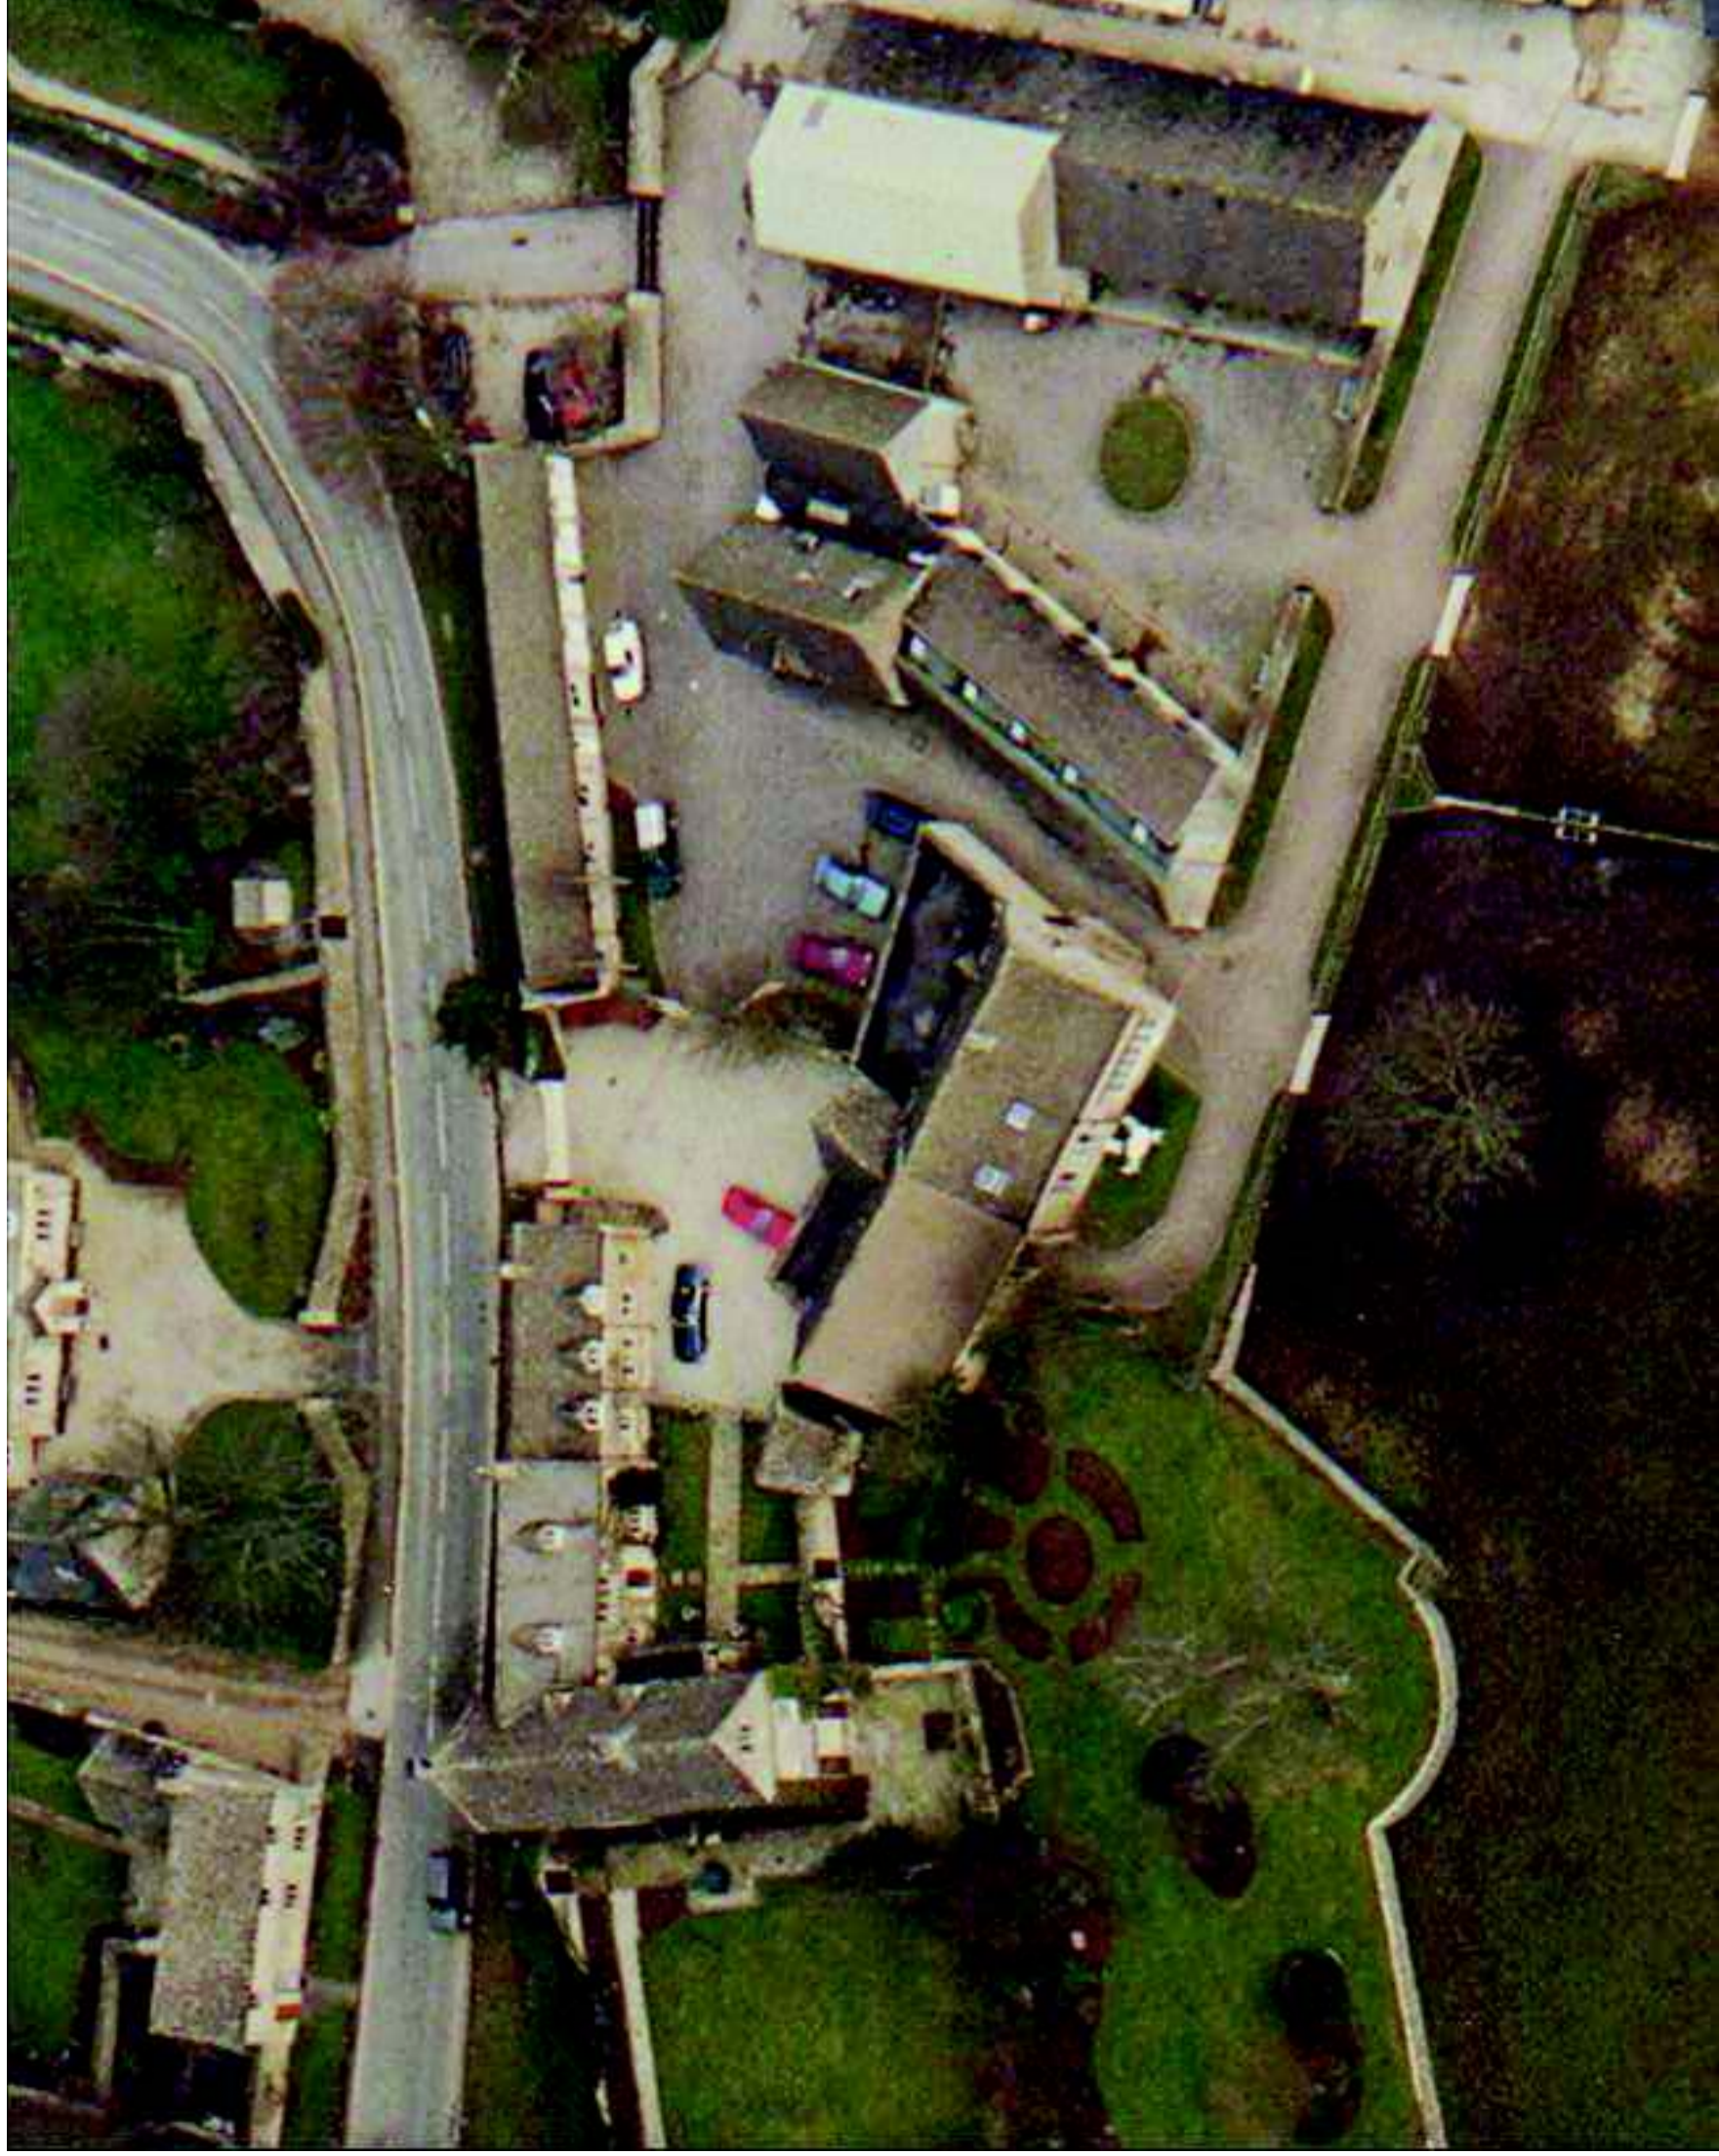
Plate 56: Manor Farm and surroundings in c. 1989, viewed from the south

It is noted in this image that a large amount of development has occurred in the area to the north of the farm.

To the south of the farm buildings, part of the field has been reclaimed creating the roadway present today.
