CONSERVATION STATEMENT

**MANOR FARM
LOWER SLAUGHTER
GLOUCESTERSHIRE**

**Conservation Statement
For
Manor Farm
Lower Slaughter, Gloucestershire**

Site Name	Manor Farm
Address	Lower Slaughter
County	Gloucestershire
NGR	SP167225
Listing	Not Listed – Curtilage of Grade II farmhouse and wall
Conservation Area	Lower Slaughter Conservation Area
Material	Cotswold Limestone
Date	18 th century – modern
Function	Farm
Alterations	Conversion to residential accommodation and stables
Original Features	Cart shed, threshing barn, barn
Historic Interest	Fair
Architectural Merit	Fair
Degree of Alteration	Very high

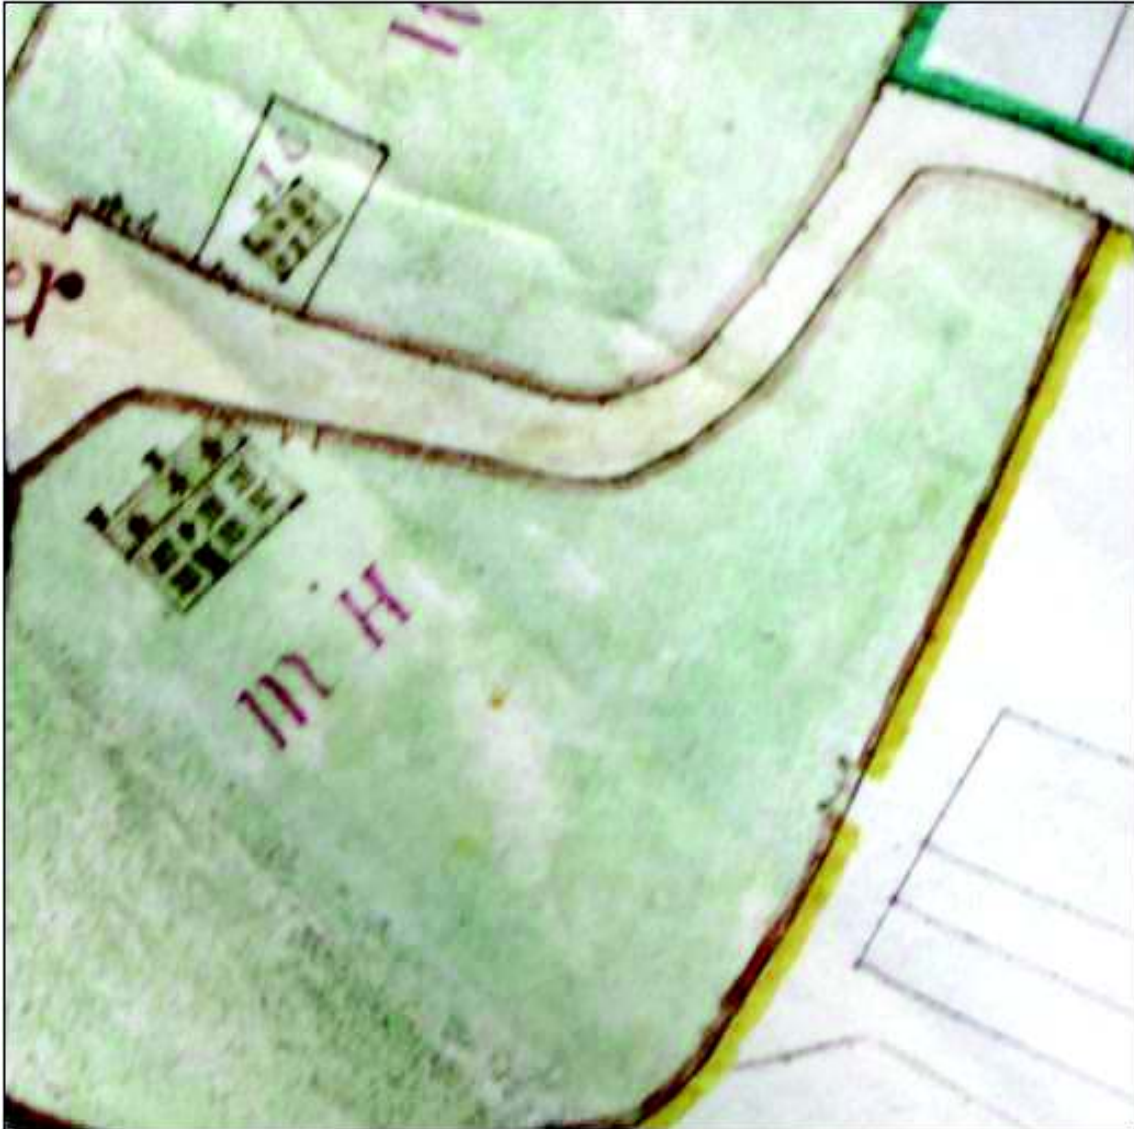
Figure 3: 1731 Map of Slaughter Fields, approx 1:1000@A4

This map shows the area of Manor Farm as a single large field, gated to the east. A house is present (this may be a forerunner to the farmhouse) and the letters 'M H' are thought to indicate that the land is in the ownership of the manor house. 'M H' is not a label for the building as several other plots of land in the vicinity are similarly labelled.

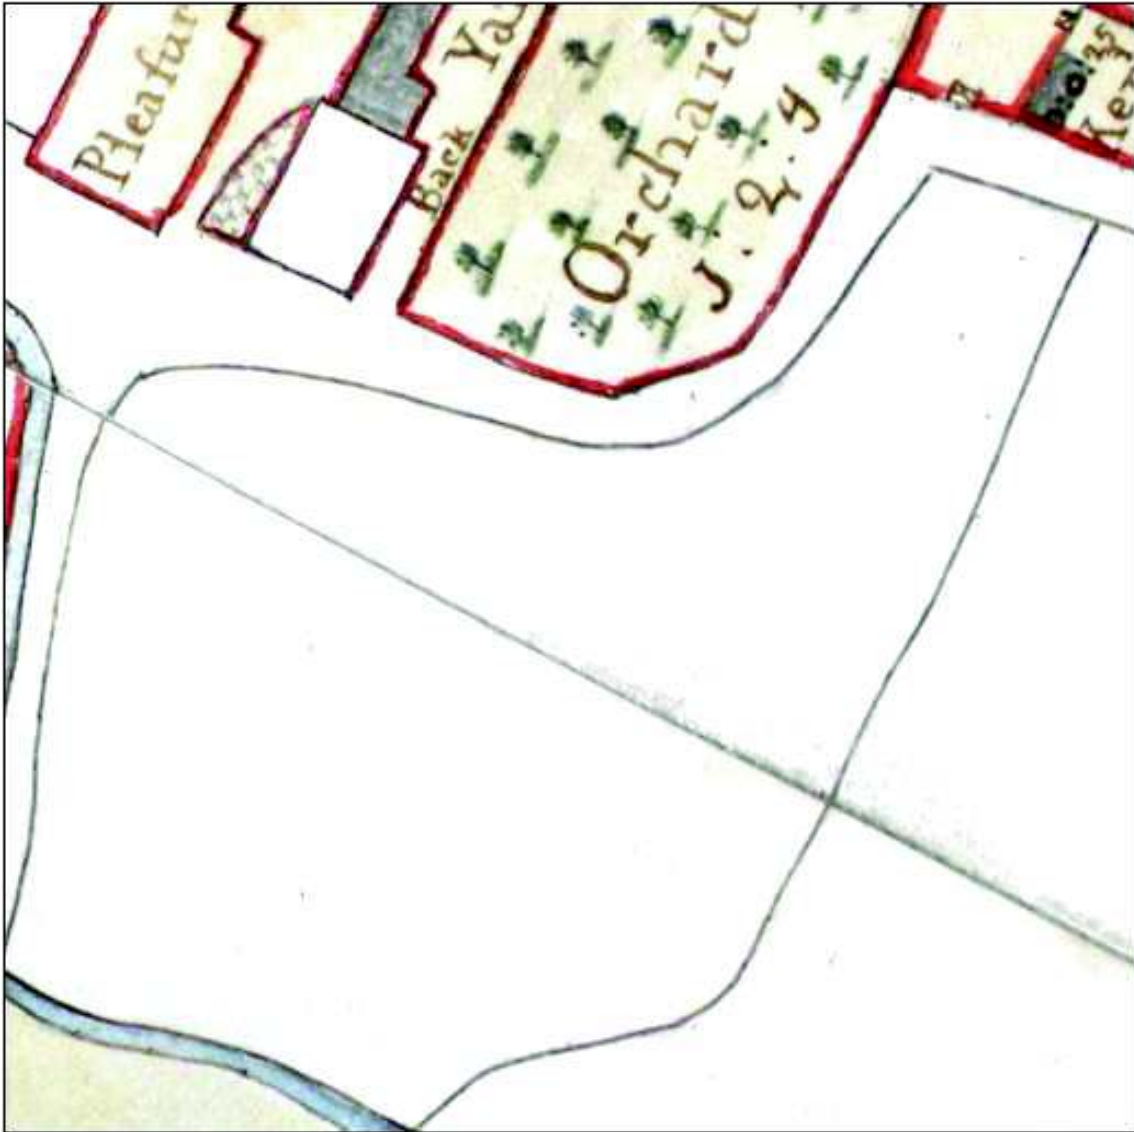
Figure 4: 1769 Parish Map, approx 1:1000@A4

The parish map of 1769 shows no buildings on the land. Nearby buildings, however, are present, marked in grey. It can be assumed, therefore, that Manor Farm did not exist at this point.

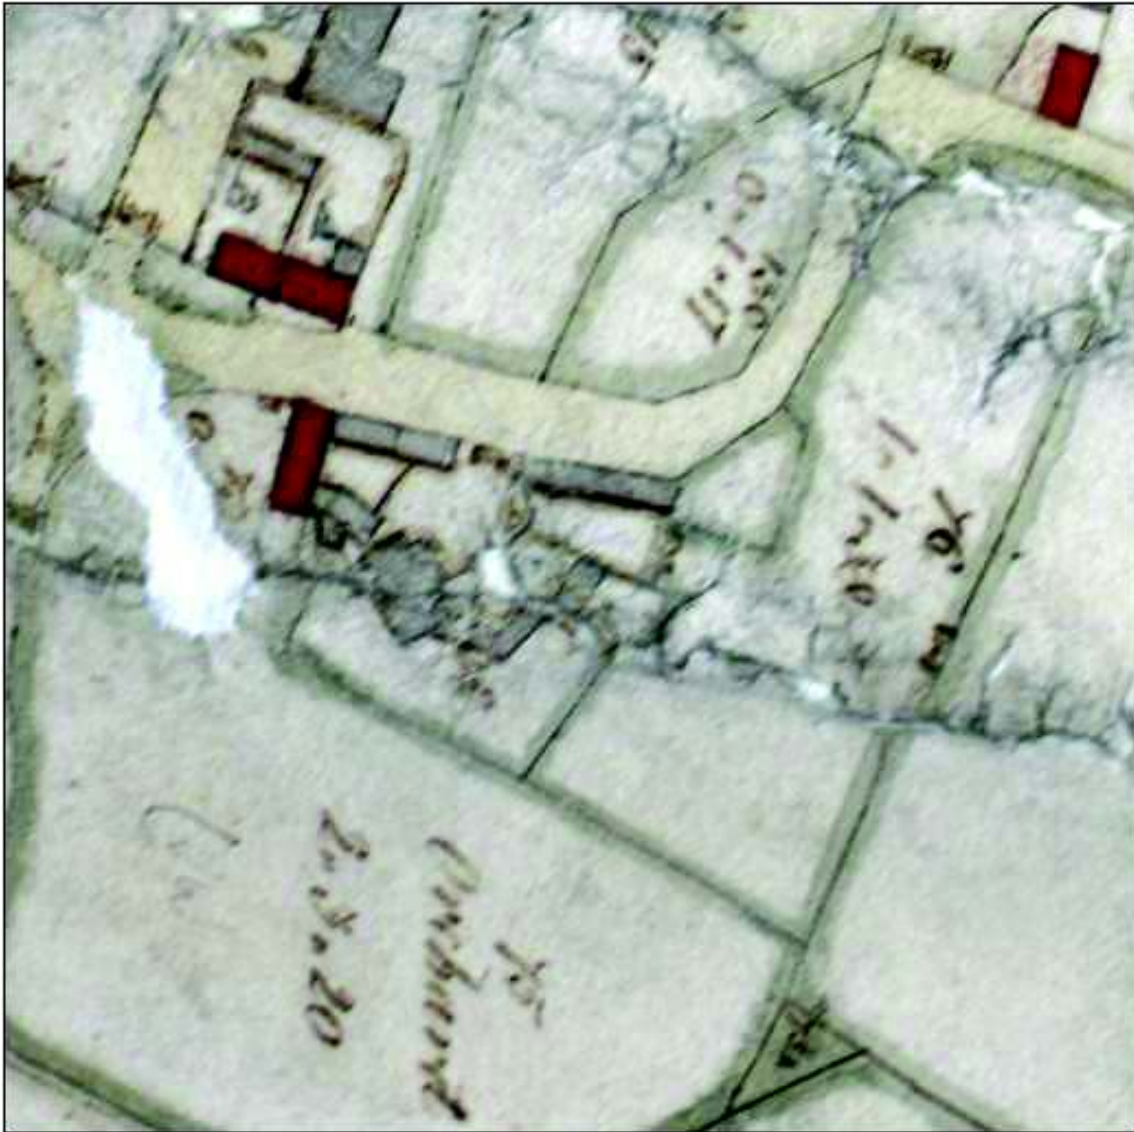
Figure 5: 1847 Parish Map, approx 1:1000@A4

A somewhat unclear map, the farmhouse and cart shed are clearly visible along the road. 4A is present as are 3A and the pre-3B structure. It is thought that nothing is different to the 1885 plan which follows.

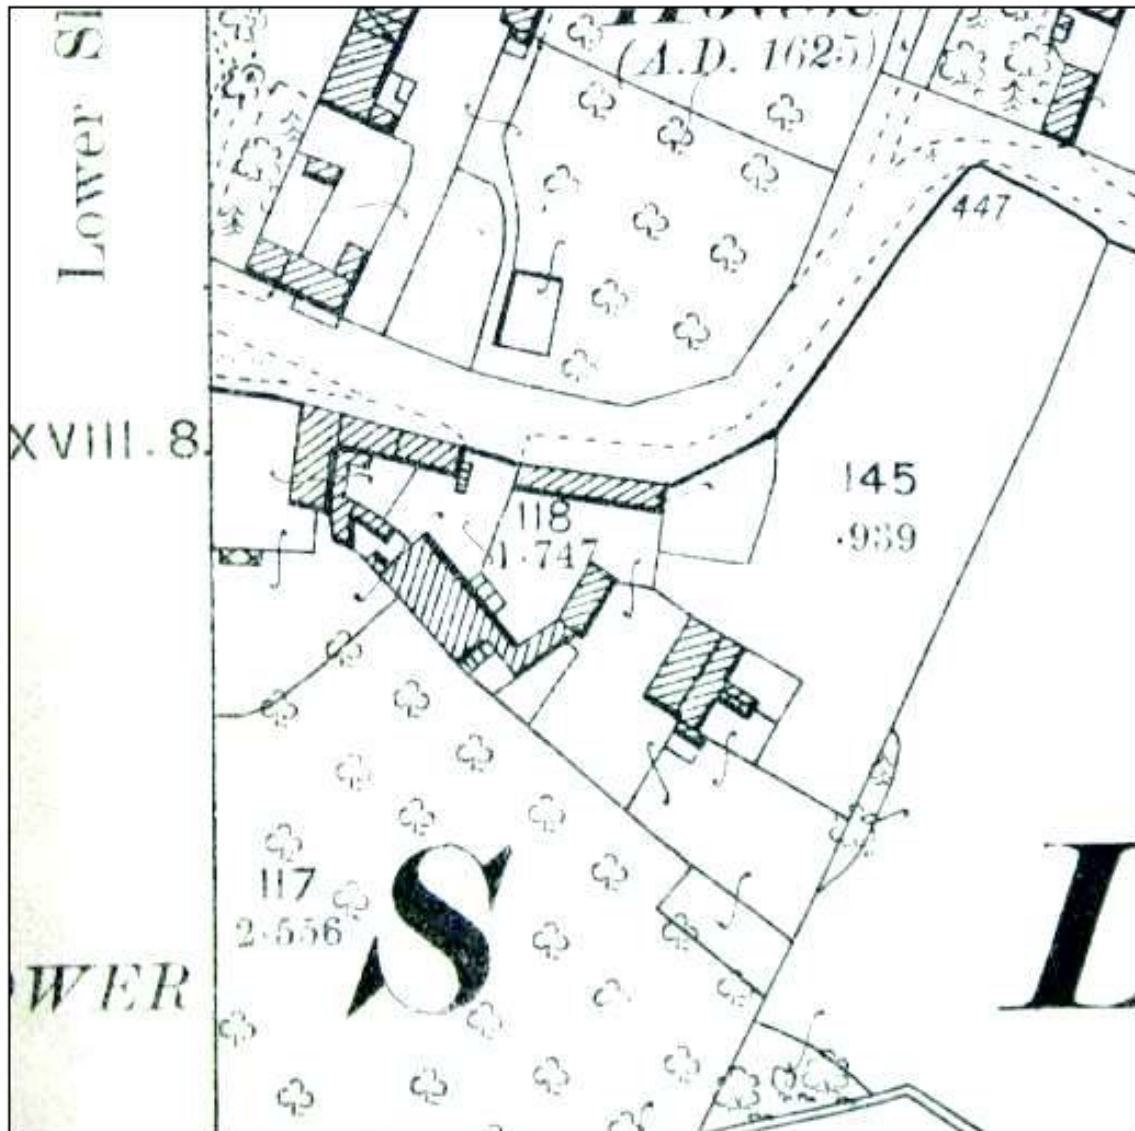
Figure 7: 1902 Ordnance Survey, 1:1000@A4

Building 2A has been constructed. A building is depicted in the location of building 2B, with a projecting section straddling two paddocks to the east.

South of this, a small building with enclosed area is present, considered to be a pigsty or similar.

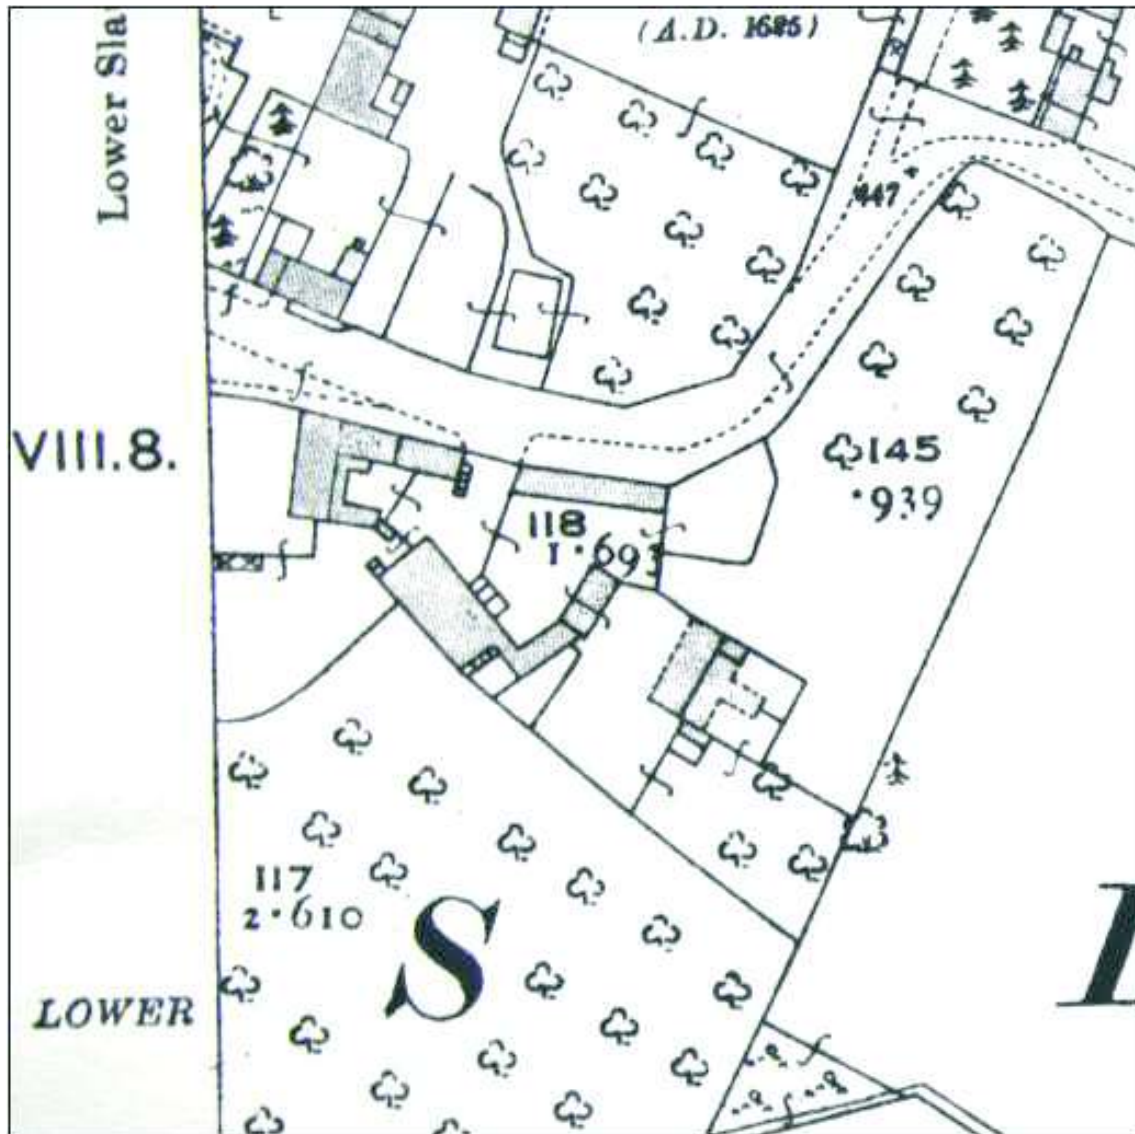
Figure 8: 1922 Ordnance Survey, 1:1000@A4

By the 1920s buildings were depicted as being open or enclosed. It can be seen that 2A, the building in the location of 2B, and the protruding section to the east are all open fronted. Otherwise, there is no change from the 1902 map.

On the 1922 map, the T-shaped building was open faced to the east except for the northernmost end, and was open around the perimeter of the protruding 'T' section. It is likely that this was the case before this, however the 1902 map has no means of distinguishing open sides of buildings from closed. The building was still open sided on both the estate plan and the air photograph of 1964, however was enclosed by 1977.

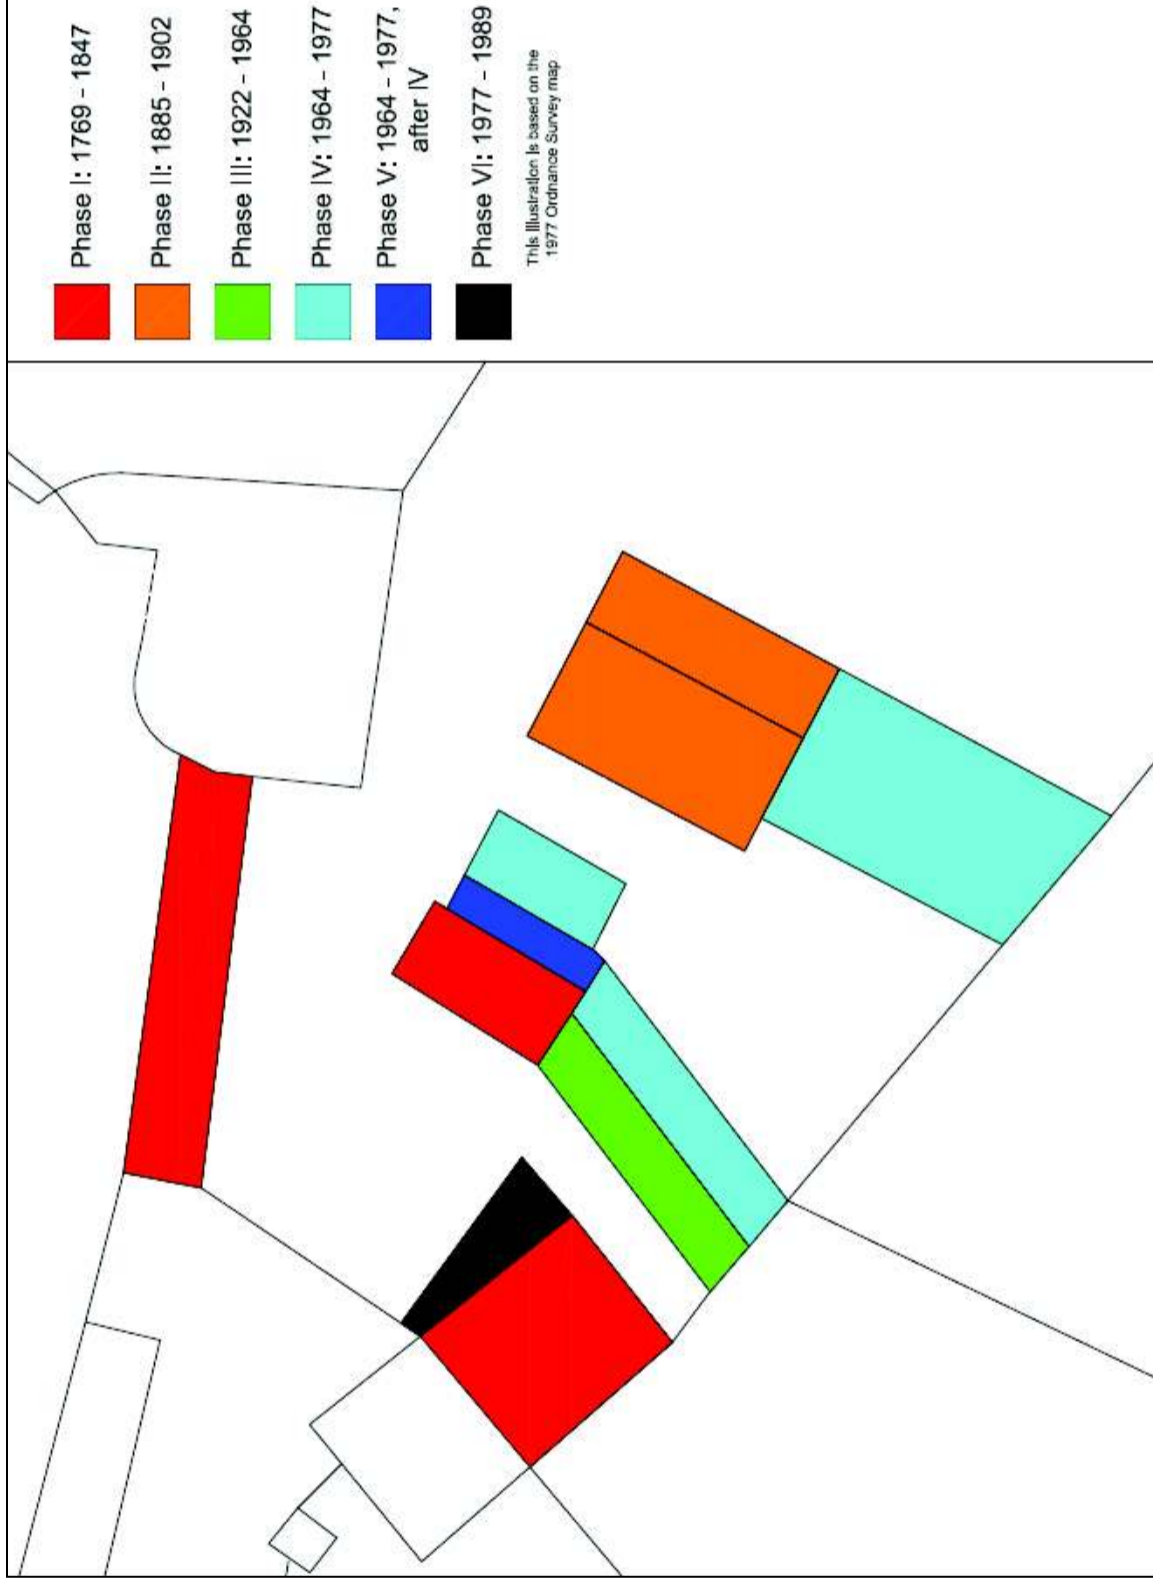
Figure 11: Overall phase plan, 1:500@A3

- Phase I: 1769 - 1847
- Phase II: 1885 - 1902
- Phase III: 1922 - 1964
- Phase IV: 1964 - 1977
- Phase V: 1964 - 1977, after IV
- Phase VI: 1977 - 1989
