Swindon United Charities Almshouses  
(Christ Church Cottages / Anderson's Hostel)

Cricklade Street  
Swindon

**Conservation Statement For  
Swindon United Charities Almshouses  
(Christ Church Cottages / Anderson's Hostel)  
Cricklade Street, Old Town, Swindon**

**In connection with planning application  
reference number: S/LBC/08/1674**

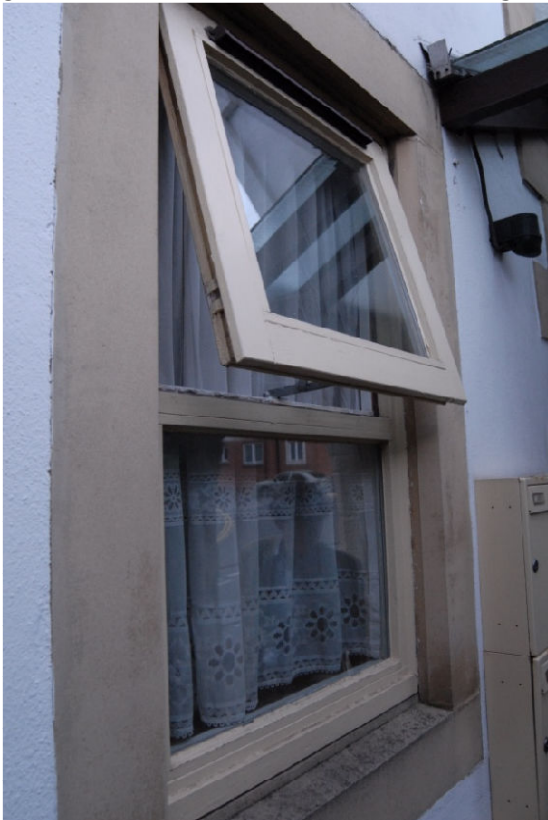
At that time some windows were replaced with modern casement windows which are out of keeping with the character of the building.

There can be no doubt that extensive repairs to the original windows are necessary - this is obvious. Some of the windows are “dangerous” in that excessive force is needed to open them and inevitably a hand is placed on thin Victorian glass to add more force. Another window cannot be secured. Most leak and there is extensive mould present. All, apart from one, are difficult to open.

For a number of years attempts have been made to repair these windows but these repairs have been unsuccessful. The specialist firm, Cotswold Casements, considers that they are “beyond repair”. It is emphasised that the proposal is to replace some elements of the windows on an exact like with like basis.

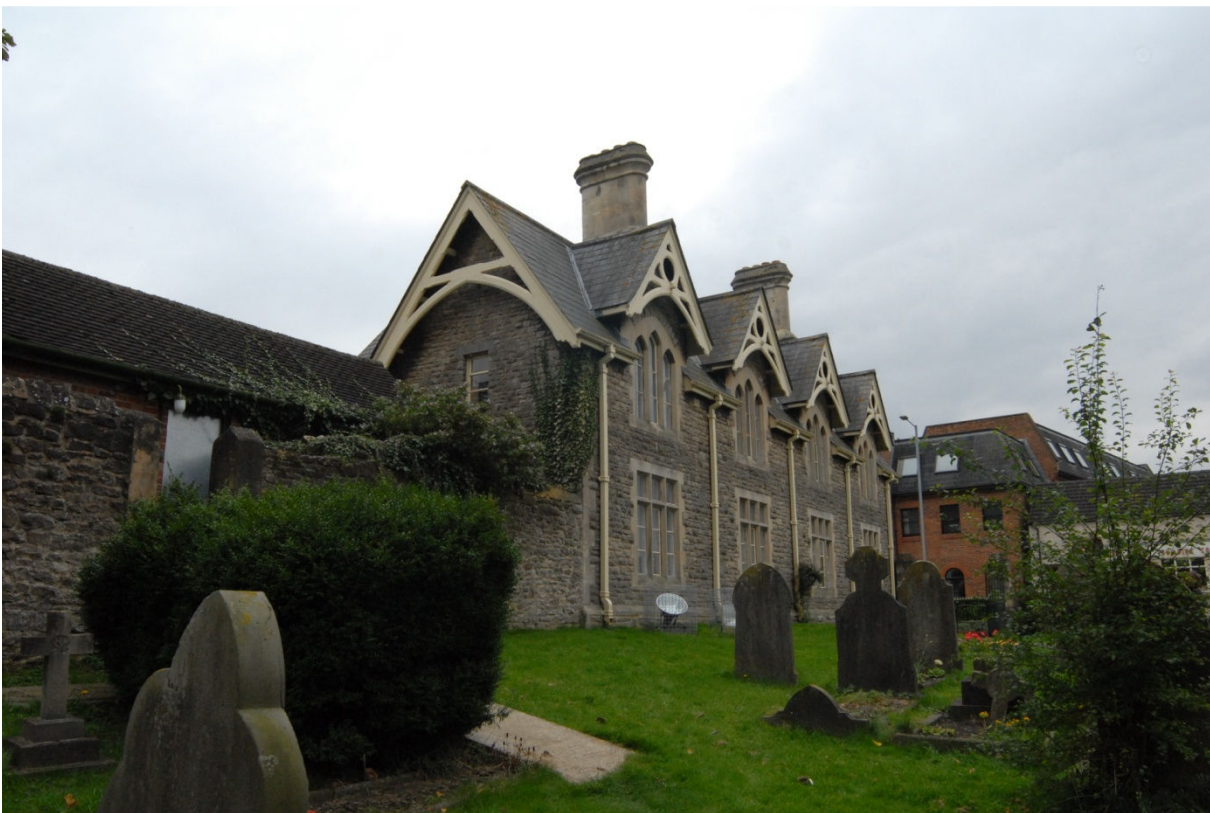
**Plate 1: Almshouses, 27-30 Cricklade Street, Swindon**

The windows on the front elevation are uniformly arranged in groups of three. Those on the first floor are situated in ornate gables. These windows are set into stone surrounds

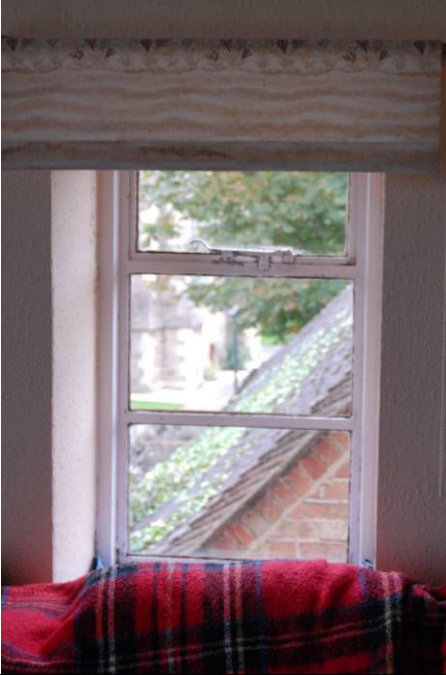
<b>Wall</b>	East
<b>Window</b>	1

<b>Window ID</b>	1A
<b>Configuration</b>	Top-hung casement
<b>Furniture</b>	?Original stay
<b>Defects</b>	
<b>Window ID</b>	1B
<b>Configuration</b>	1x2
<b>Furniture</b>	
<b>Defects</b>

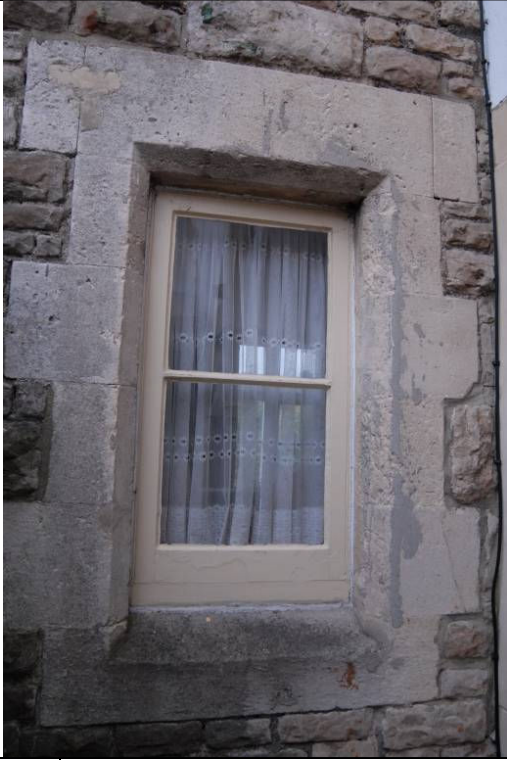
<b>Wall</b>	Rear
<b>Window ID</b>	1

<b>Configuration</b>	1x2, non-opening
<b>Furniture</b>	None
<b>Defects</b>

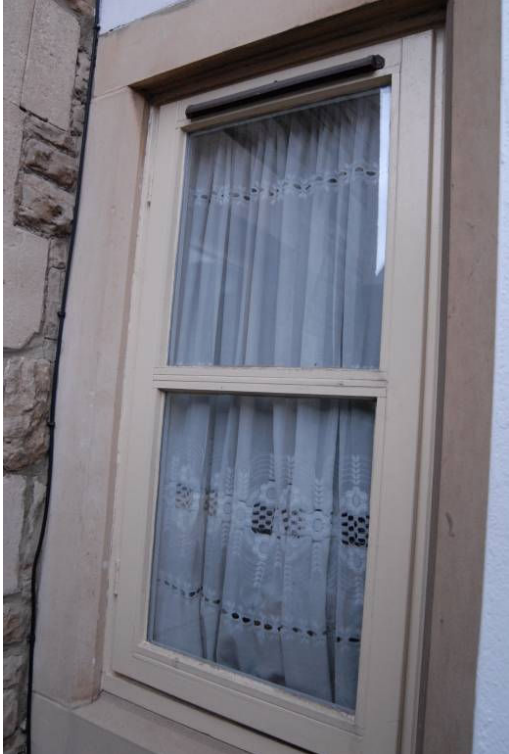
<b>Wall</b>	Side
<b>Window ID</b>	2

<b>Configuration</b>	1x2 modern side-hung casement
<b>Furniture</b>	
<b>Defects</b>

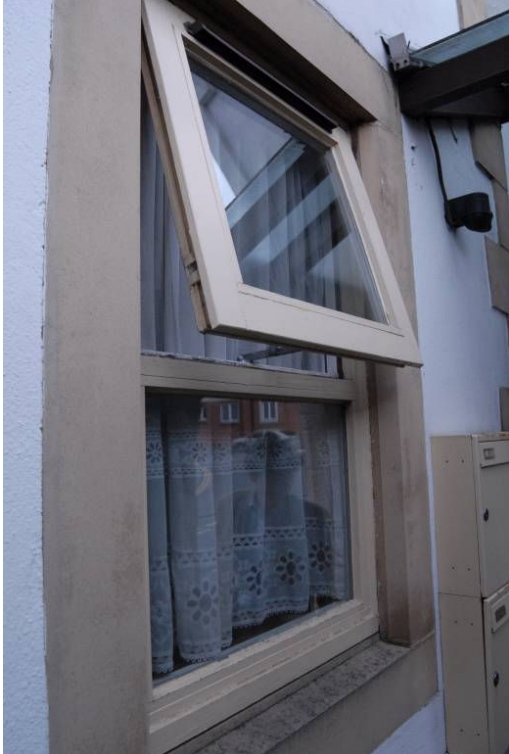
<b>Wall</b>	Side
<b>Window ID</b>	3

<b>Configuration</b>	Single pane with top-hung casement over, modern
<b>Furniture</b>	
<b>Defects</b>
